Structure Number: 0256
Facility Carried: VARNEY MILL RD

Highway Bridge Inspection Report

Bridge Name: VARNEY MILL

Town: Windham

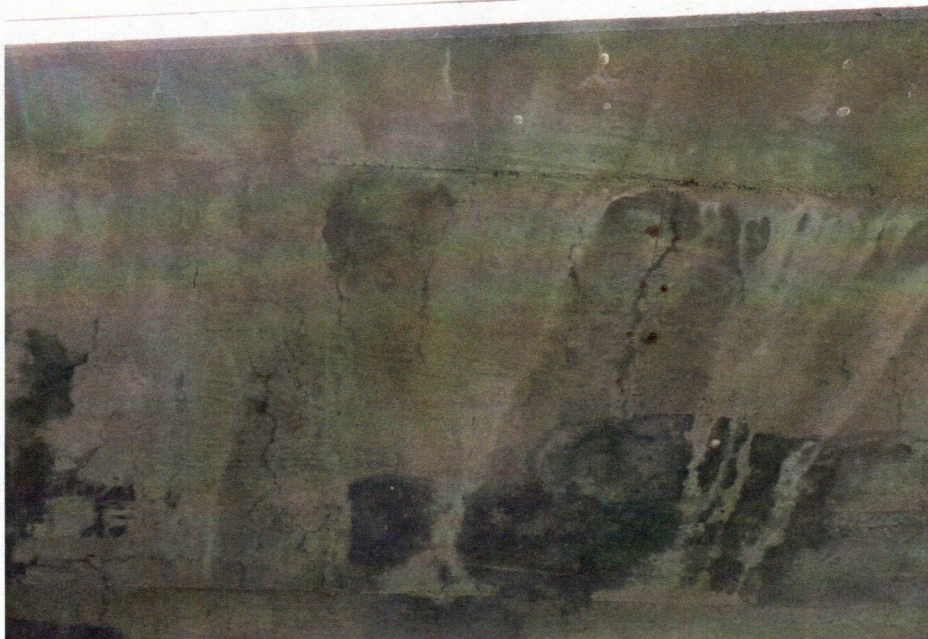
PHOTO 6

Scattered hairline cracking and discoloration in the last 5 feet of the underside of the slab below the DS fascia.
No other defects found in top of box.

Description Bottom of slab below DS fascia

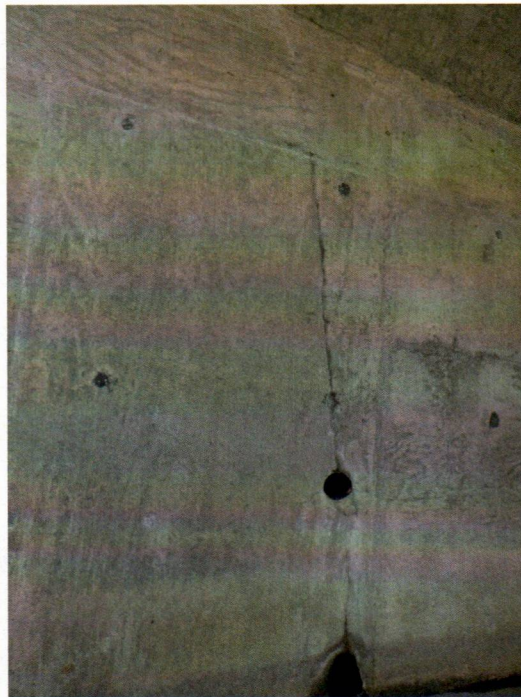
PHOTO 8

Footing visible throughout entire structure unable to full wade do to flow of water from dam upstream.
Scattered full height hairline vertical cracks on both abutments and footings.
One area of shallow spalling and dark staining on the top of the west end of south abutments footing.
Minor scaling throughout footings.

Description Multiple full ht cracks in both abutments

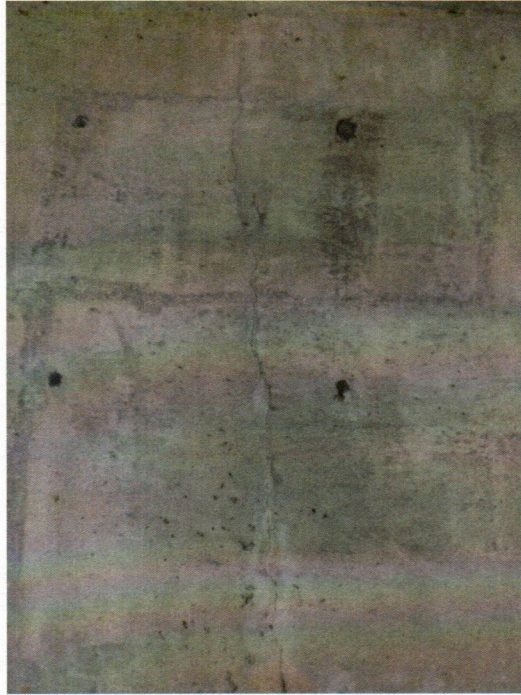
PHOTO 9

Description Multiple full ht vertical cracks in both abutments

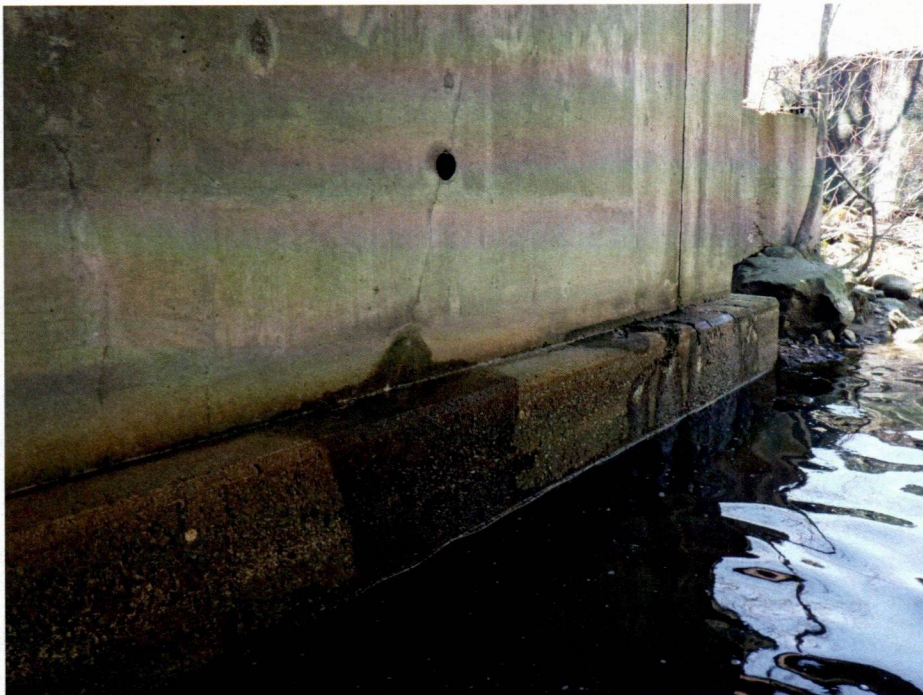
PHOTO 12

Description Spalling in US end of south footing

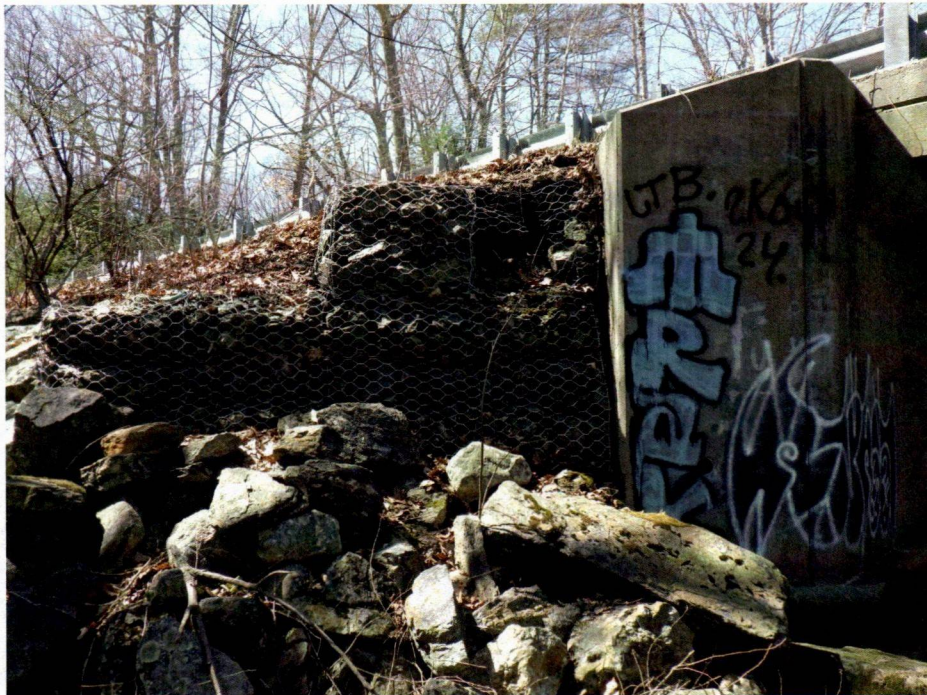
PHOTO 16

Approach rails have moderate flattening and scattered minor impact damage.
One gabion basket on the SE wall has been damaged and missing most of its rocks. Ends of broken gabion basket wires look cut.
All Gabon baskets have bulging at the bottoms.
Isolated moderate impact damage in approach rails.

Description SE gabion basket failure

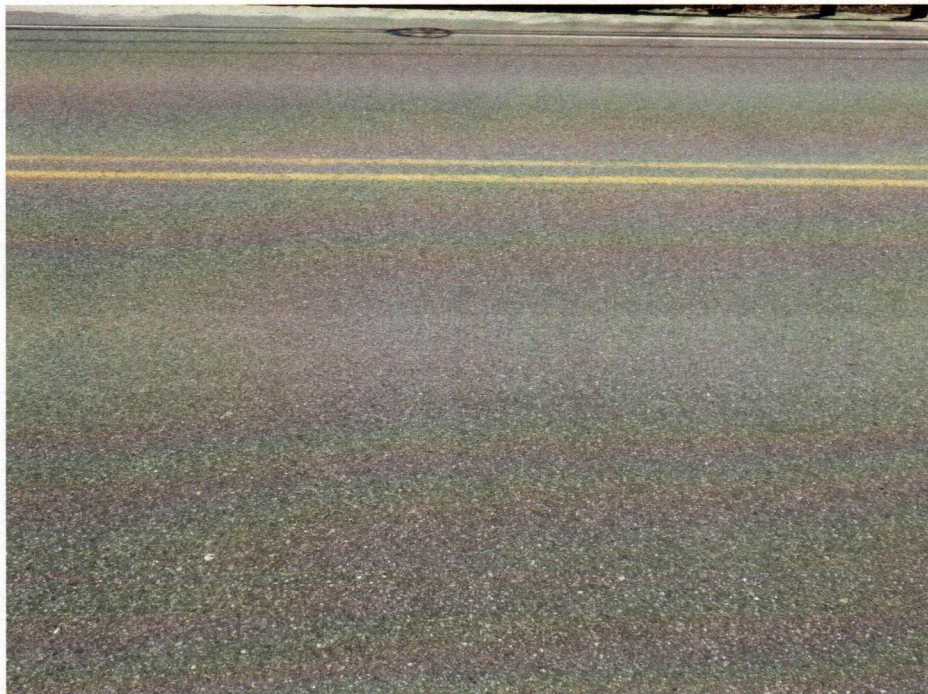
PHOTO 18

Bituminous wearing surface is in good condition.

Description Bituminous wearing surface

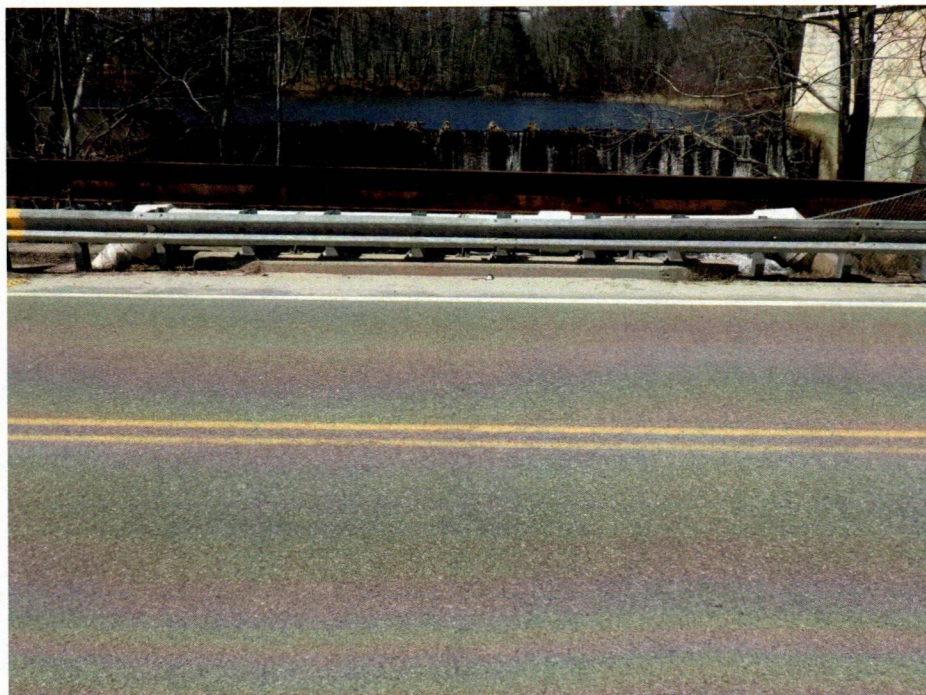
PHOTO 19

Curbs have scattered minor hairline cracking.
Bridge rails have scattered areas of scraping with surface corrosion and minor impact damage.

Description West bridge rail

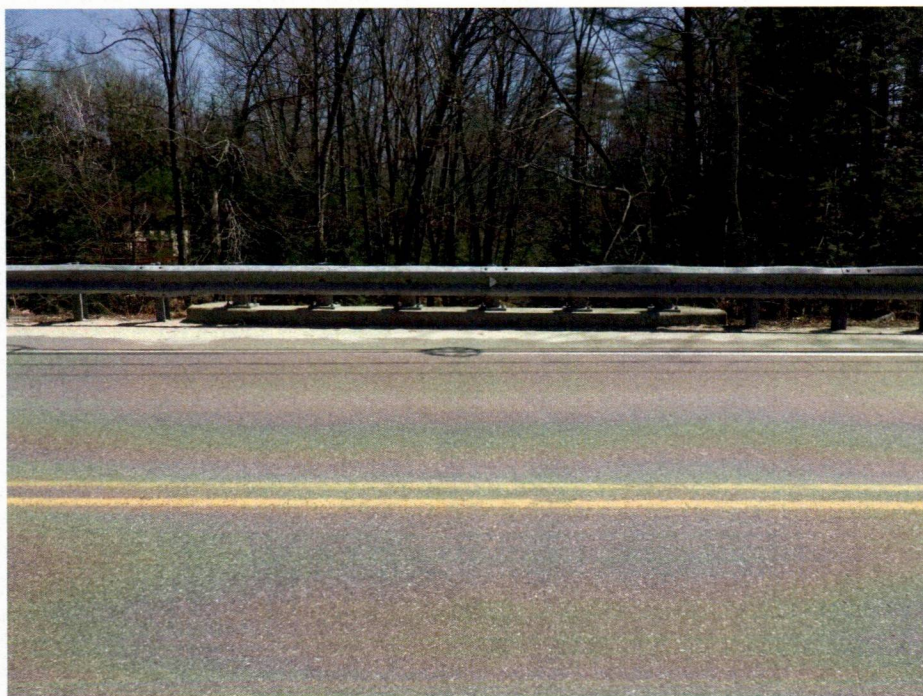
PHOTO 20

Description East bridge rail

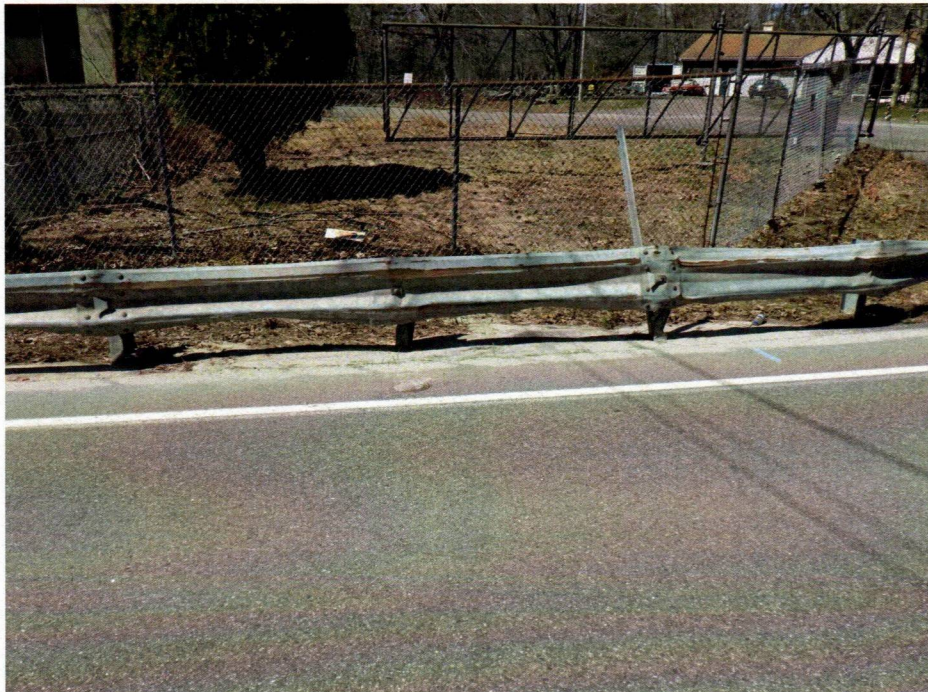
PHOTO 22

Description Flattened right approach rail headed south

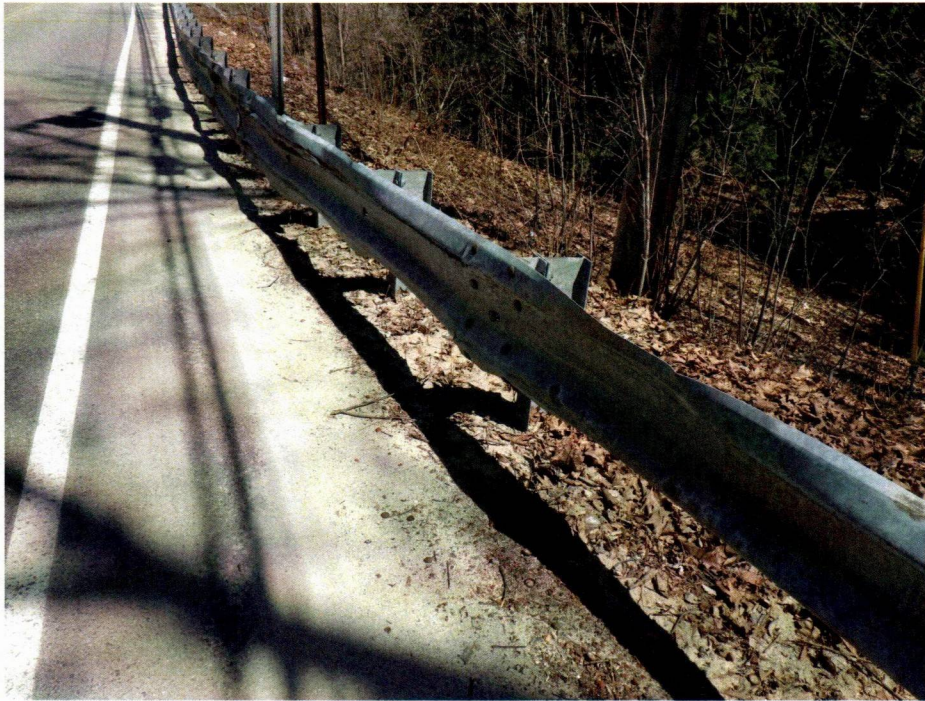
PHOTO 23

Description Flattened right approach rail headed north

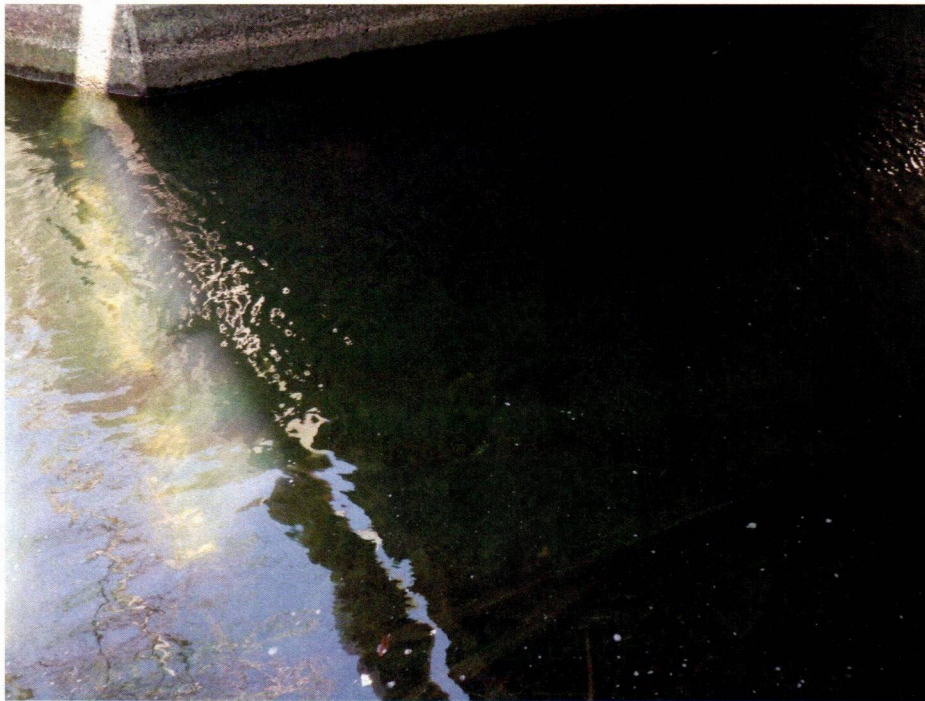
PHOTO 24

Dam directly upstream of structure.
Ledge and rocks throughout.
Scour hole at inlet doesn't effect structure footings.

Description Scour hole at inlet (2)
