FIELD OBSERVATION REPORT

Project: Sebago Heights Subdivision – Phase 3&4

Client: Town of Windham

Visit Date: October 24, 2016

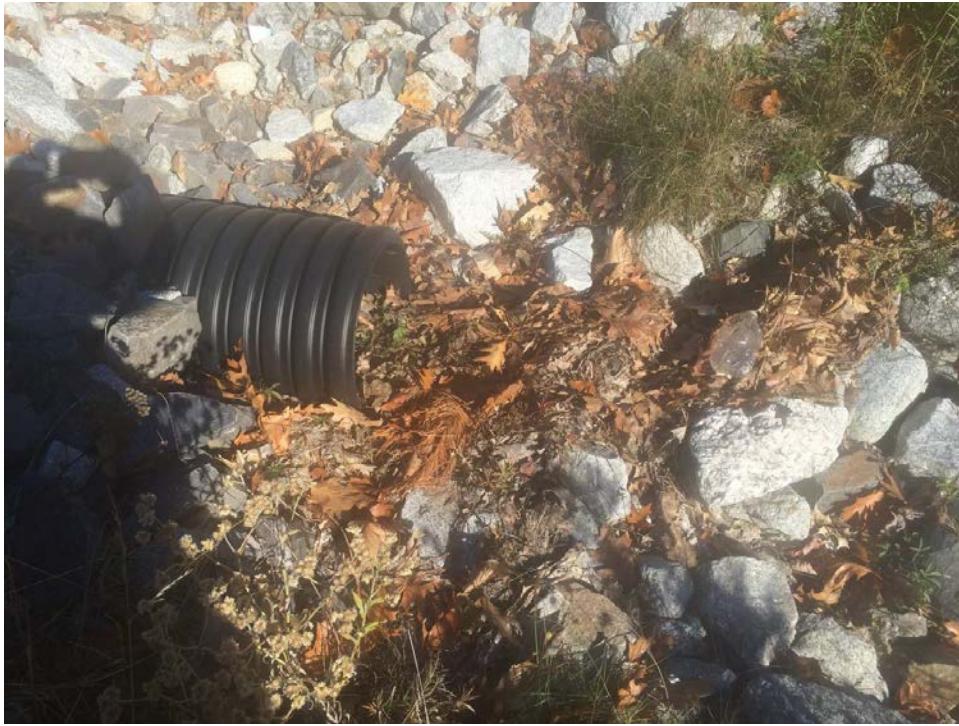
- CB34 – Approximately 4-5" of sediment in sump.
- CB34 Outlet to swale – Vegetation growth at outlet. Leaves and other debris also appear to be obstructing the outlet flow. Vegetation, leaves, and debris shall be removed.

Photo 1 – CB34 outlet with leaves and sediment obstructing outlet flow.

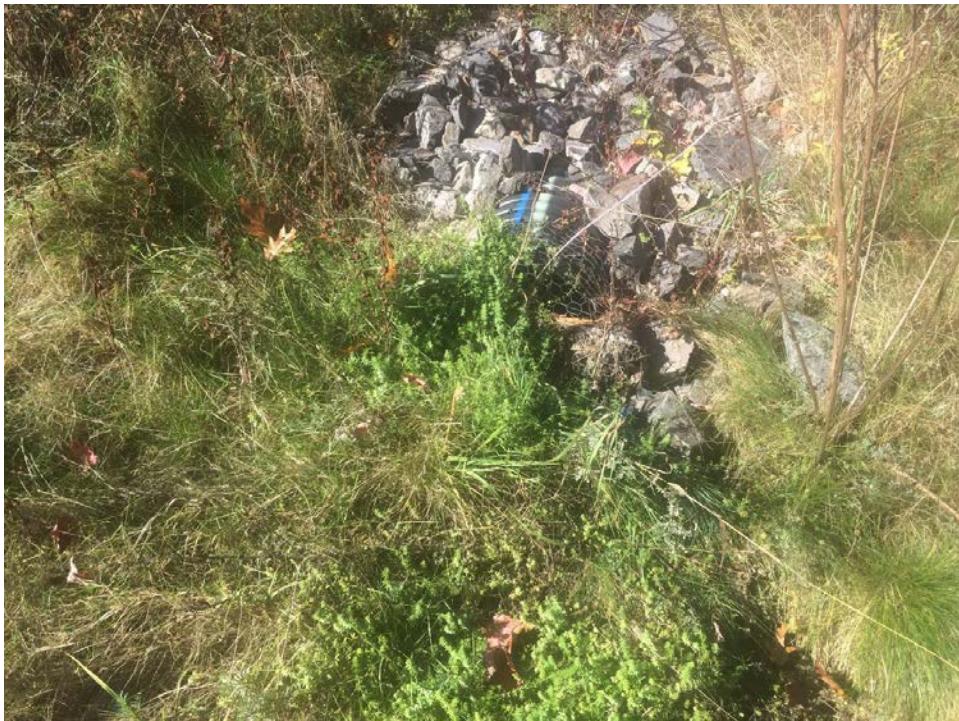
- CB32 – Approximately 1-2" of sediment in sump. Brick collar appears to be in good condition.
- CB33 – Approximately 1-2" of sediment in sump.
- CB33 Outlet to swale – Vegetation growth has obstructed outlet flow. Vegetation shall be removed.

Photo 2 – CB33 outlet with vegetation overgrowing and obstructing the outlet flow.

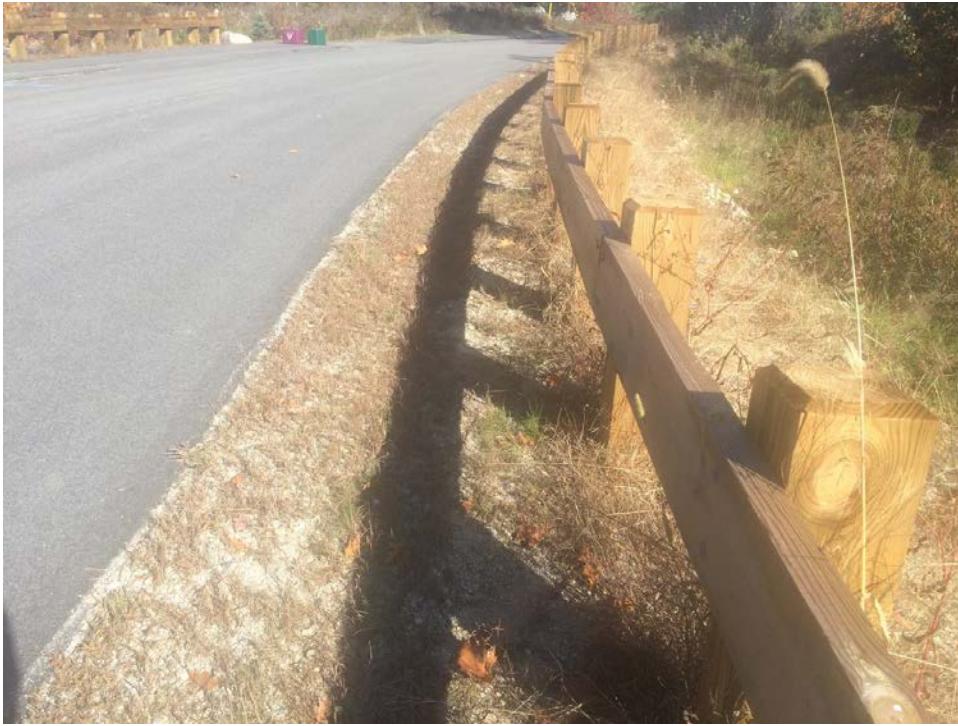
- Vegetation is sparse from +/- sta. 11+50 to +/- sta. 12+50 LT along fence line. Area shall be re-seeded.
- CB28 – Approximately 8-10" of sediment in sump.

Photo 3 – +/- sta. 11+50 to +/- sta. 12+50 with sparse vegetation near fence line.

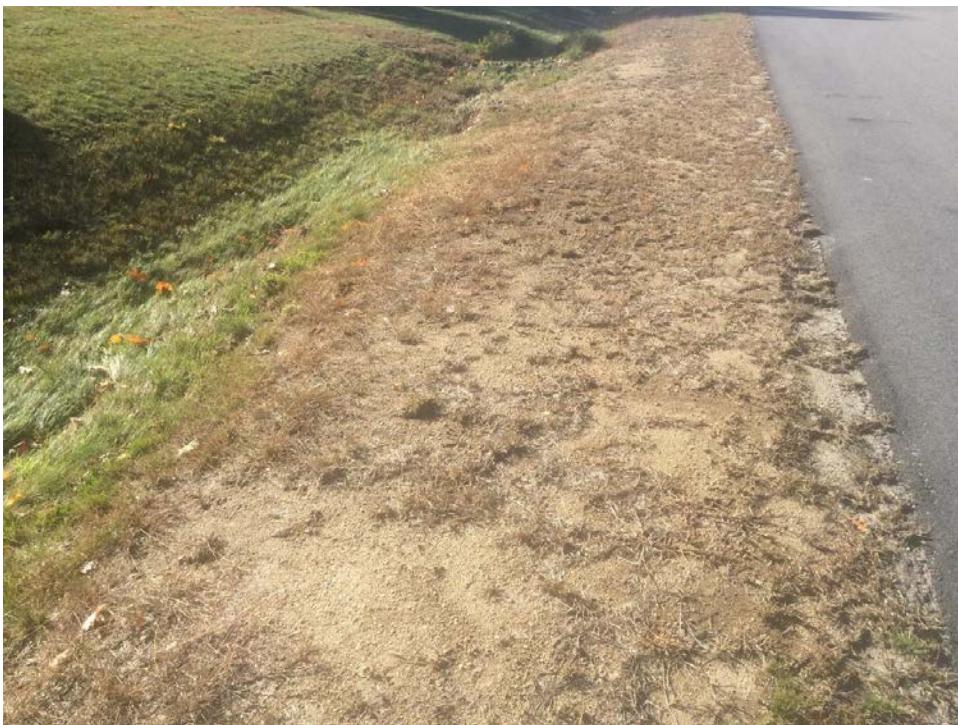
- Vegetation is sparse from +/- sta. 22+00 to 24+50 RT on drainage swale slope. Area shall be re-seeded.
- Roadway crossing culvert near +/- sta. 22+40 LT has sediment and vegetation obstructing the inlet in the riprap apron. Sediment and vegetation shall be removed from the riprap apron.

Photo 4 – Area of sparse vegetation near +/- sta. 23+75 RT.

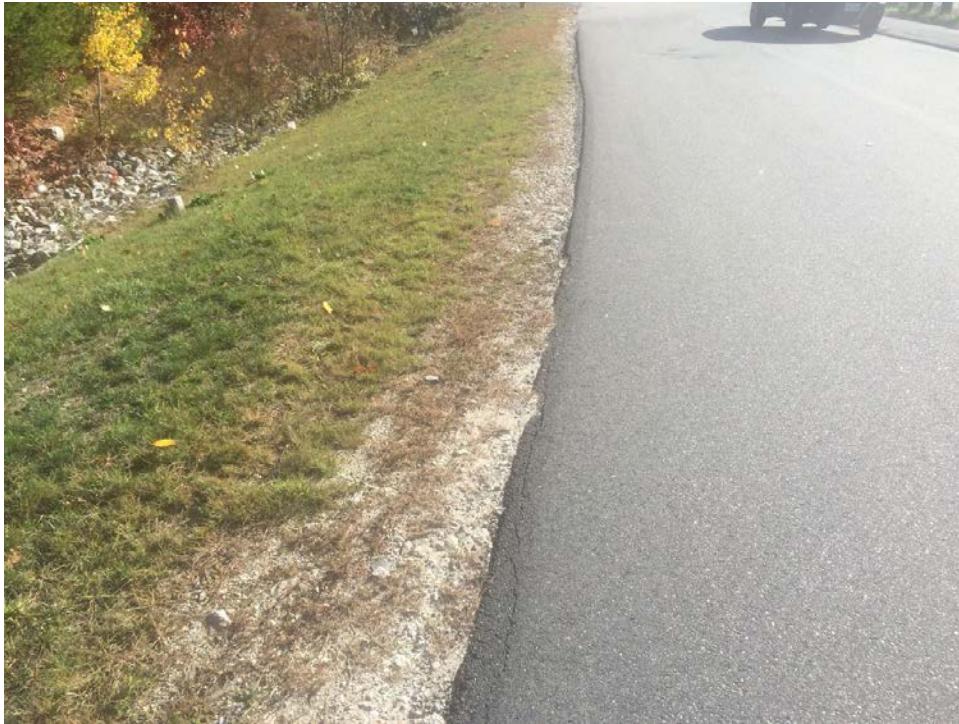
- Sediment in riprap apron for CB21 outlet. Sediment shall be removed from the riprap apron.
- Vegetation is sparse at the edge of pavement from +/- sta. 17+00 to 21+00 RT. Area shall be re-seeded.

Photo 5 – Area of sparse vegetation at edge of pavement near +/- 21+00 RT.

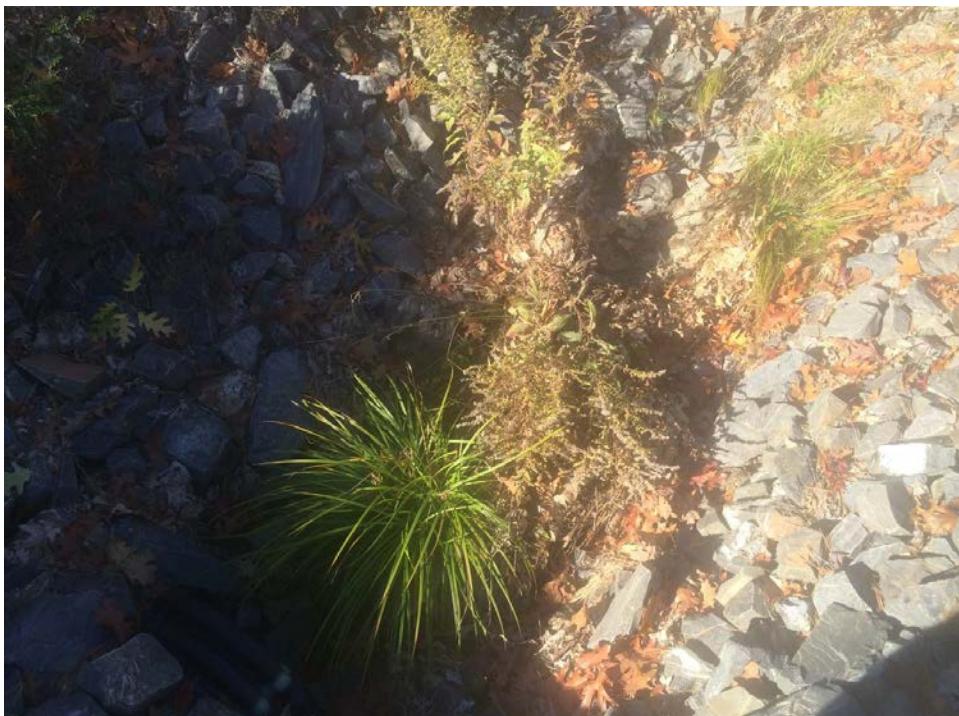
Photo 6 – Vegetation and sediment obstructing culvert inlet near +/- sta. 22+40 LT.

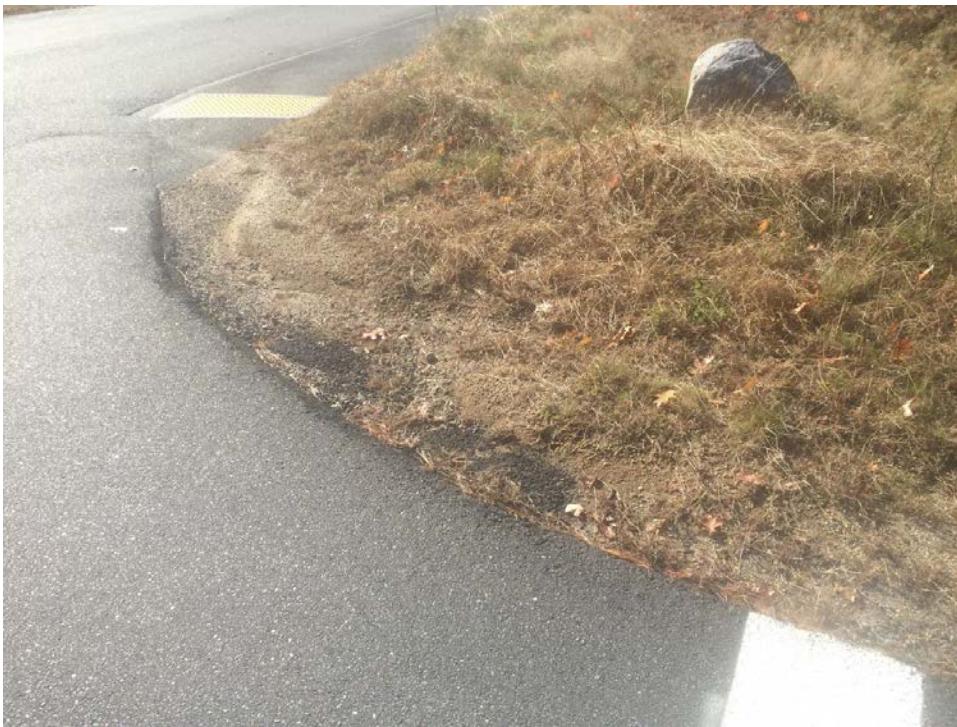
- Bare area at sidewalk near +/- sta. 22+40 LT. Area shall be re-seeded to establish vegetation.
- Vegetation is sparse behind CB26 near transformer. Area shall be re-seeded.

Photo 7 – Bare area near sidewalk at +/- sta. 22+40 LT.

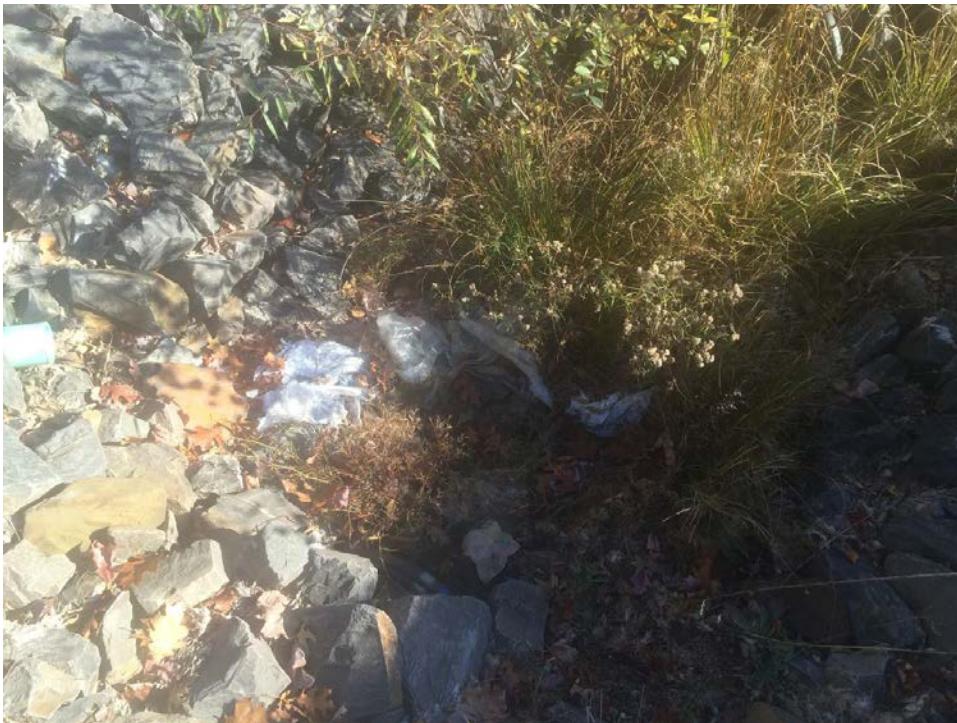
- Trash/debris in the riprap apron near +/- sta. 59+00 LT. Trash/debris shall be removed from the riprap apron.
- CB21 – Approximately 10+” of sediment in sump. Brick collar appears to be in good condition.

Photo 8 – Trash/debris in riprap apron near +/- sta. 59+00 LT.

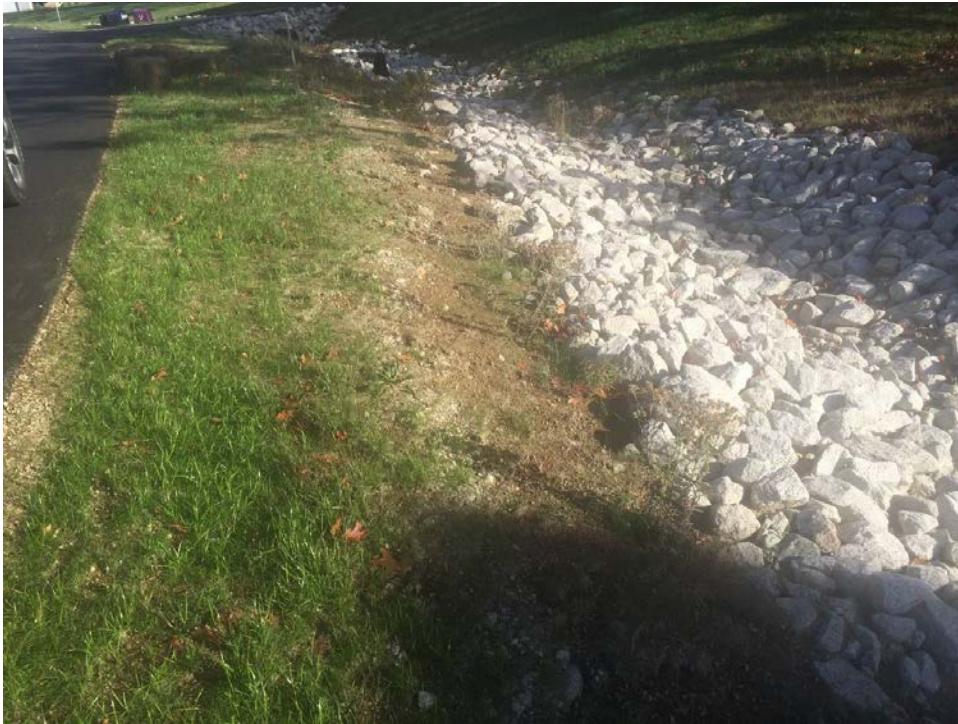
- Vegetation is sparse from +/- sta. 25+50 to +/- sta. 27+50 RT between the edge of pavement and riprap swale. Area shall be re-seeded.
- Bare area near +/- sta. 26+50 LT behind sidewalk. Area shall be re-seeded to establish vegetation.
- Bare area near +/- sta. 27+75 LT at the transformer. Cable and conduit debris also in the area. Cable and conduit shall be removed and area re-seeded to establish vegetation.
- Vegetation is sparse from +/- sta. 28+50 and 30+50 RT between the edge of pavement and riprap swale. Area shall be re-seeded to establish vegetation.
- CB35 – Approximately 1-2” of sediment in sump. Brick collar appears to be in good condition.
- CB36 – <1” of sediment in sump.
- CB37 – <1” of sediment in sump.
- CB38 – Approximately 1-2” of sediment in sump.
- See photos 9 – 11.
- All CBs with 2” or more of sediment in the sump shall be cleaned out.

Photo 9 – Sparse vegetation from +/- sta. 26+50 to +/- 27+50.

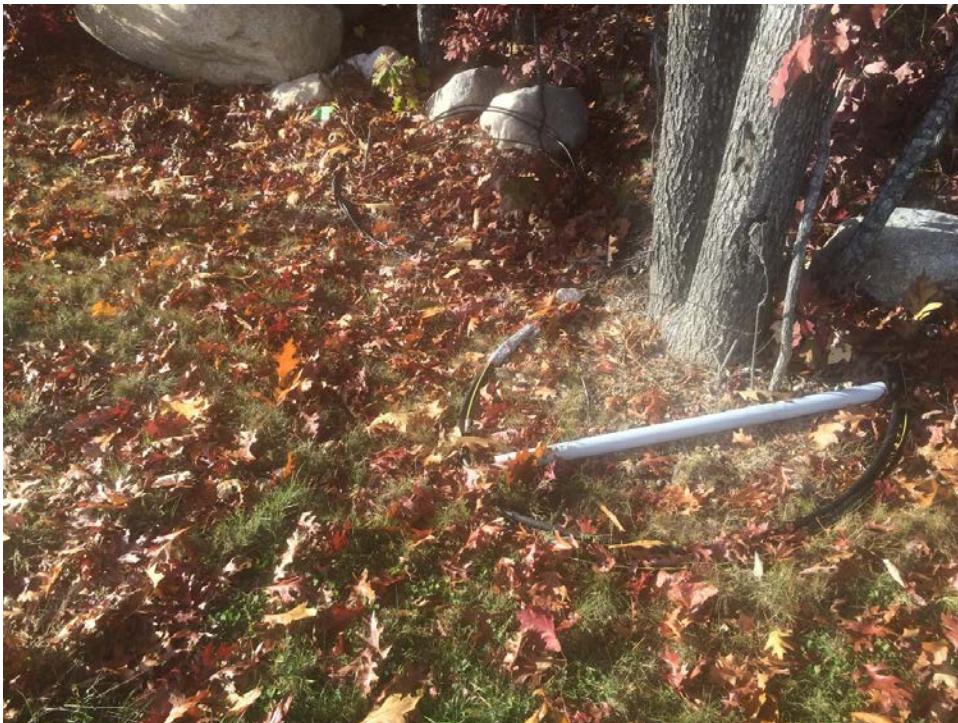
Photo 10 – Cable and conduit debris near transformer at +/- sta. 27+75 LT.

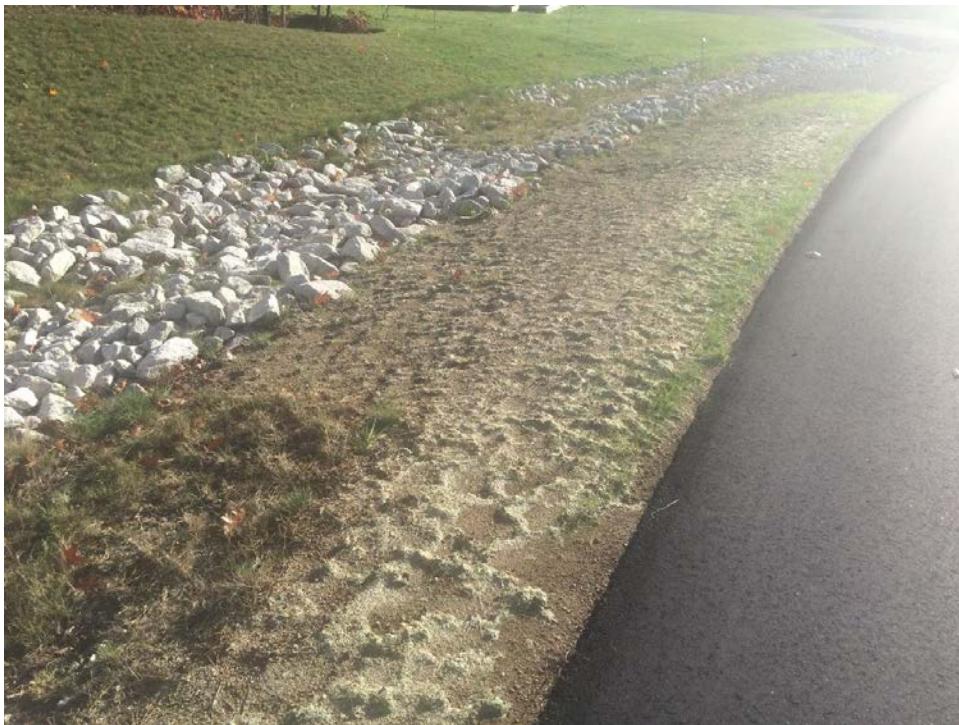
Photo 11 – Sparse vegetation near +/- sta. 30+50 between edge of pavement and riprap swale.
