2017 Forest Lake Watershed Survey

September 2017 ~ Forest Lake Association

Prepared by
Debi Curry, Secretary
Forest Lake Association
2017 Watershed Survey Steering Committee

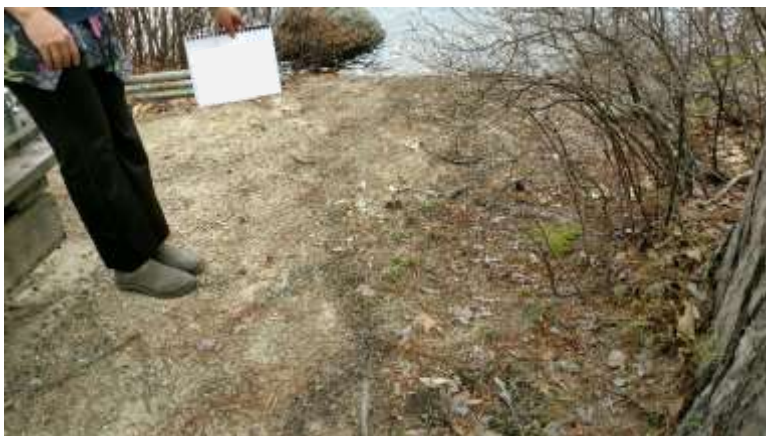
Bare Soil

Bare soil surfaces directly affect runoff rates, which increase because there is nothing to absorb the rain water. Conversely, vegetation allows for greater infiltration because the roots in the plants absorb the water and pulls it into the ground.

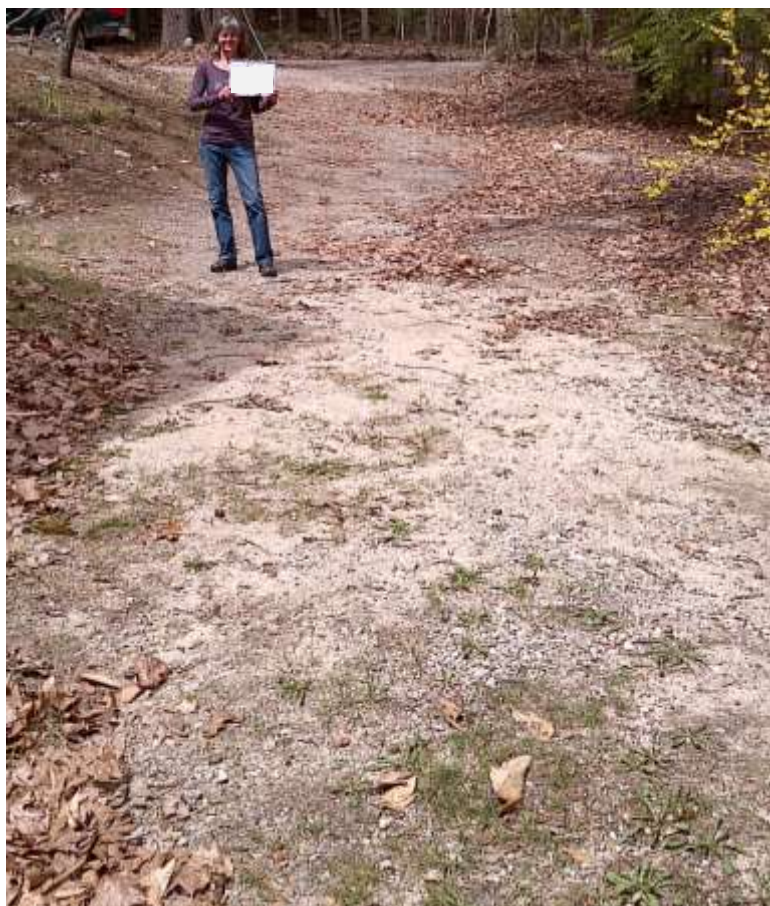
Surface Erosion: Rill

Rill erosion forms small channels, often only .3 cm deep. Rills are caused when water running across the surface of the ground gathers in a natural depression in the soil, and the concentrated water flows through and further erodes the depression.
