GORRILL
PALMER

FIELD OBSERVATION REPORT

Project: Sebago Heights Subdivision
Client: Town of Windham
GP Field Rep: Owen Chaplin, E
Weather: Sunny/Clear
Temp. Range: 50-55° F
Time onsite: 2:00 - 4:00 PM

GPCEI Project No: 2786.13
Visit Date: October 30, 2015
Report Date: October 30, 2015

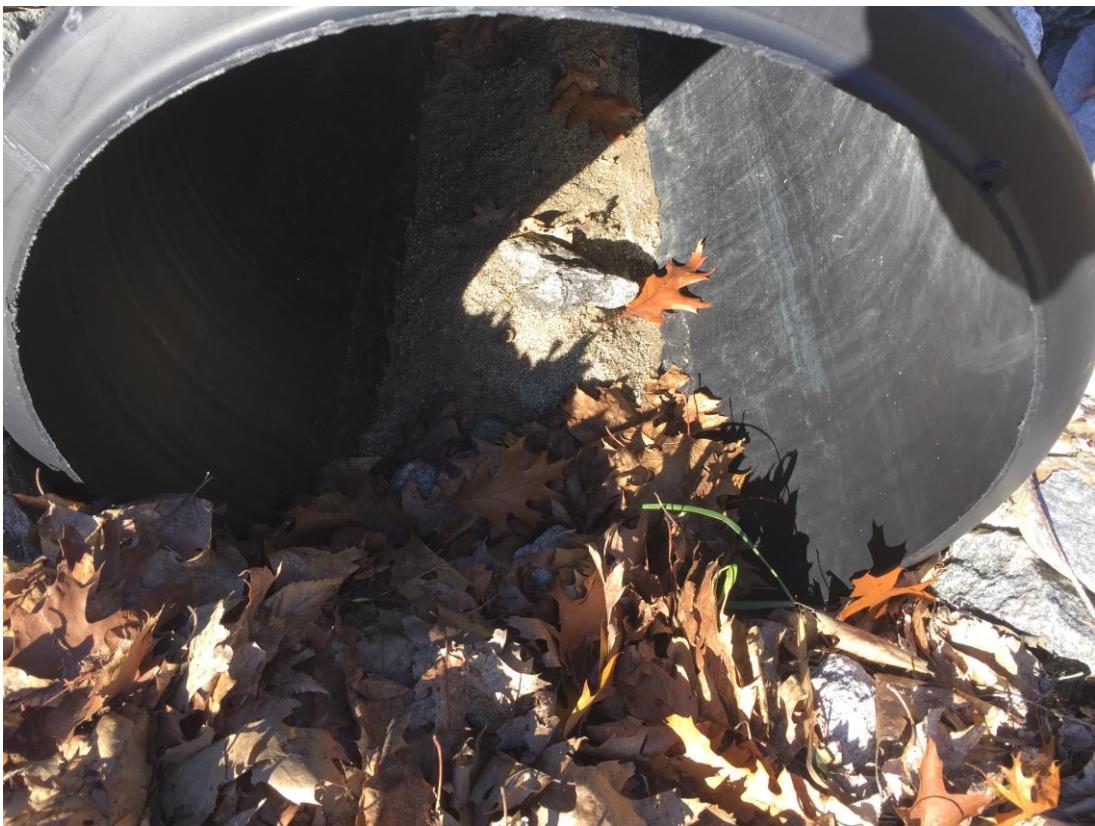
- Sediment buildup in driveway culvert at #34 Thrush Terrace (see Photo 1).
- Gravel shoulder on Thrush Terrace from Sta. 11+00 to 13+00, LT is stabilized but not vegetated (see Photo 2). Similar situation occurring on Harvest Hill Road from Sta. 17+00 to 21+00, RT.

Photo #1 – Sediment Buildup in Driveway Culvert (Sta. 17+50, LT).

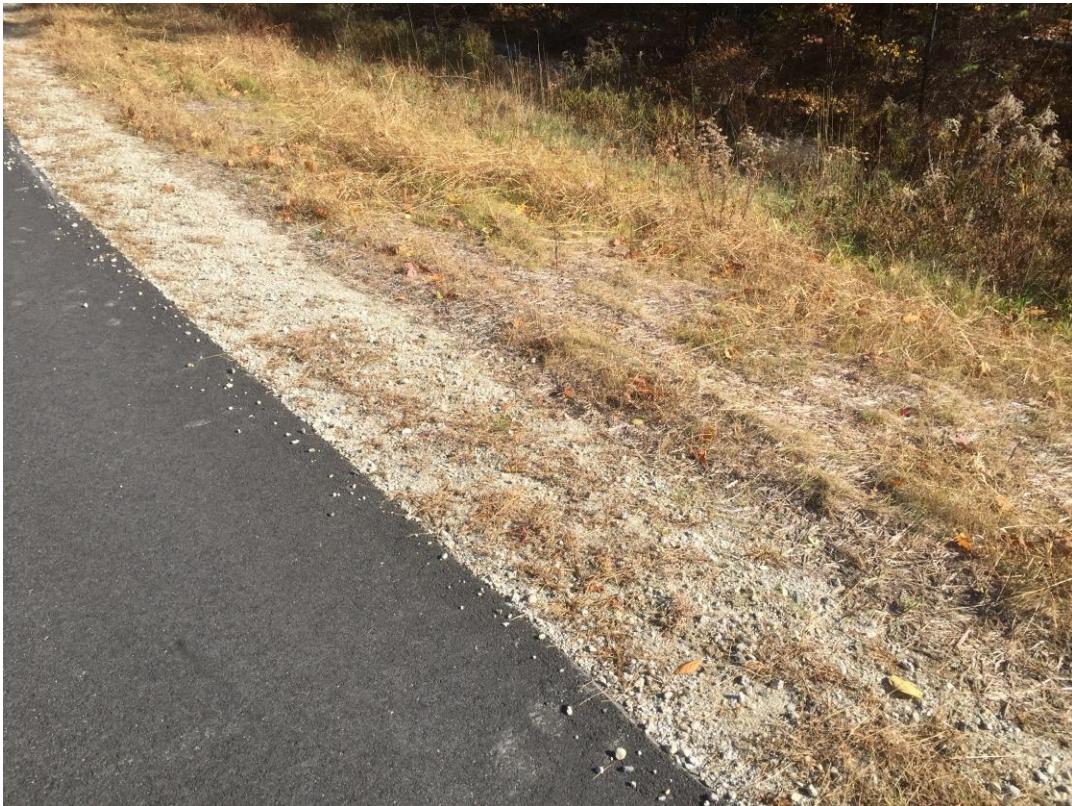
Photo #2 – Gravel Should on Thrush Terrace (Sta. 12+00, LT).

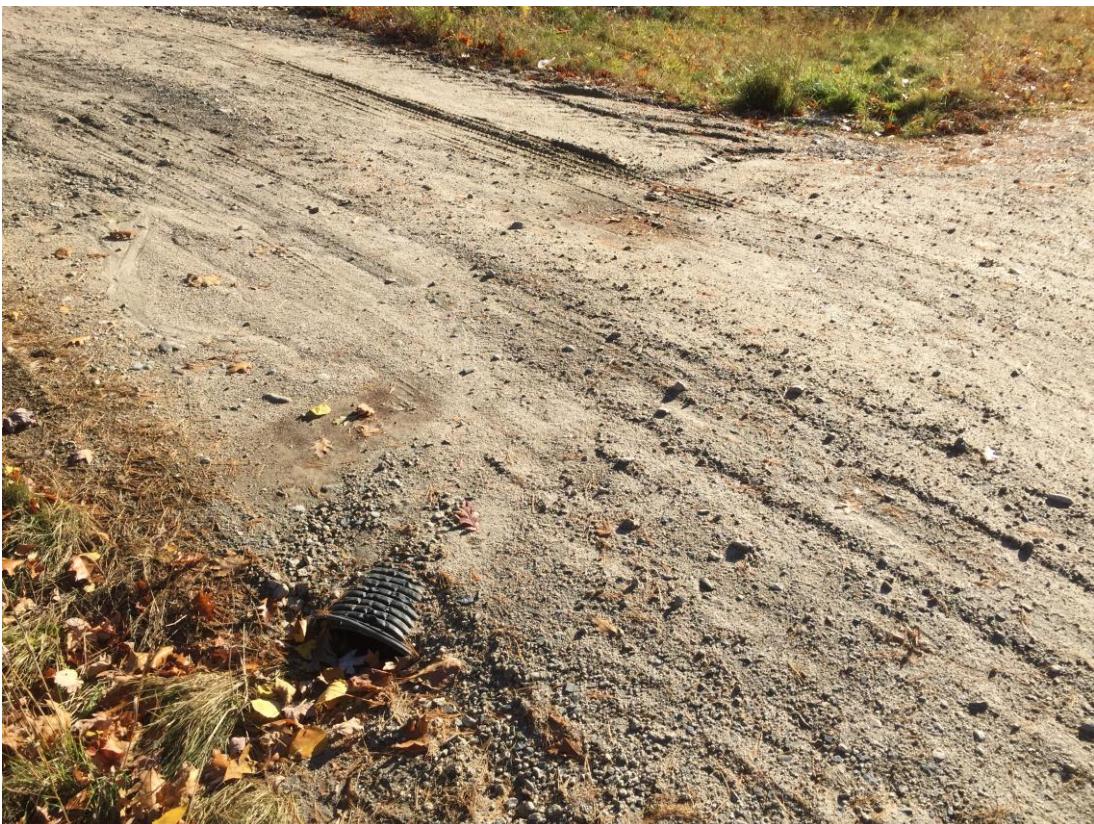
- Gravel Entrance on Thrush Terrace at Sta. 7+00, LT is severely eroded. Driveway culvert is not visible at the outlet and inlet is full of sediment. Driveway culvert has minimal cover and is exposed in some areas (see Photo 3).

Photo #3 – Gravel Entrance on Thrush Terrace (Sta. 7+00, LT).

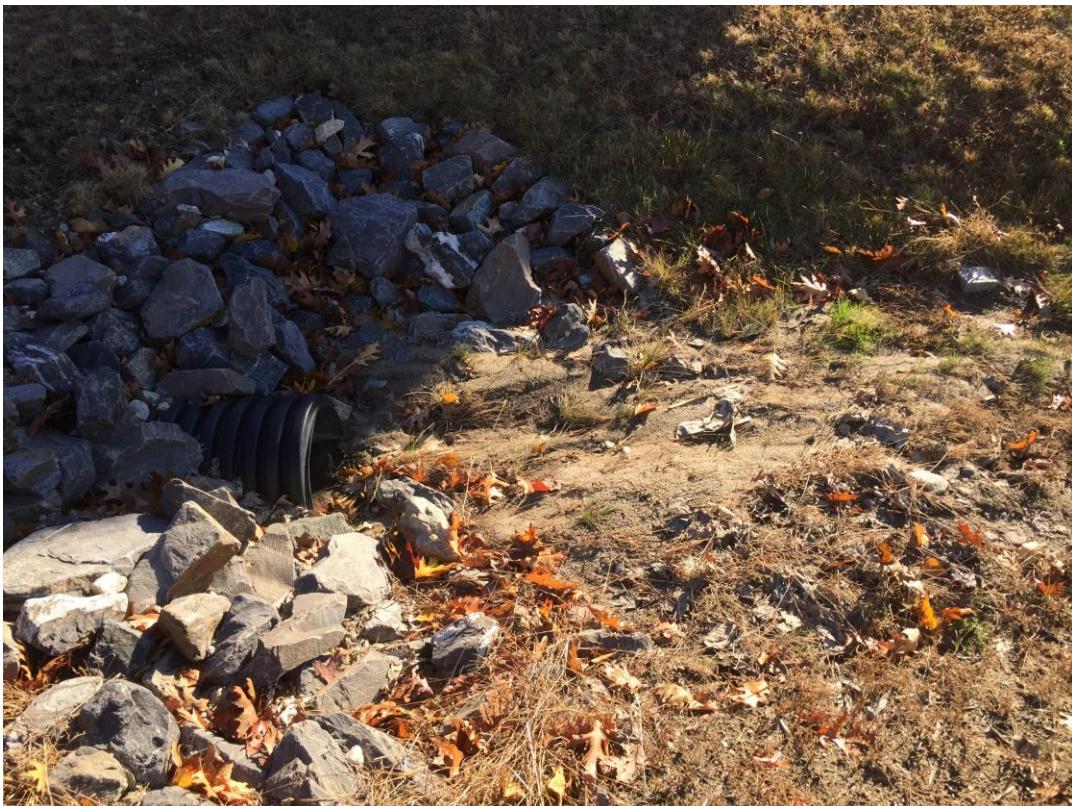
- Sediment buildup at the outlet of 47 Harvest Hill's driveway culvert - Sta. 26+00, RT (see Photo 4).
- Approximately 20' longitudinal crack along the crown of Harvest Hill Rd (see Photo 5). Crack occurs at the Phase 3/Phase 4 line on Harvest Hill Rd (Sta. 26+50).

Photo #4 – Sediment Buildup at Driveway Culvert #47 Harvest Hill Rd (Sta. 26+00, RT).

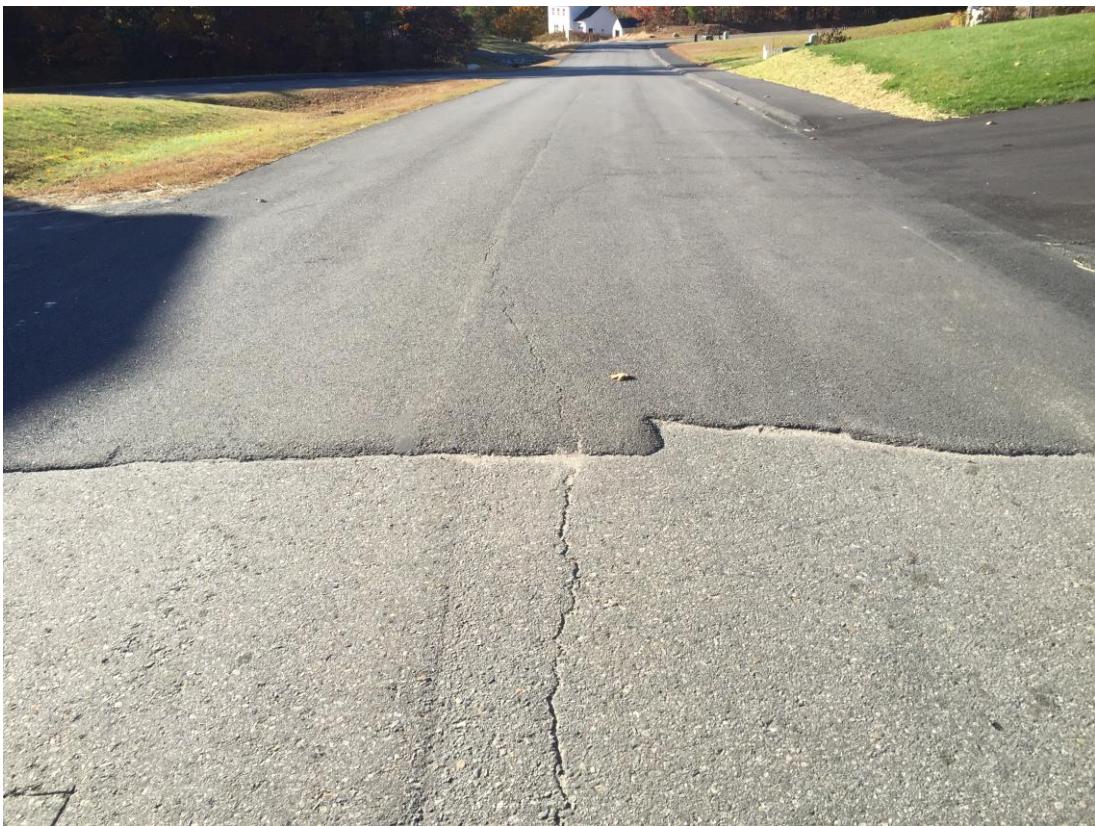
Photo #5 – Longitudinal Crack on Harvest Hill Rd (Sta. 26+50).
