FIELD OBSERVATION REPORT

Project: Valley View Subdivision

Client: Town of Windham

GPCEI Project No: 2786.05

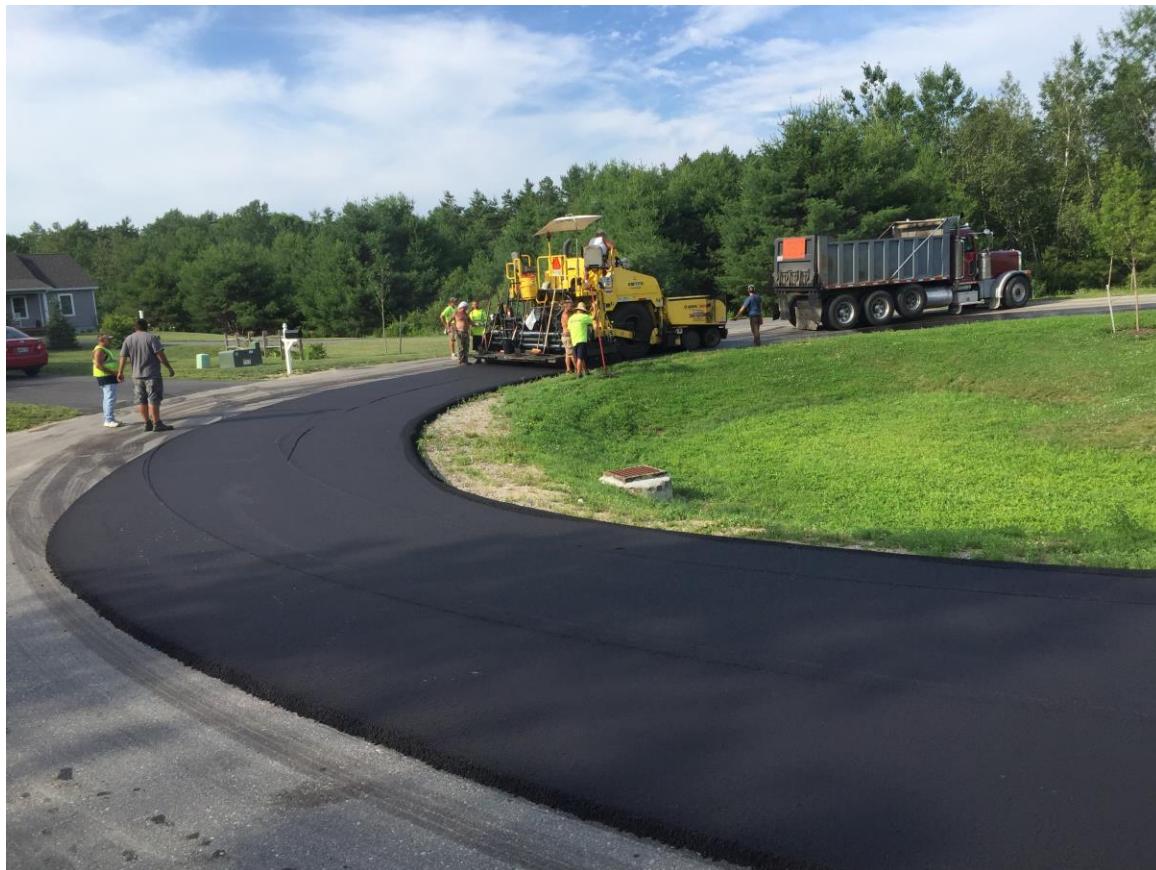
Photo 1 – Surface Paving Cul-de-Sac.

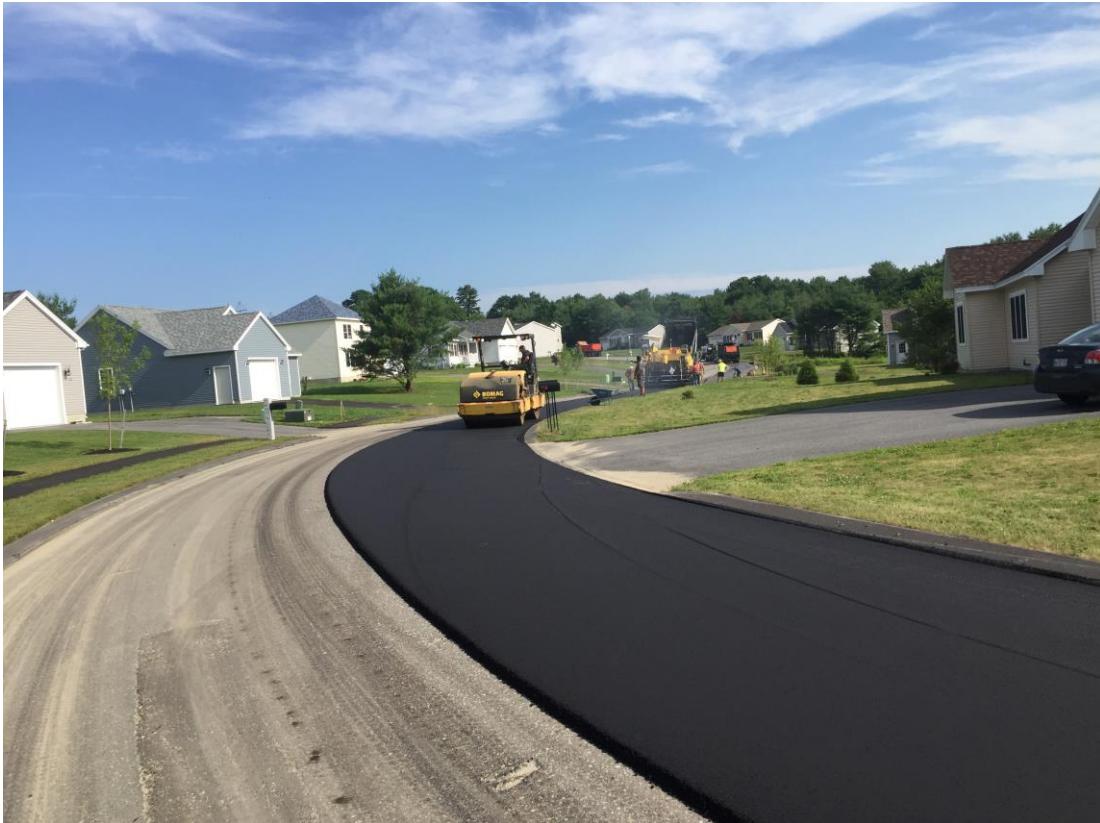
Photo 2 – Compacting Paving (Sta. 13+00).

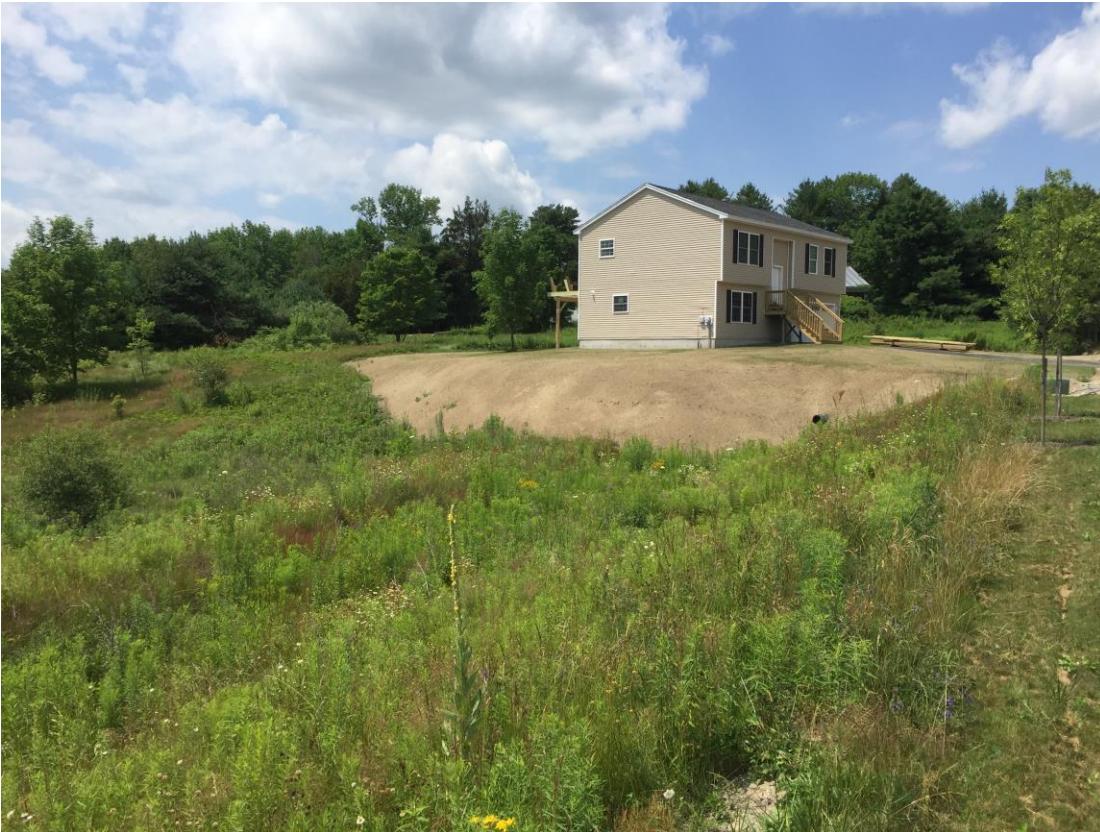
- Finished paving Twoey Drive at 1:30 PM.
- Roadway catch basins have not been cleaned of sediment.
- No corrective actions have been attempted on the underdrain soil filters as described in field report dated 5/25.

Photo 3 – Underdrain Soil Filter #1 (Sta. 3+10, RT).
