Highway Bridge Inspection Report

**JONES
WEBB RD
over
BLACK BROOK**

Inspection Date: 11/21/2025

Structure Number: 0234
Facility Carried: WEBB RD

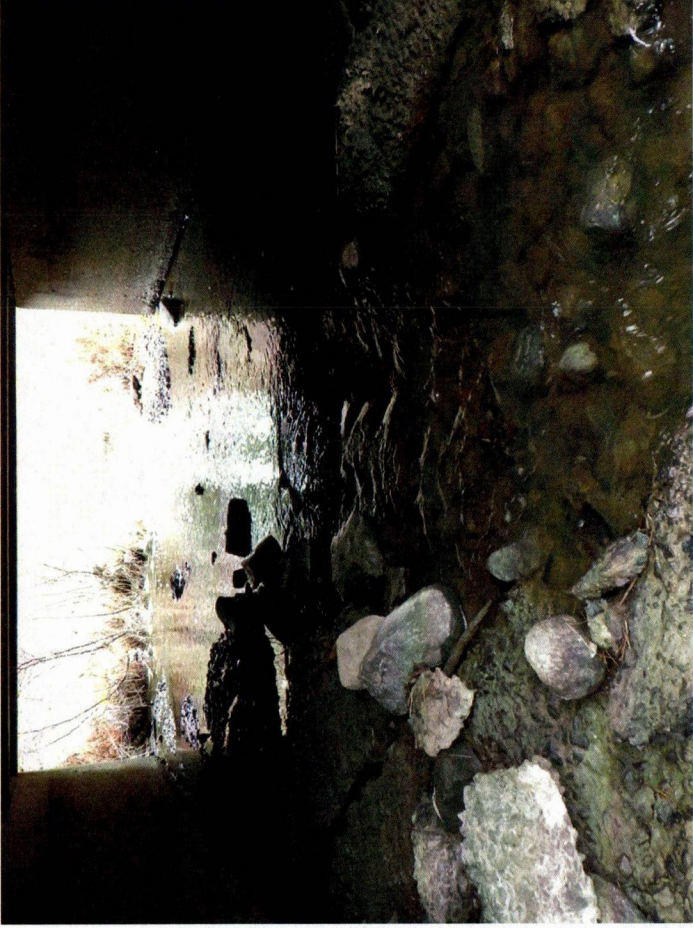
PHOTO 1

Channel

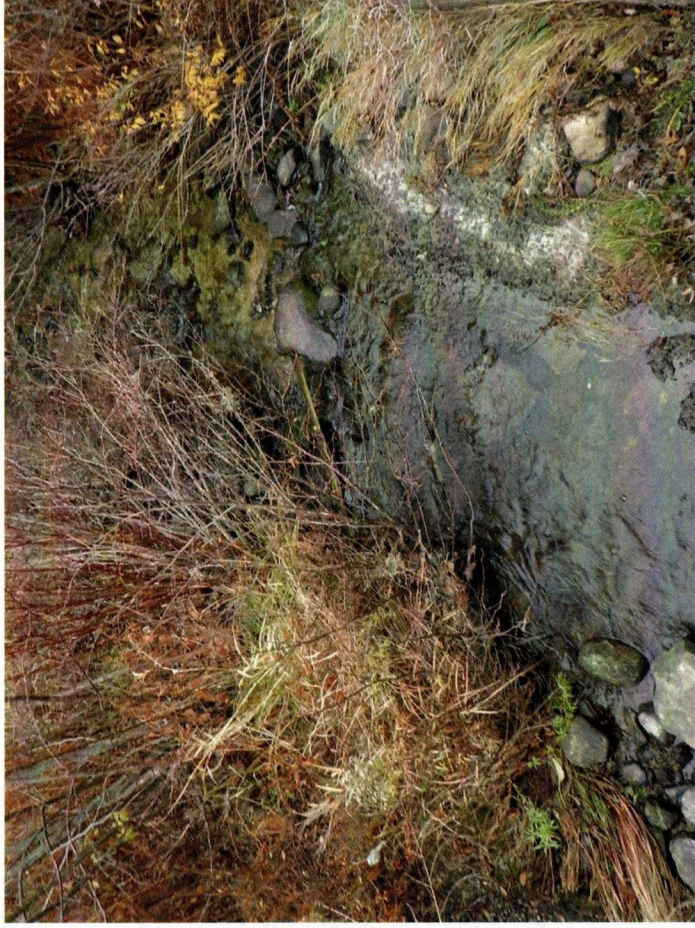
PHOTO 2

Downstream

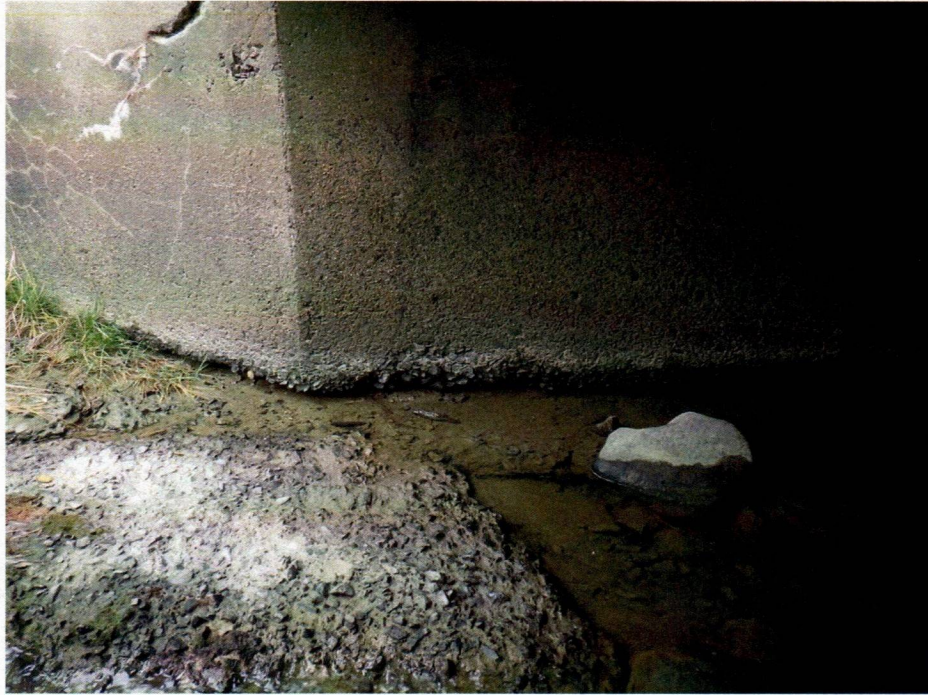
PHOTO 3

Both Abutments has a few scattered areas of undermining from 3" up to 12" deep were the concrete from abutment seeped under forms and spalled away.
There is a 3 ft vertical crack on the North abutment that is hairline at the top to 3/4" thick at the bottom.
Both abutments have moderate scaling at the waterline and below.
SE wingwall has an isolated diagonal 2ft long hairline to 1/2" thick crack.
Minor cracking and efflo in the other wingwalls.

Description East abutment scaling

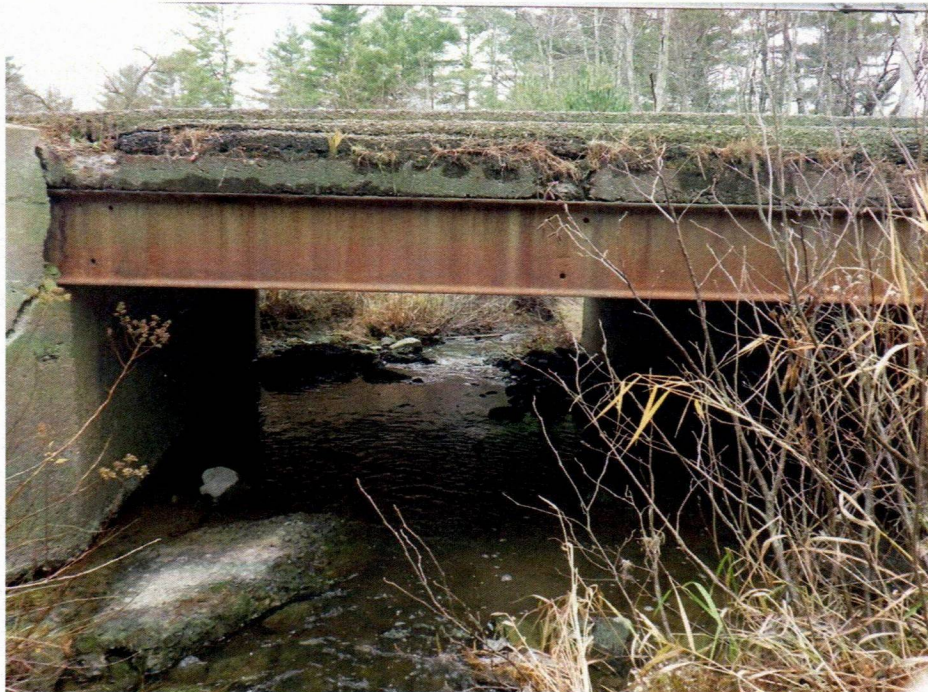
PHOTO 4

Description East end

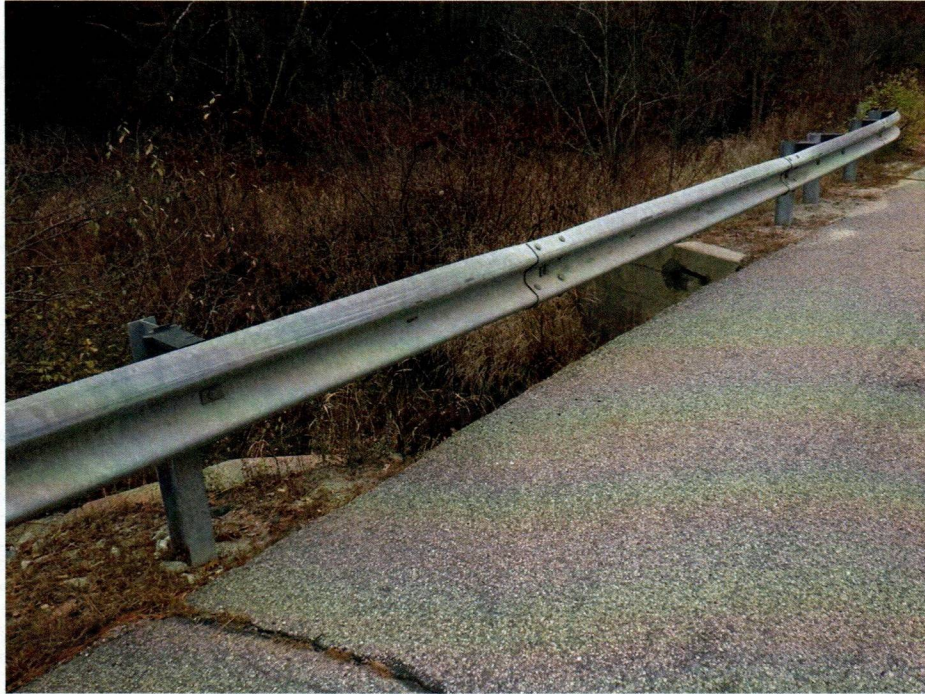
PHOTO 5

No bridge rail posts at east end of the structure.
West end has 2 bridge rail posts not connected and no offset blocks.
Bridge rail is offset from the pavement 8-12 inches and can easily be pushed away from the roadway.
Stay in place (SIP) forms prevent visual inspection of underside of deck.
The SIP forms are moderately corroded on the bottom of the deck exterior bay ends. There is minimal corrosion on the SIP forms in the interior bays. The rusting occurs at the ends of each form.

Description East rail

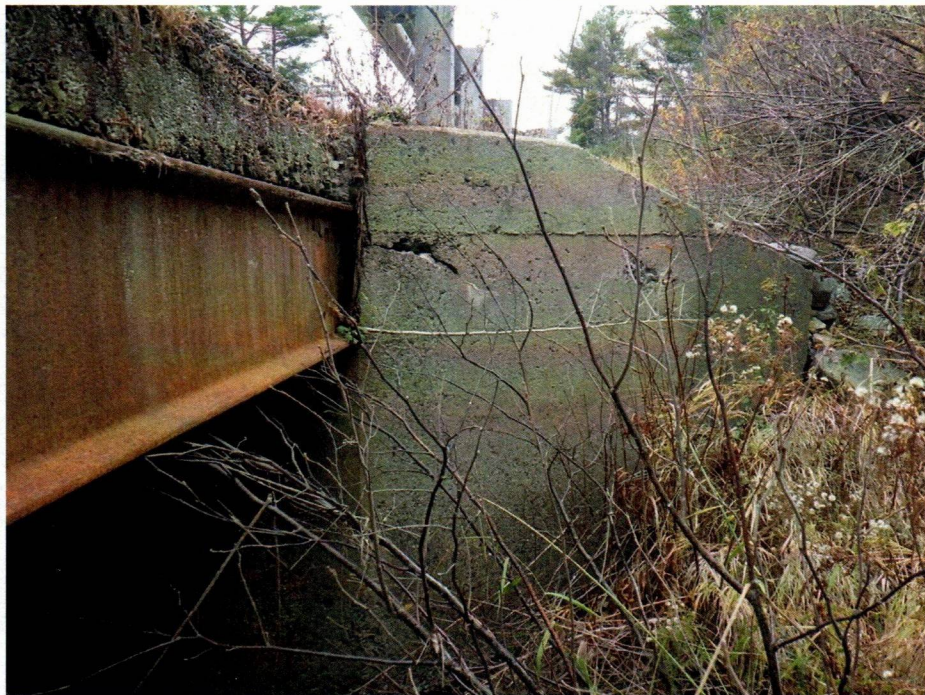
PHOTO 6

Description NE corner cracking

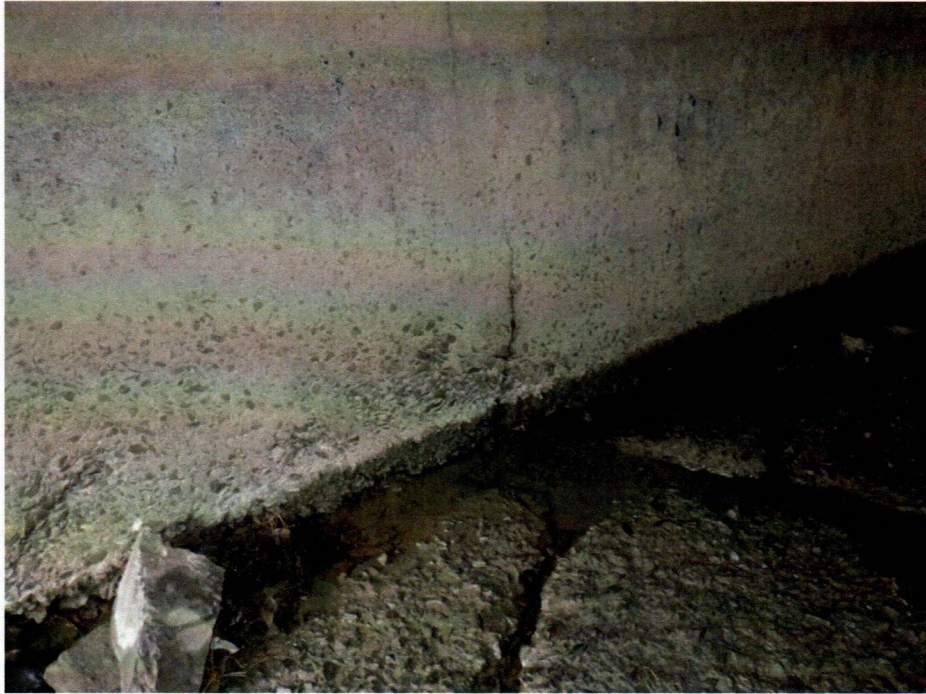
PHOTO 7

Description North abutment scaling

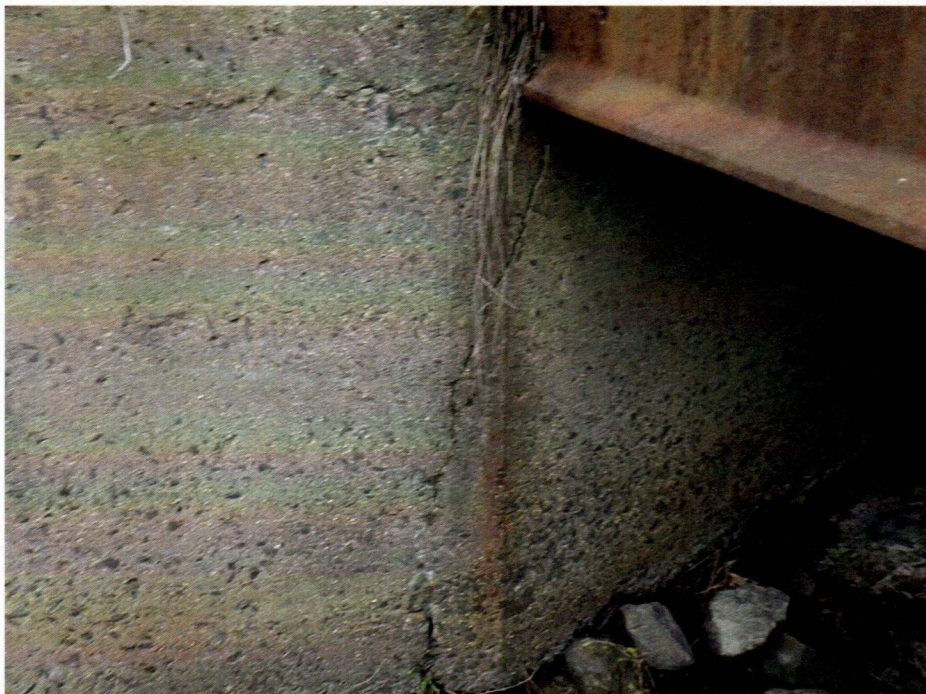
PHOTO 8

Description NW corner crack

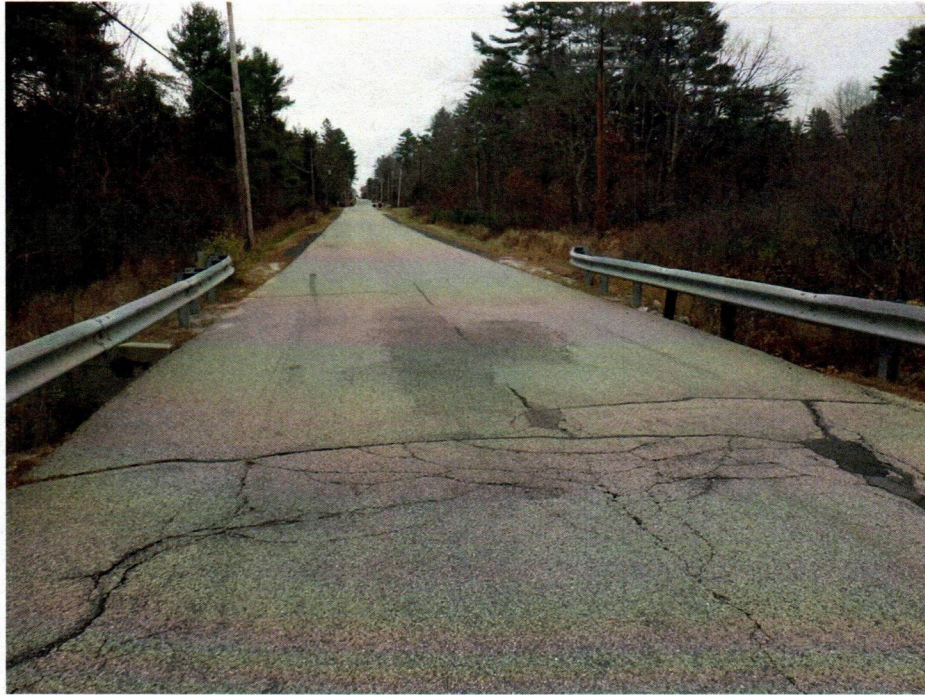
PHOTO 9

Longitudinal cracks leading up to abutments with rutting.
Cracks had been sealed.
Transverse cracking across abutments.
Longitudinal crack along the centerline.

Description Road facing South

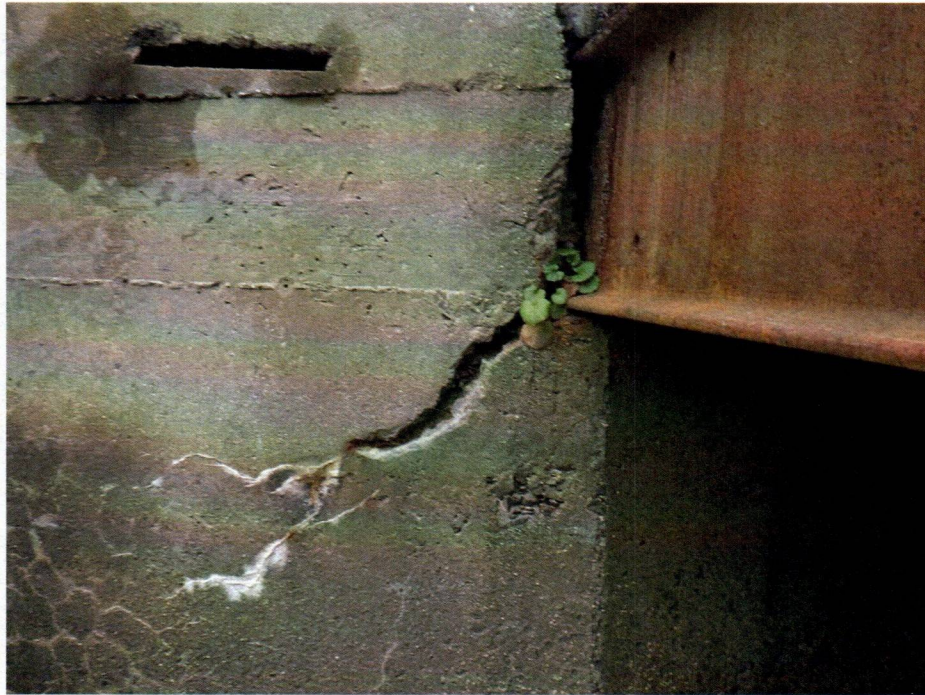
PHOTO 10

Description SE corner crack

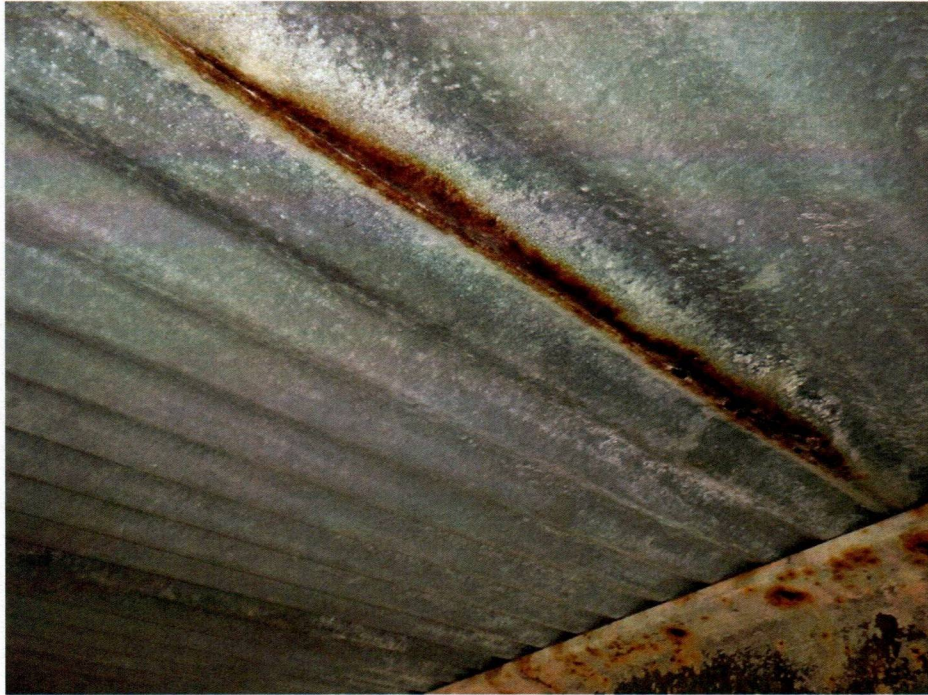
PHOTO 11

Description Some rusting on deck

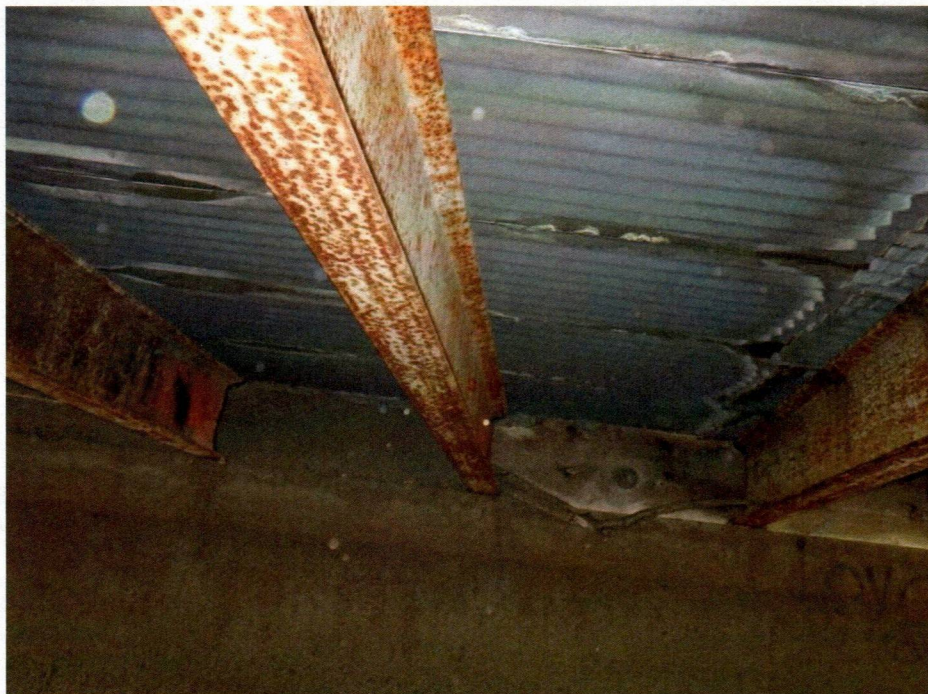
PHOTO 12

Exterior unpainted beams have flake rusting along top flange and minor pitting throughout and minor scaling at interior beam ends.
Interior painted beams have minimal section loss with 100% paint failure, speckled and spot rust throughout.

Description Super (2)

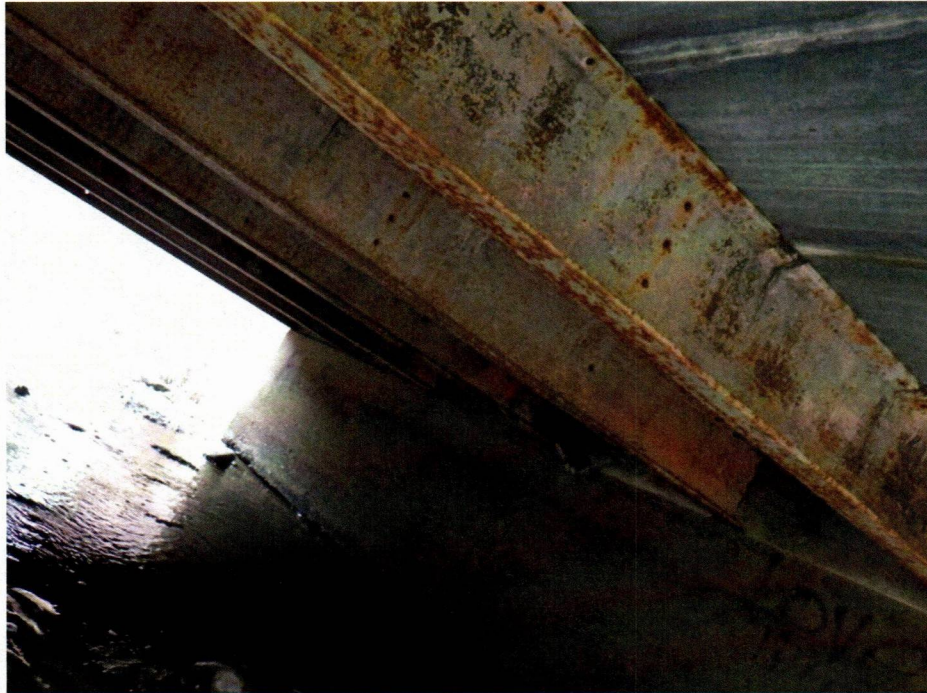
PHOTO 13

Description Super

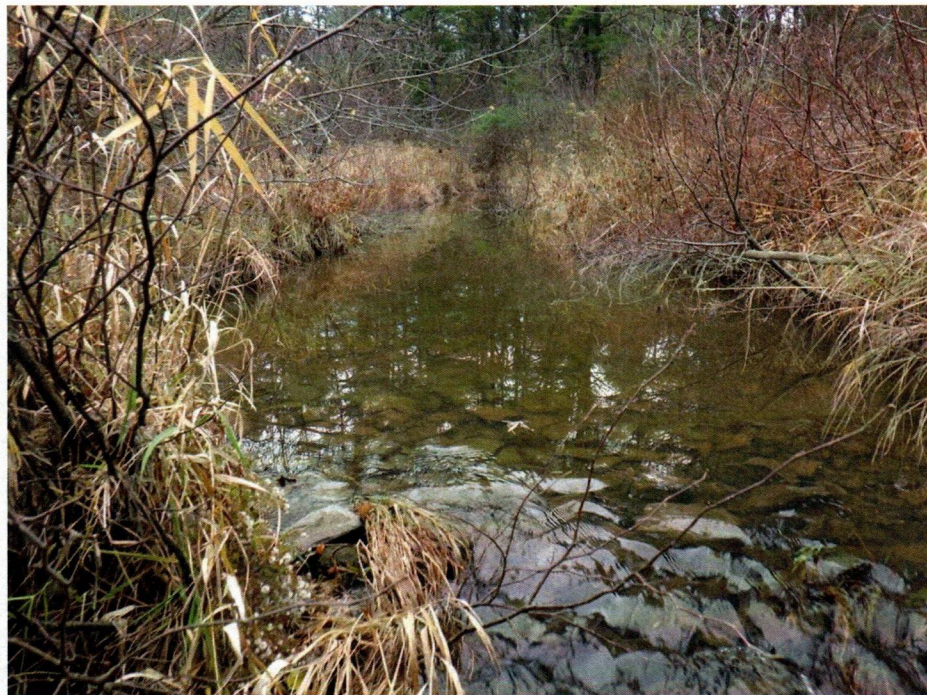
PHOTO 14

Description Upstream

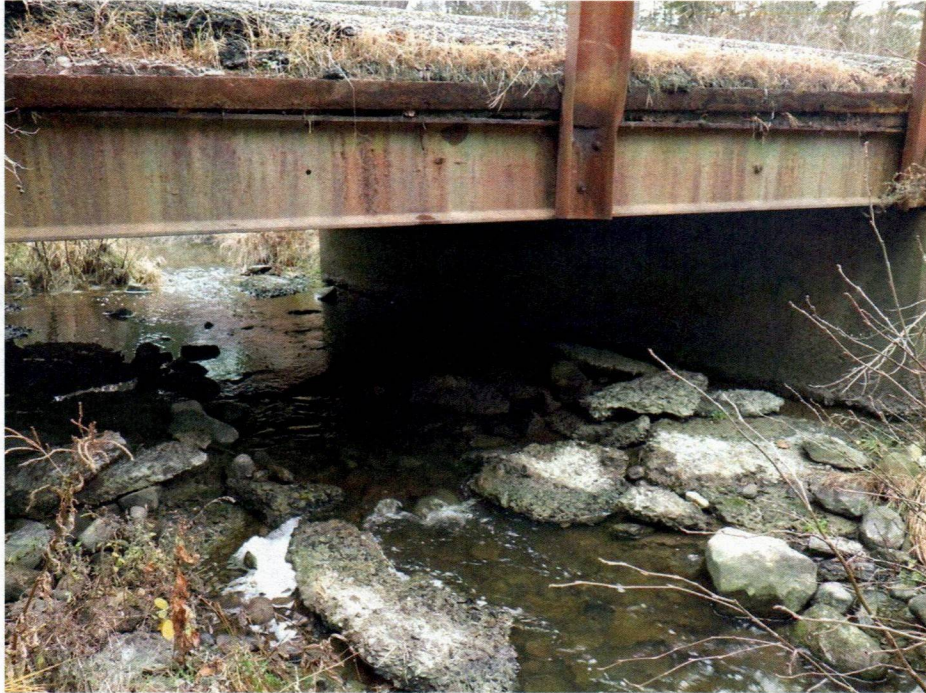
PHOTO 15

Description West end

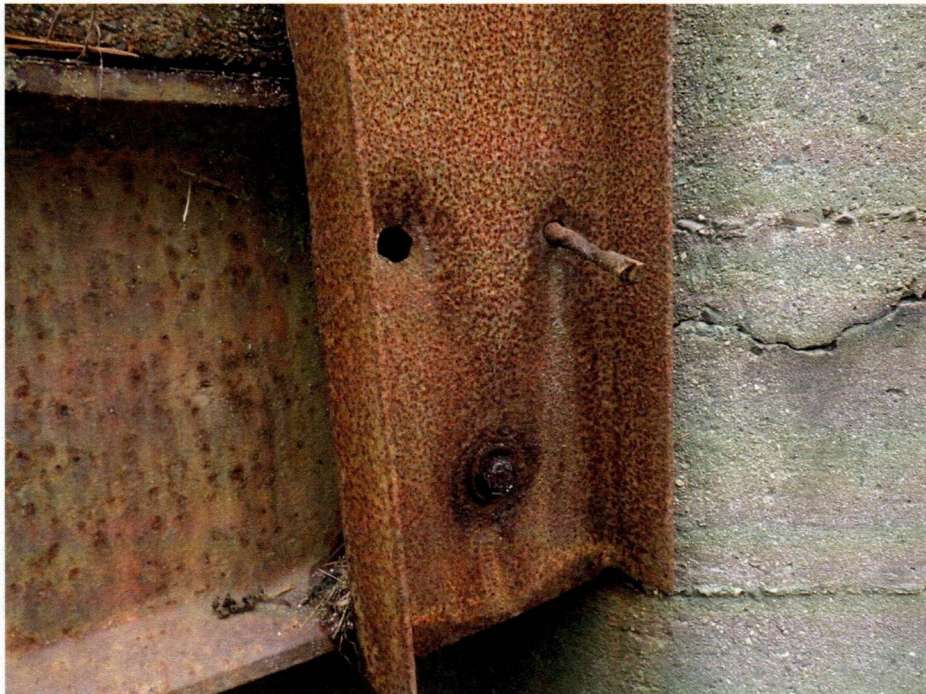
PHOTO 16

Description West rail hardware failing

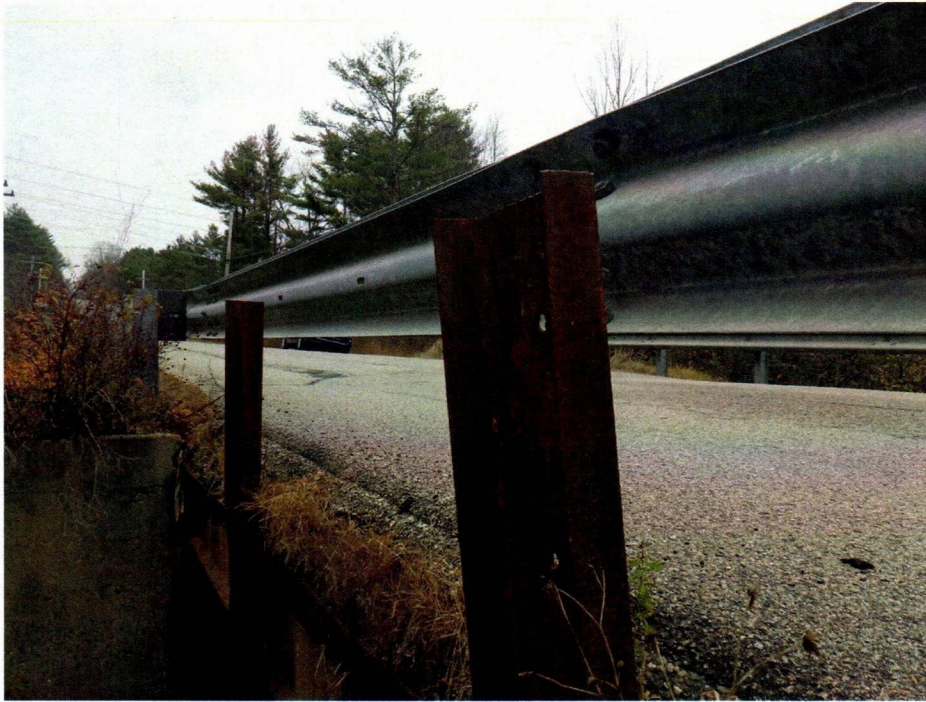
PHOTO 17

Description West rail not connected

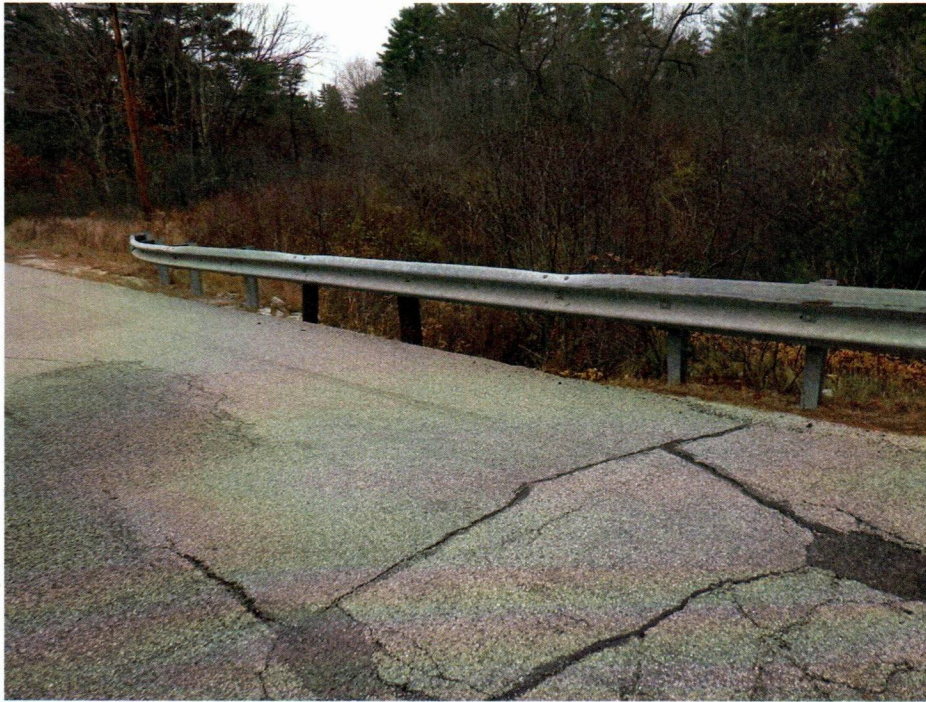
PHOTO 18

Description West rail
