FIELD OBSERVATION REPORT

Project: Sebago Heights Subdivision – Phase 3&4

GPCEI Project No: 2786.69

Visit Date: November 4, 2016

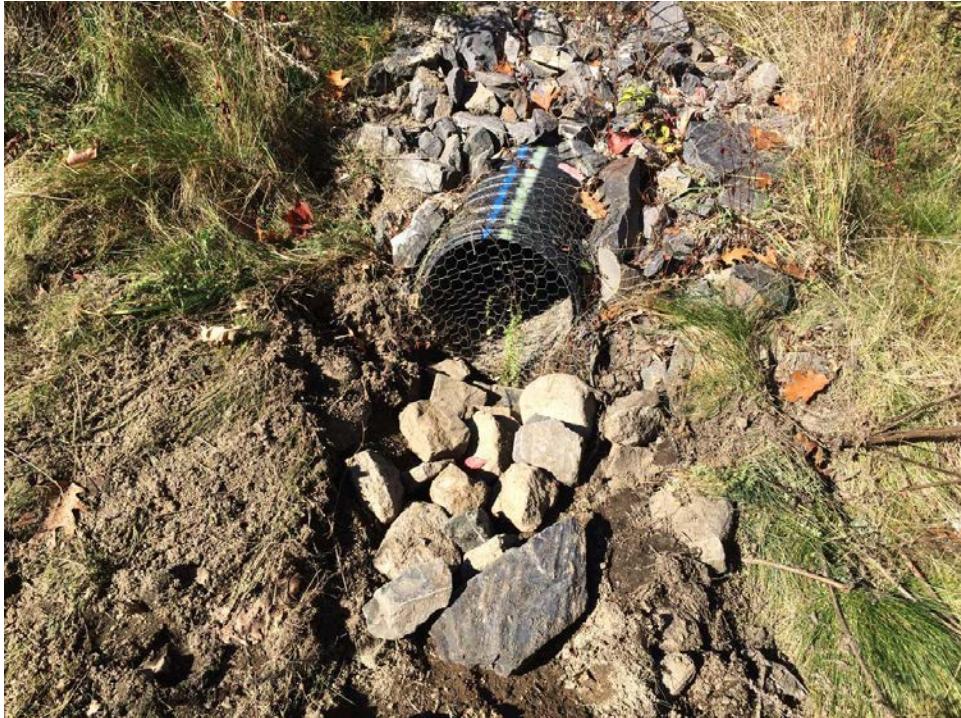
- **Completed** – CB33 Outlet to swale – Vegetation growth has obstructed outlet flow. Vegetation shall be removed.
- **Completed** - CB34 – Approximately 4-5" of sediment in sump.

Photo 1 – CB 33 outlet with vegetation removed.

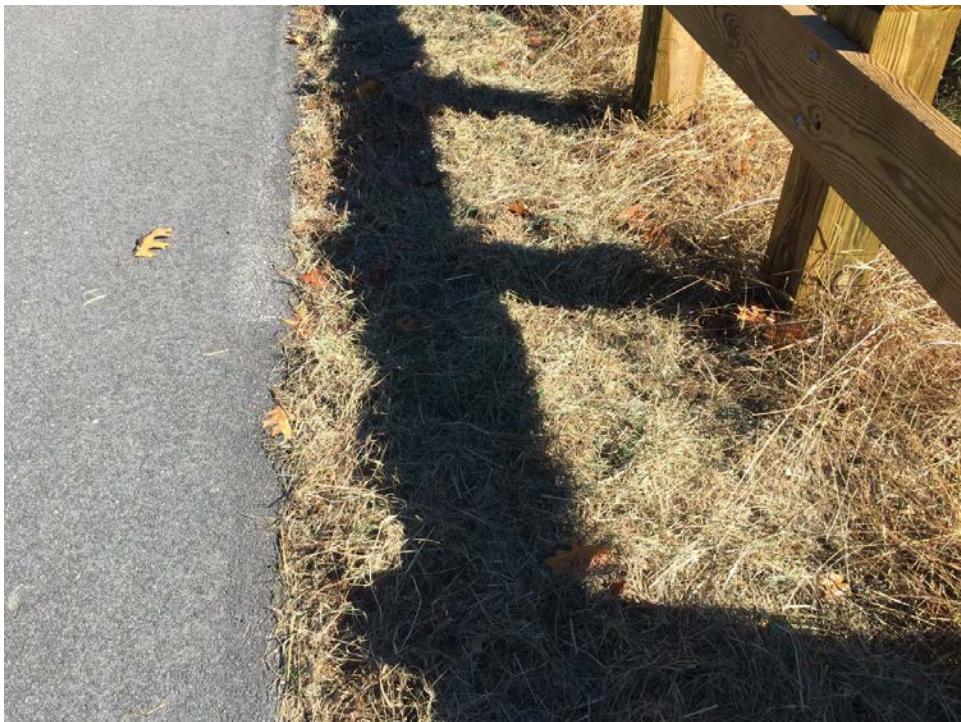
- **Completed** – Riprap area for CB28 inlet has leaves and sediment. Leaves and sediment shall be removed from the riprap area.
- **Completed** – Vegetation is sparse from +/- sta. 11+50 to +/- sta. 12+50 LT along fence line. Area shall be re-seeded. **Monitor and recheck area in spring 2017.**

Photo 2 - +/- sta. 11+75 seeded and mulched.

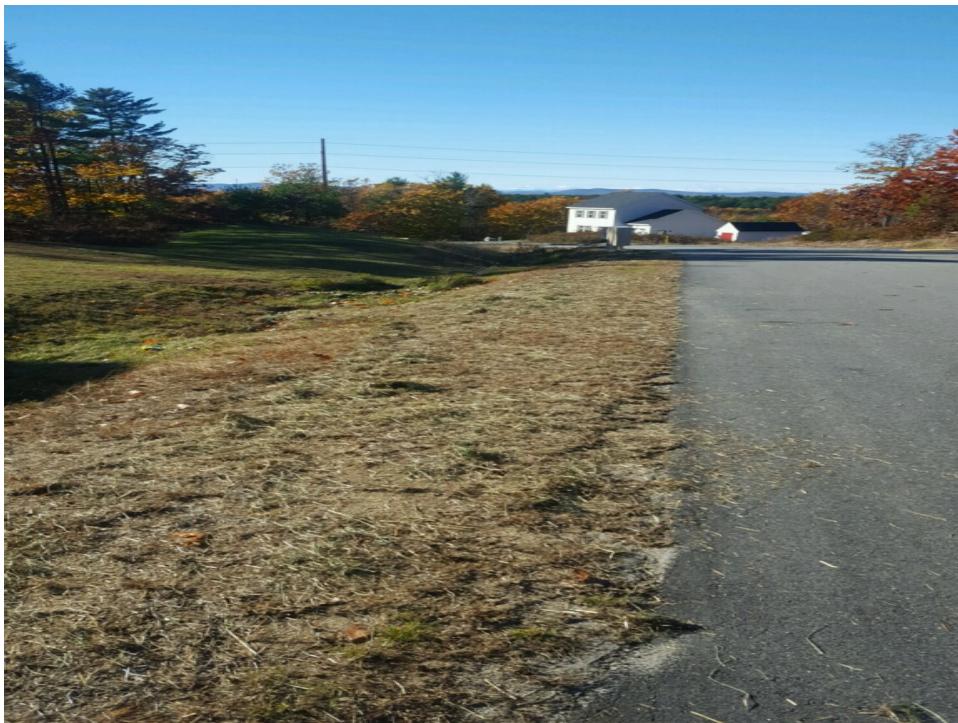
- **Completed** – Vegetation is sparse from +/- sta. 22+00 to 24+50 RT on drainage swale slope. Area shall be re-seeded. **Monitor and recheck area in spring 2017.**

Photo 3 – Near +/- sta. 23+75 RT seeded and mulched.

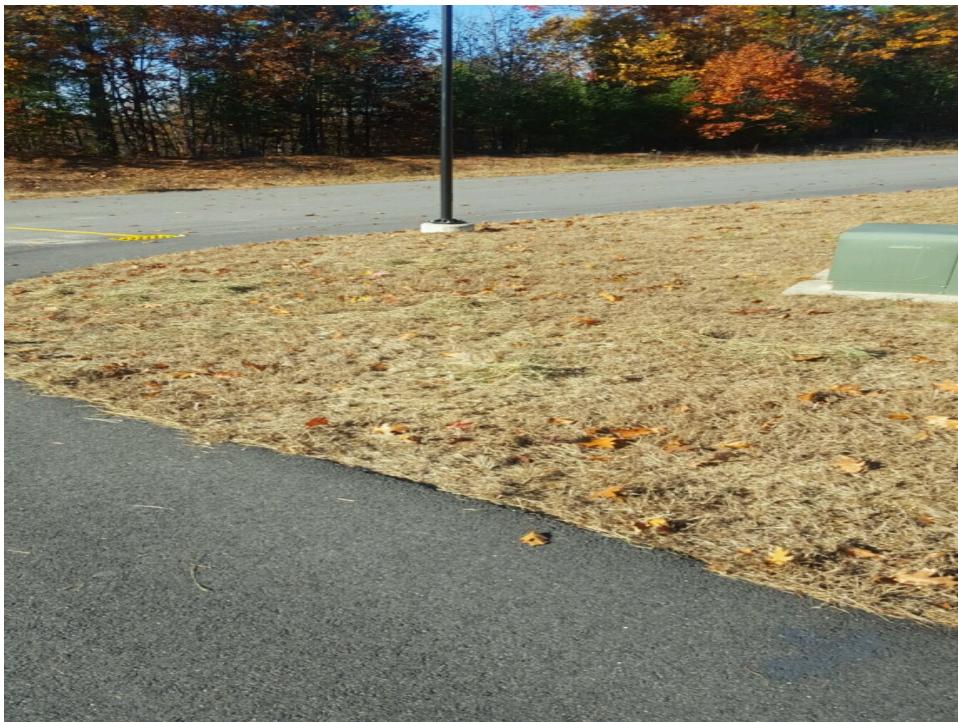
- **Completed** – Vegetation is sparse behind CB26 near transformer. Area shall be re-seeded. **Monitor and recheck area in spring 2017.**

Photo 4 – Area near transformer behind CB26 seeded and mulched.

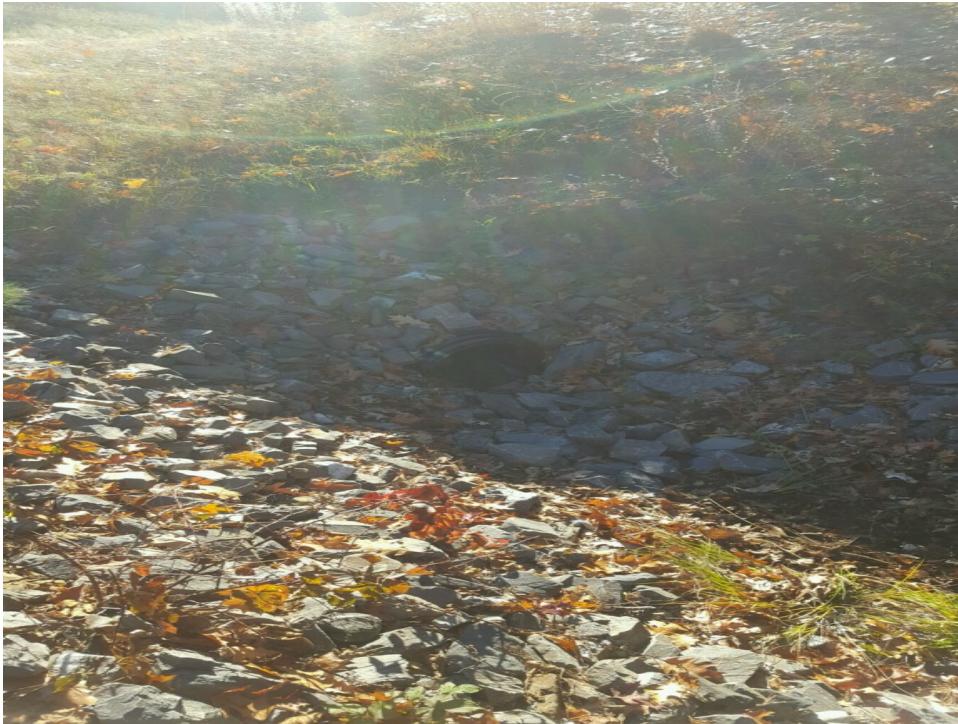
- **Completed** – Roadway crossing culvert near +/- sta. 22+40 LT has sediment and vegetation obstructing the inlet in the riprap apron. Sediment and vegetation shall be removed from the riprap apron.

Photo 5 – Roadway crossing culvert near +/- sta. 22+40 LT with sediment and vegetation obstructing flow removed.

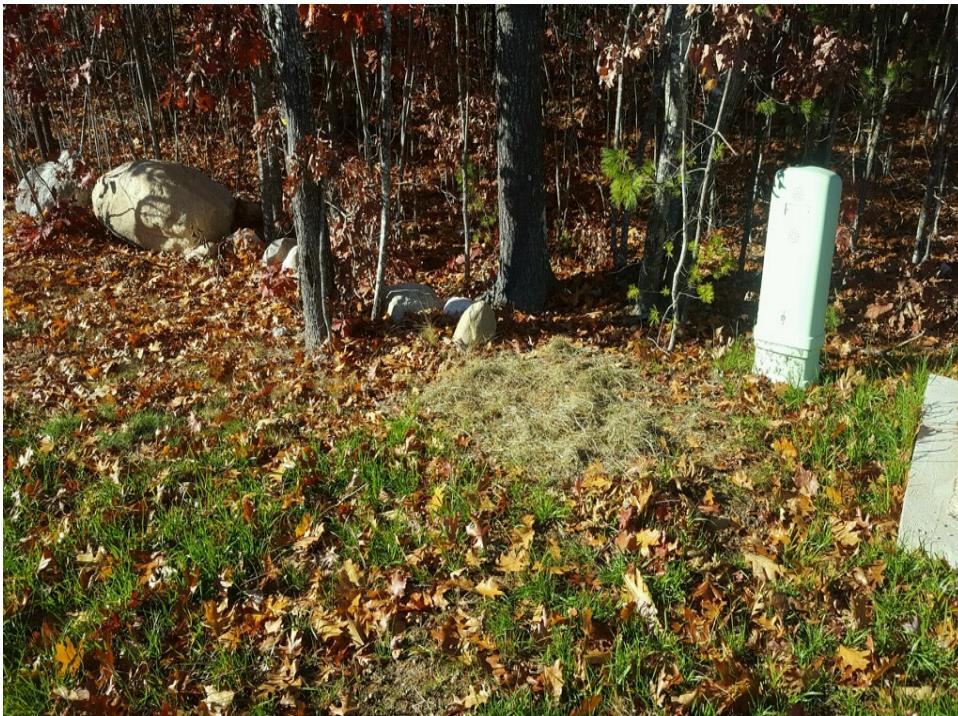
- **Completed** – Bare area near +/- sta. 27+75 LT at the transformer. Cable and conduit debris also in the area. Cable and conduit shall be removed and area re-seeded to establish vegetation. **Monitor and recheck area in spring 2017.**

Photo 6 – Debris removed and area seeded and mulched near sta. 27+75 LT.

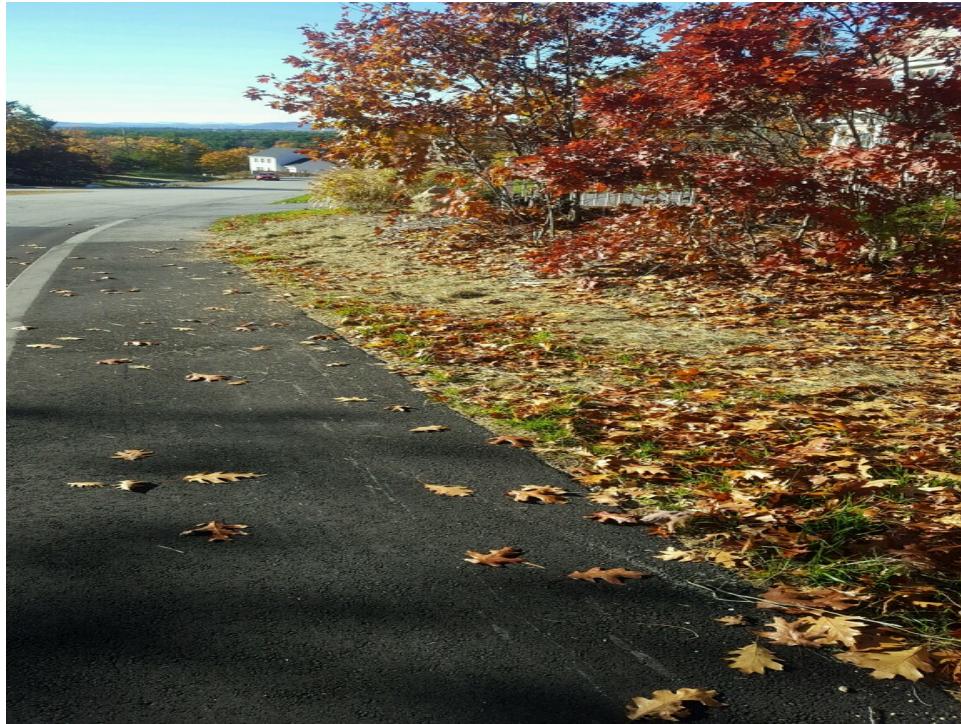
- **Completed** – Bare area near +/- sta. 26+50 LT behind sidewalk. Area shall be re-seeded to establish vegetation. **Monitor and recheck area in spring 2017.**

Photo 7- Bare area near +/- sta. 26+50 LT seeded and mulched.
