Town of Windham

FIELD OBSERVATION REPORT

Project: Chute Road South Subdivision

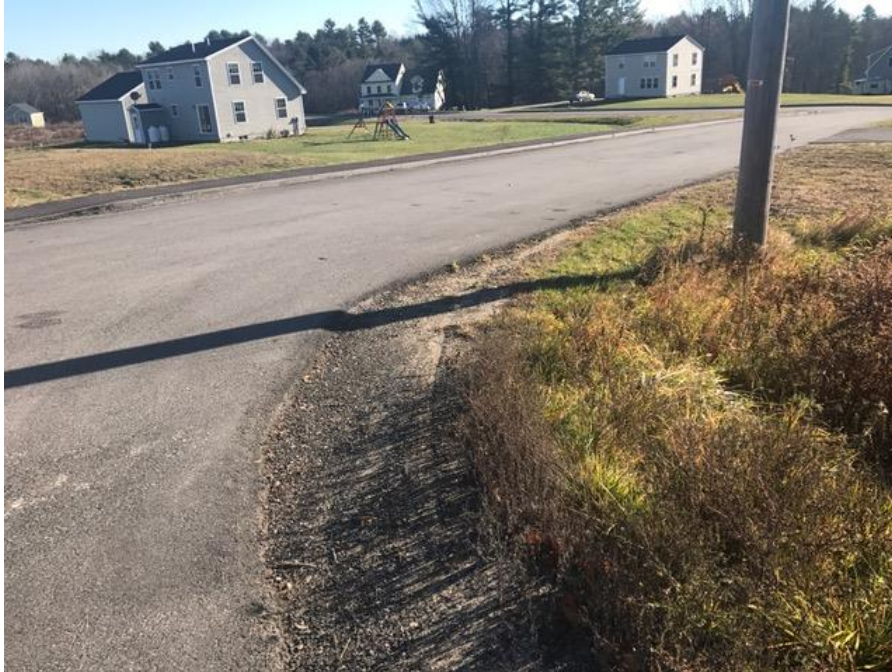
Photo 1 – Recommend adding additional shoulder loam material at the intersection of Chute Road and Georges Lane.

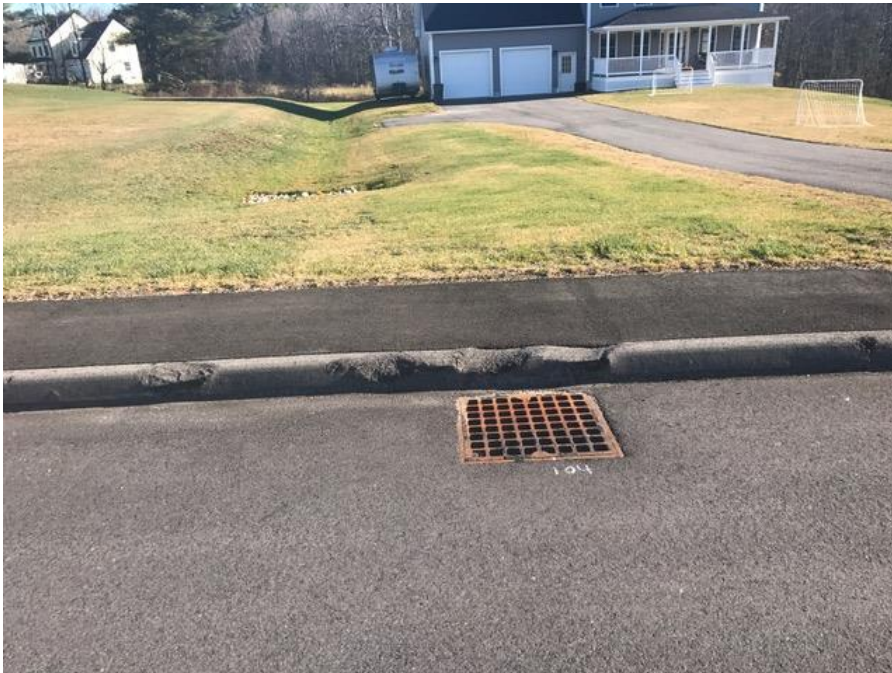
Photo 2 – Damaged bituminous curb needing repair behind CB #5.
