# **2017 Forest Lake Watershed Survey**

## **September 2017 ~ Forest Lake Association**

Prepared by  
Debi Curry, Secretary  
Forest Lake Association  
2017 Watershed Survey Steering Committee

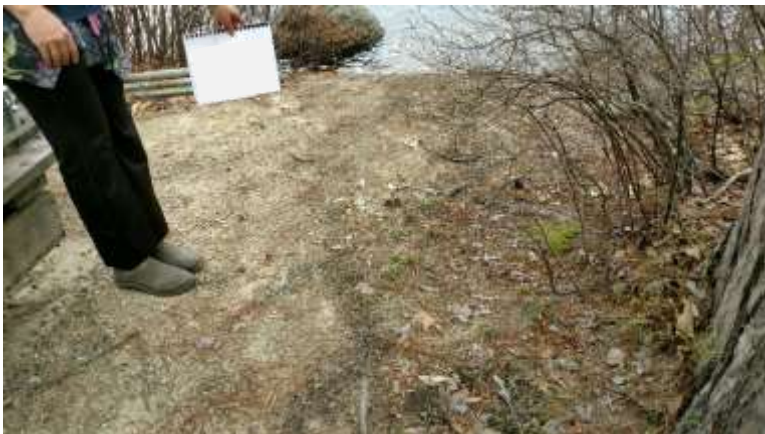
#### Bare Soil

Bare soil surfaces directly affect runoff rates, which increase because there is nothing to absorb the rain water. Conversely, vegetation allows for greater infiltration because the roots in the plants absorb the water and pulls it into the ground.

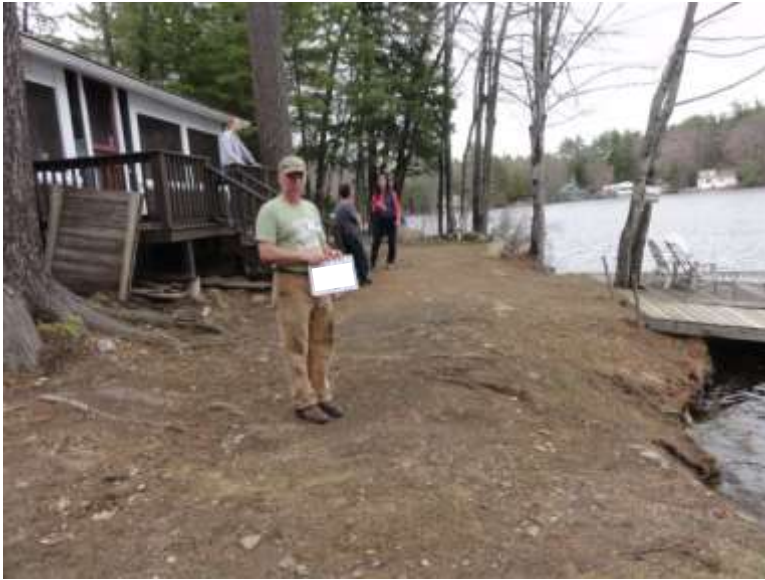
### **Sheet Erosion**

Sheet erosion occurs when a thin layer of topsoil is removed by water runoff.

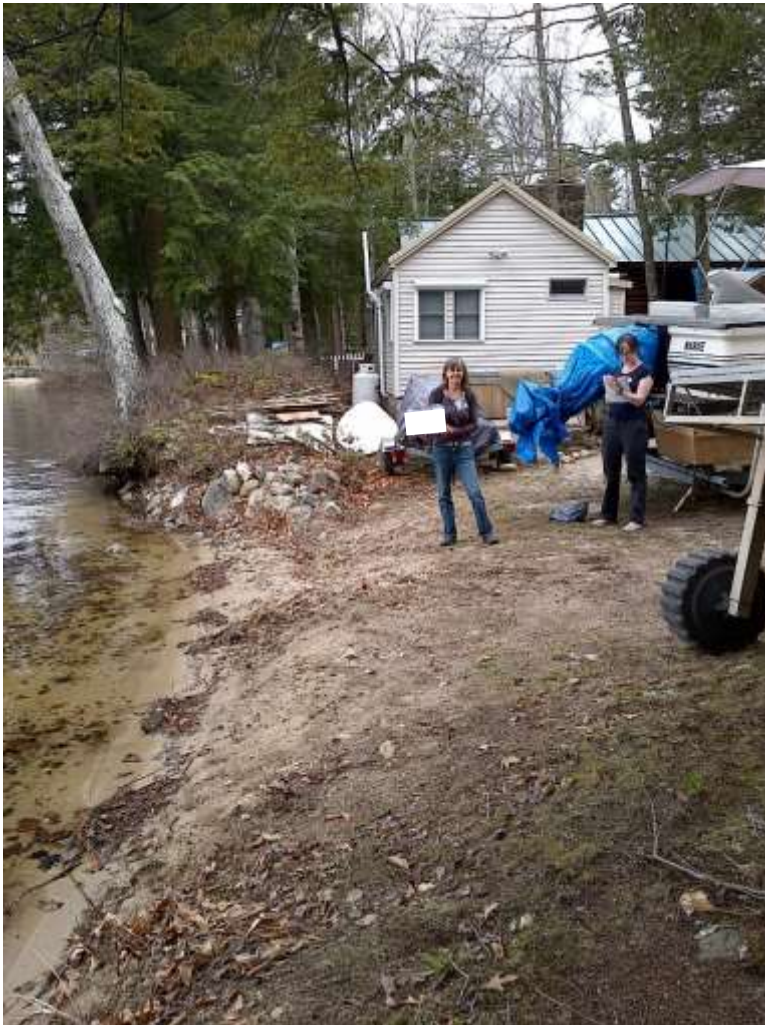
### **Lack of Shoreline Vegetation**

Native vegetation usually found at the shoreline strengthens its structural integrity and prevents the land from breaking apart. The deep roots of these plants bind the earth together while their foliage and branches protect from the erosion caused by rainfall and winds. Removing these plants can cause the shore to weaken and easily crumble into the water.

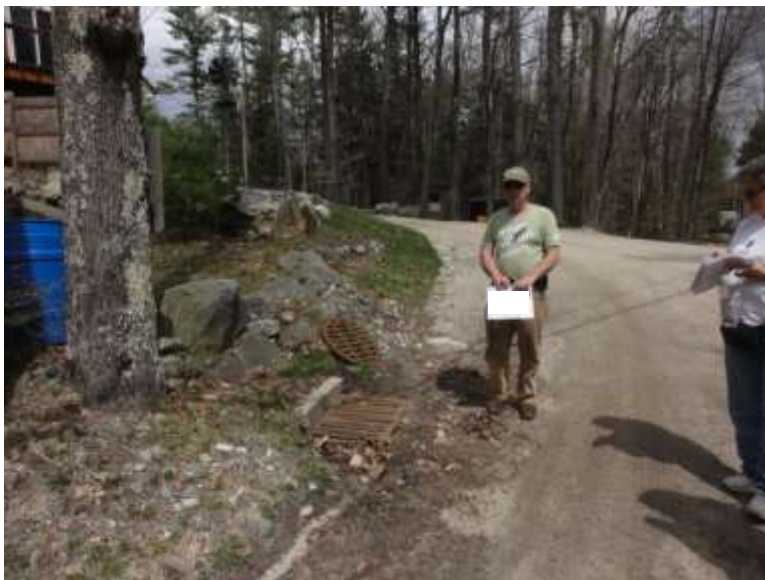
#### Surface Erosion: Rill

Rill erosion forms small channels, often only .3 cm deep. Rills are caused when water running across the surface of the ground gathers in a natural depression in the soil, and the concentrated water flows through and further erodes the depression.

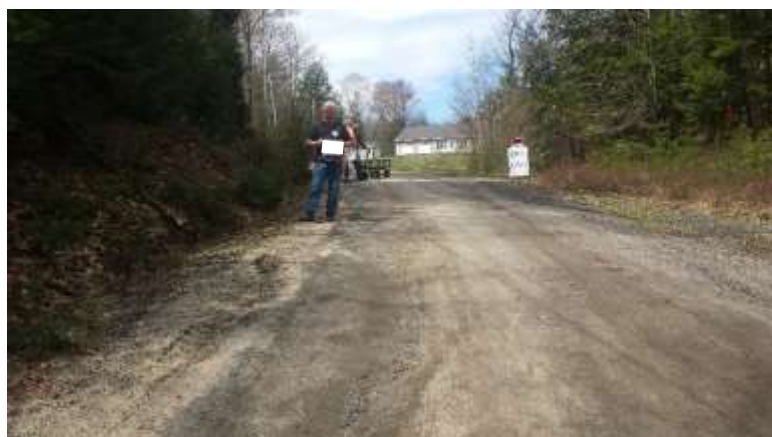
### Winter Sand

Phosphorus is attached to winter sand. Winter sand along the road shoulder can also interrupt the flow of stormwater and cause erosion of the road surface or shoulder. When grading the road, blade the edge of the shoulder to eliminate any build-up of sand and gravel.

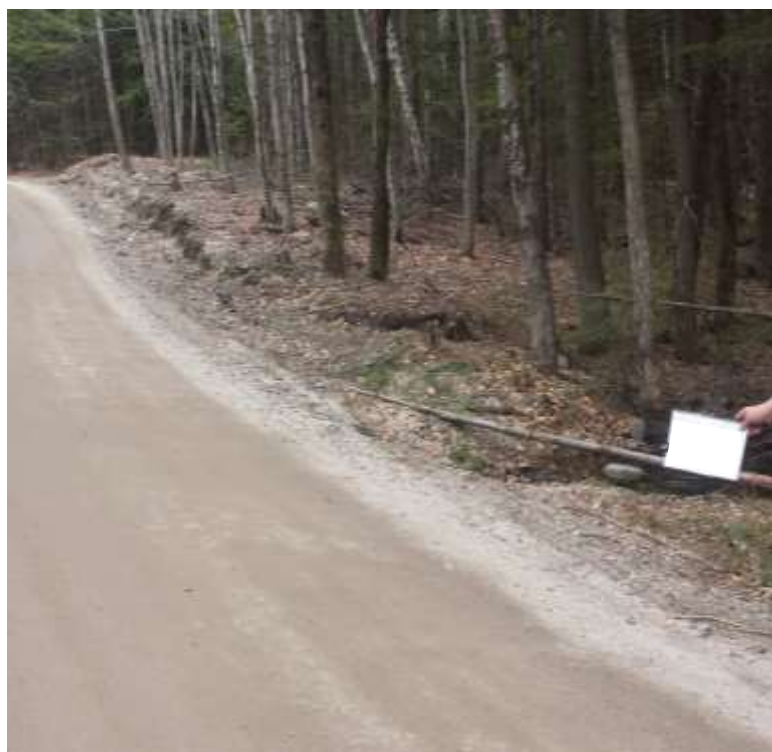
### Gully Erosion

Gully erosion is similar to rill erosion; it can occur when sheet flow becomes concentrated in large defined channels. This may occur in unrepaired rill erosion areas. It is associated with larger volumes of soil erosion.

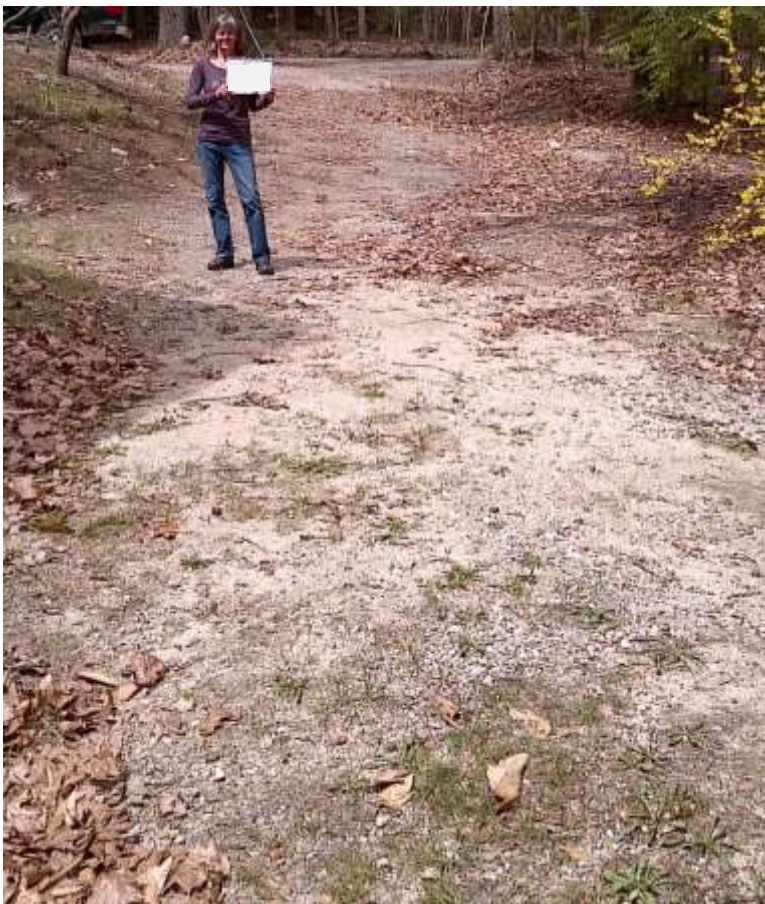
#### Surface Erosion: Rill

Rill erosion forms small channels, often only .3 cm deep. Rills are caused when water running across the surface of the ground gathers in a natural depression in the soil, and the concentrated water flows through and further erodes the depression.

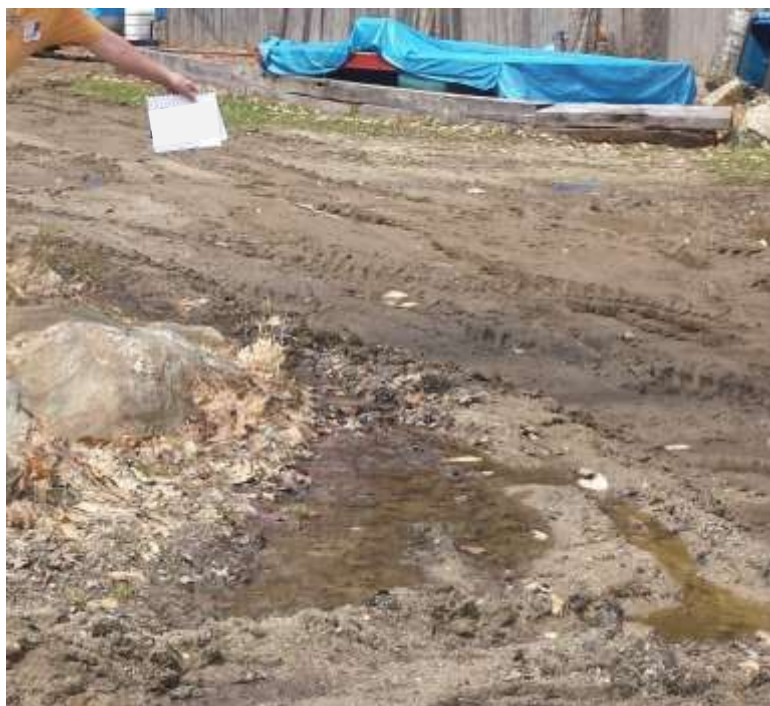
### Gully Erosion

Gully erosion is similar to rill erosion; it can occur when sheet flow becomes concentrated in large defined channels. This may occur in unrepaired rill erosion areas. It is associated with larger volumes of soil erosion.
