September 18, 2018

**Re: WINDHAM SAND/SALT STORAGE SHED INTERIOR WALL CONDITION, WINDHAM PUBLIC WORKS FACILITY, WINDHAM, ME**

**Appendix A**  
**Existing Sand/Salt Building**  
**Foundation Plan/Sections**

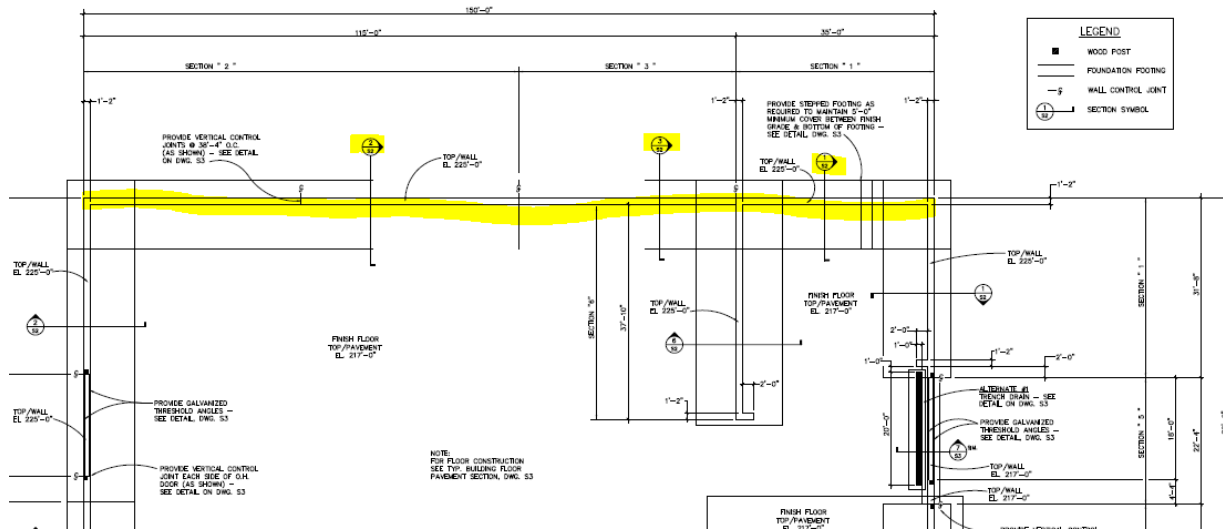
In Appendix A we have included the base plan from the original foundation plans AEI prepared back in 1999. The wall length in question is highlighted and the identified wall sections are provided.
