LITTLE SEBAGO LAKE WATERSHED

PROTECTION PLAN

Cumberland County Soil & Water Conservation District

Prepared by Heather True, CCSWCD
June 2013

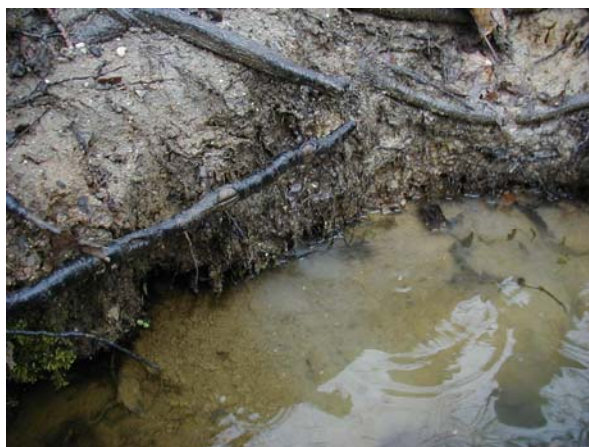
When combined with many other similar sites from throughout a watershed, even erosion from small sources such as this can have a significant impact on lake water quality.

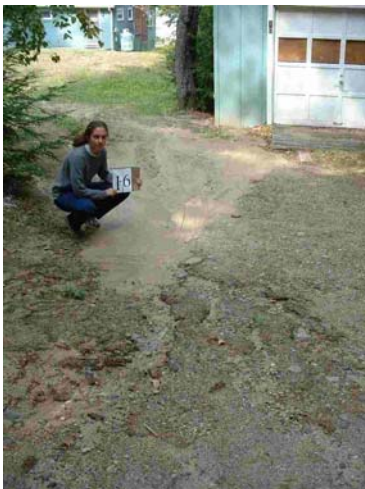
Runoff from the driveway and rooftops on this property combine to transport significant sediment into Little Sebago Lake.

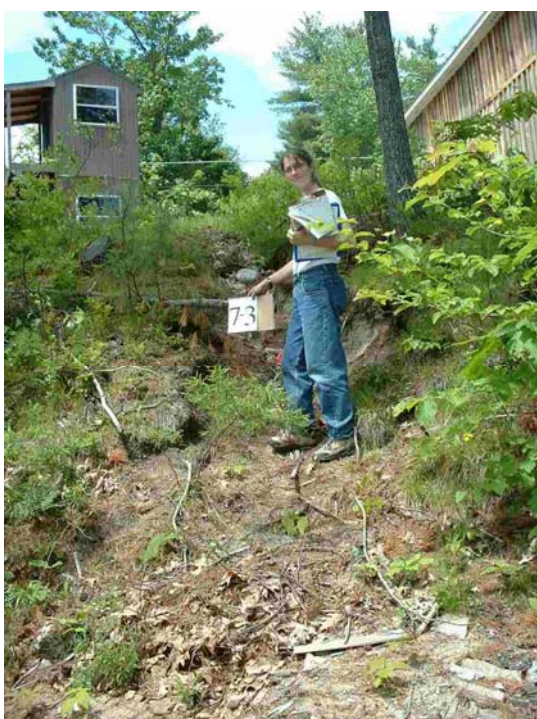
Below is an actual example of residential polluted runoff on Little Sebago Lake, as well as a description of the problems and possible solutions for this site.

Problems:

Recommended Solutions:

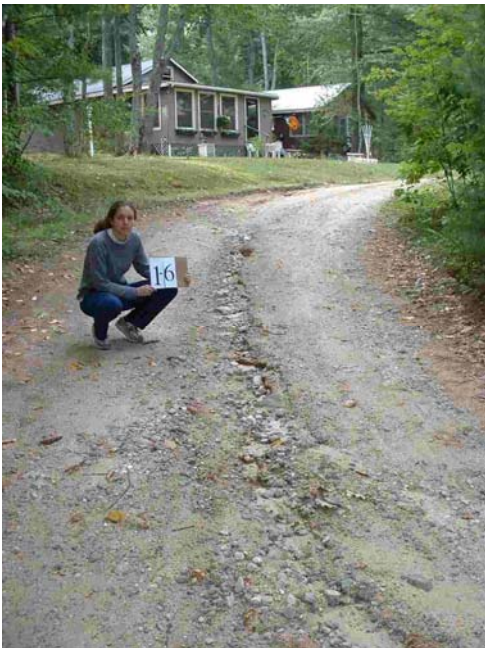
Below is an actual example of polluted runoff from a driveway on Little Sebago Lake, as well as a description of the problems and possible solutions for this site.

Problems

Recommended Solutions:

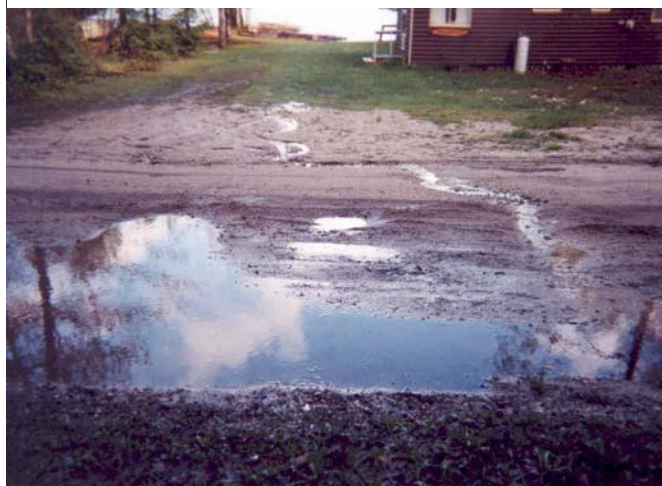
Below is an actual example of polluted runoff from a private road on Little Sebago Lake, as well as a description of the problems and possible solutions for this site.

Problems:

Recommended Solutions:

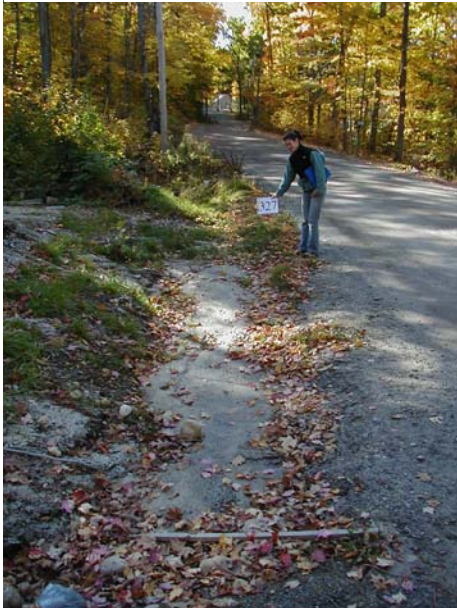
Below is an actual example of polluted runoff from a town road within the Little Sebago Lake watershed, as well as a description of the problems and possible solutions for this site.

Problems:

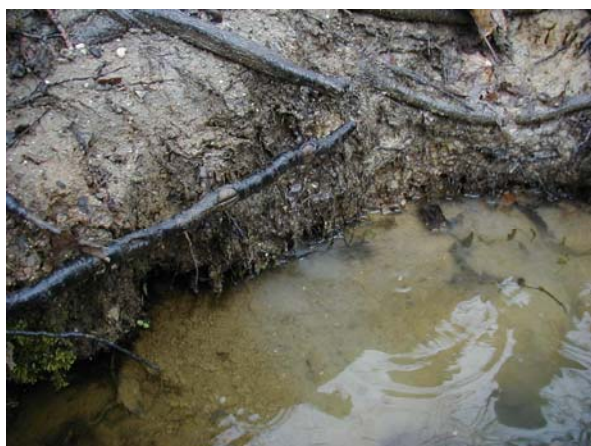
When combined with many other similar sites from throughout a watershed, even erosion from small sources such as this can have a significant impact on lake water quality.

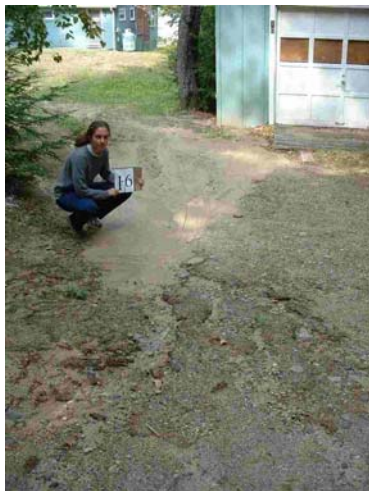
Runoff from the driveway and rooftops on this property combine to transport significant sediment into Little Sebago Lake.

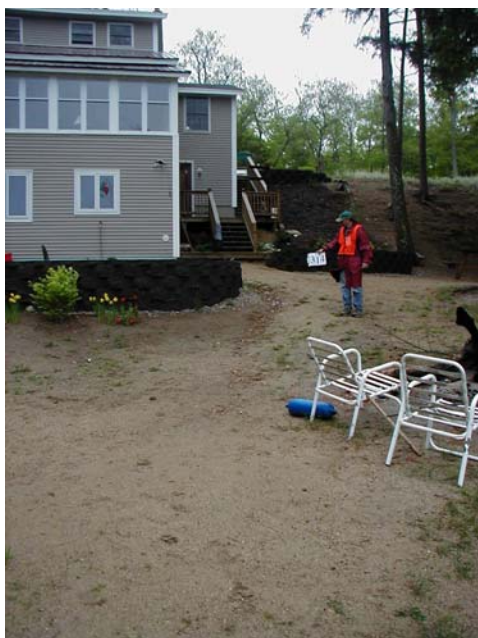
Since this site was documented during the survey, the landowners have taken steps to stabilize this site. Each step taken helps reduce the amount of soil that reaches the lake.

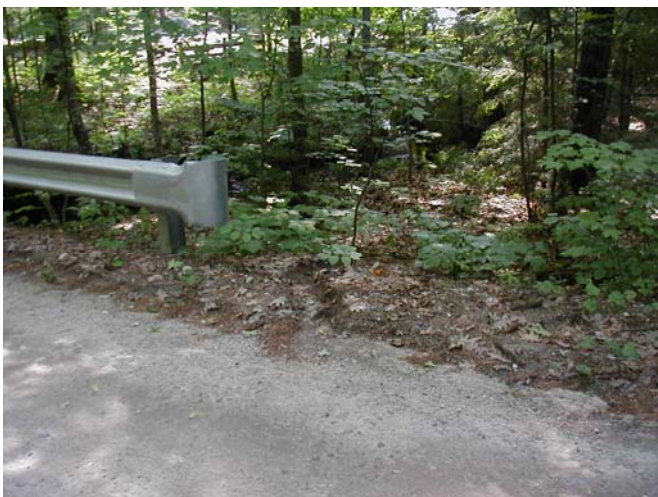
Problems:

- Grader or plow berm limits stable escape for water from road
- Moderate road shoulder erosion
- Direct flow of road material to stream.

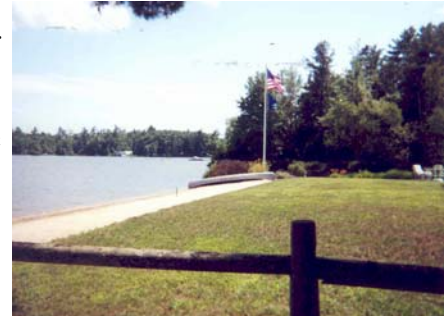
Numerous lakeshore properties had little or no vegetation at the water's edge. Lawns alone do little to prevent polluted stormwater from reaching the lake.
