# **TOWN OF WINDHAM FINAL PLAN APPLICATION**

**Solar Development  
Franklin Drive  
Windham, ME 04062**

# **Final Plan Application Franklin Drive – Solar Development Table of Contents**

**RE: Final Plan Application – Solar Development**  
**Franklin Drive, Windham ME; Map 18, Lot 26-2-A03**

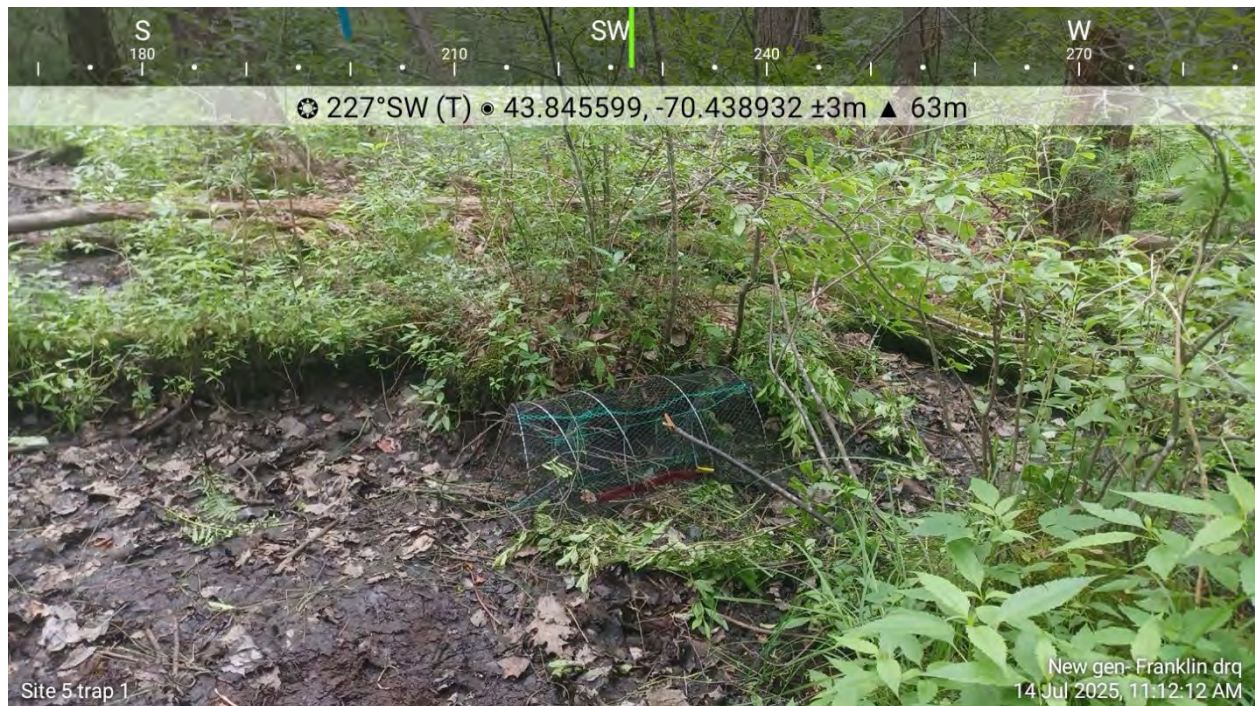
Site 5. Trap 1. After an overnight, July 14<sup>th</sup>, 2025
