# IMPAIRED STREAMS MONITORING PLAN

Windham, ME

June 2022

**Prepared by:** FB Environmental

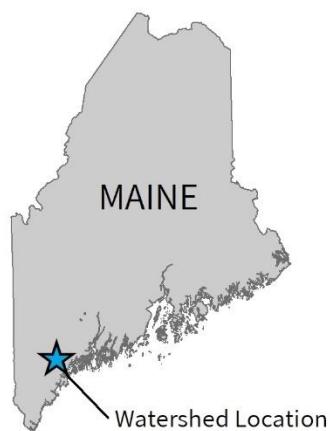
### Overview Map

## Impaired Stream Watersheds

Data Sources: NHD, ESRI,  
Town of Windham, MEGIS.  
Coordinate System: NAD  
83 UTM Zone 19N  
Map by: FB Environmental  
December 2021

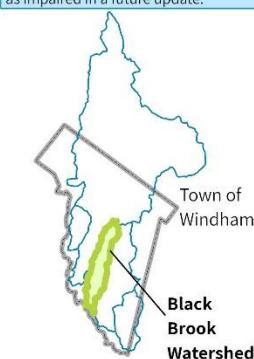
Data Sources: Town of Windham,  
Maine DEP, PRLT, WLT, NHD,  
Maine GeoLibrary, ESRI.  
Coordinate System: NAD 83  
UTM Zone 19N  
Map by: FB Environmental,  
January 2022.

**Note:** The currently underway Black Brook Watershed Management Plan will likely provide more detailed pollutant source identification.

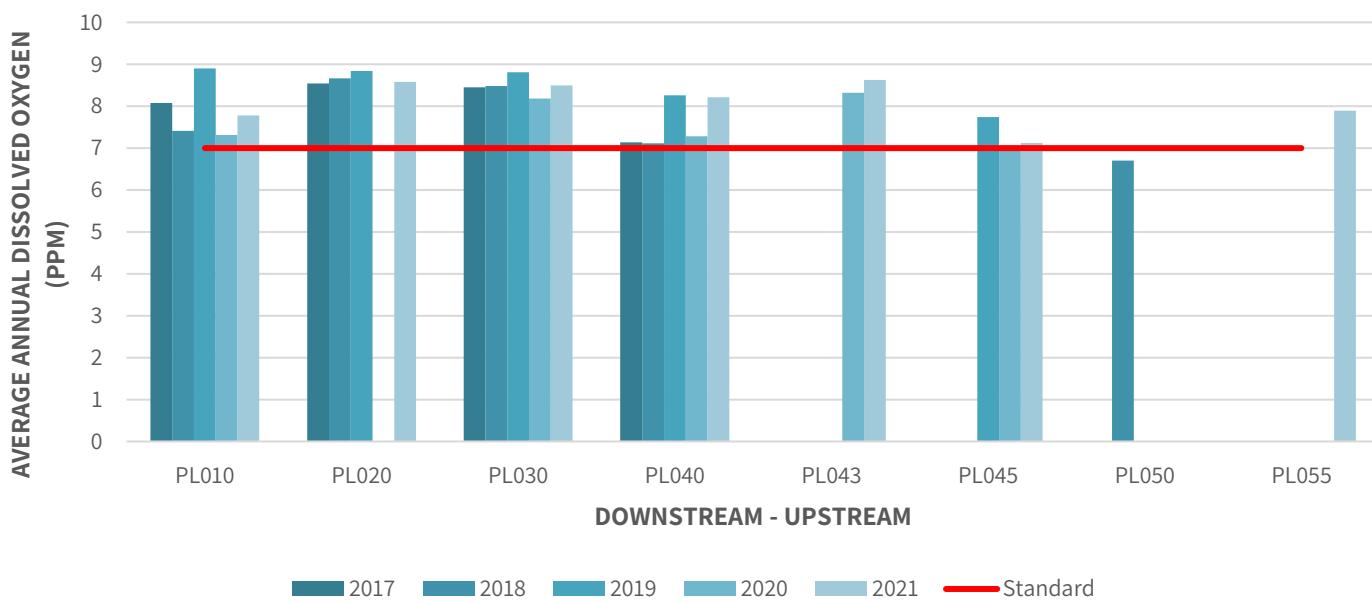
**Figure 2. Average annual instantaneous dissolved oxygen for eight sites on the Pleasant River, listed from downstream to upstream (left to right). The state standard for dissolved oxygen in Class B waterbodies is <7 ppm.**

The river is listed for a dissolved oxygen impairment due to historical data collected in 2011 or earlier. Periphyton and benthic macroinvertebrate data has demonstrated class B attainment or better. Instantaneous dissolved oxygen readings collected by PRLT demonstrate that the downstream sites have average annual dissolved oxygen concentrations that are just above the state standard while upstream sites suffer from lower average annual DO as well as elevated bacteria levels, however, available data at upstream sites is limited (Figure 2).

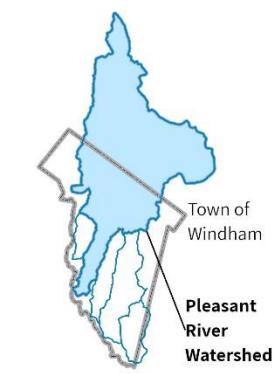
Data Sources: Town of Windham, Maine DEP, PLT, WLT, NHD, Maine GeoLibrary, ESRI.  
Coordinate System: NAD 83  
UTM Zone 19N  
Map by: FB Environmental, January 2022.

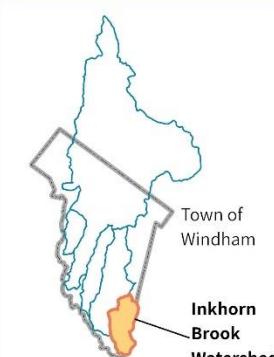
Data Sources: Town of Windham, Maine DMR, PRLT, WLT, NHD, Maine GeoLibrary, ESRI.  
Coordinate System: NAD 83 UTM Zone 19N  
Map by: FB Environmental, January 2022.

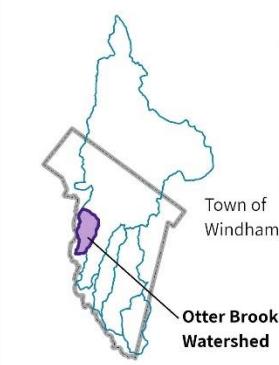
Data Sources: Town of Windham, Maine DEP, PLT, WLT, NHD, Maine GeoLibrary, ESRI.  
Coordinate System: NAD 83  
UTM Zone 19N  
Map by: FB Environmental, January 2022.

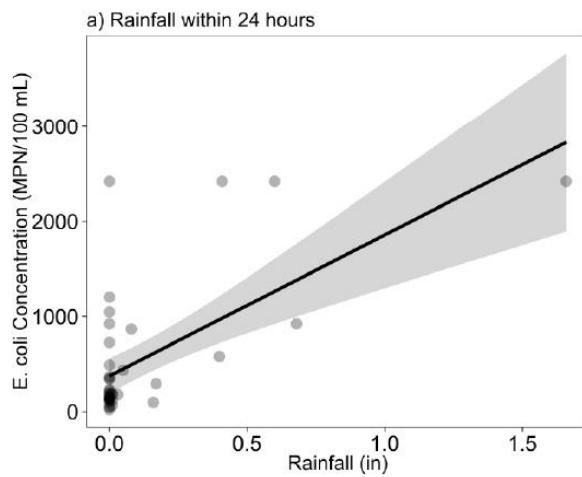
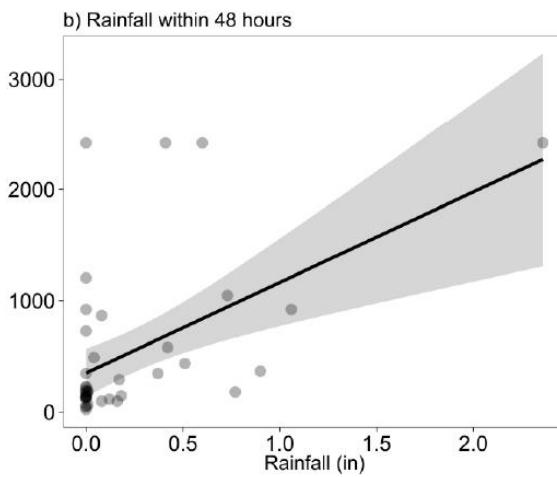
a) Black Brook, site RBK05/BL010

**ATTACHMENT 2.** Precipitation within the 24- and 48-hour periods prior to sampling over the previous five years of sampling. Sites were assessed by “adjacent spatial location” (meaning VRMP sites and PRLT sites in the same sites that are the same road crossing in the EGAD database, but that may have slightly different coordinates).
