**Re: Environmental Site Assessment, Phase I
South Windham Fire Station
8 Main Street
Windham, ME**

Phase I Environmental Site Assessment Report

South Windham Fire Station
8 Main Street
Windham, ME 04062

December 15, 2017
Project # BE-076

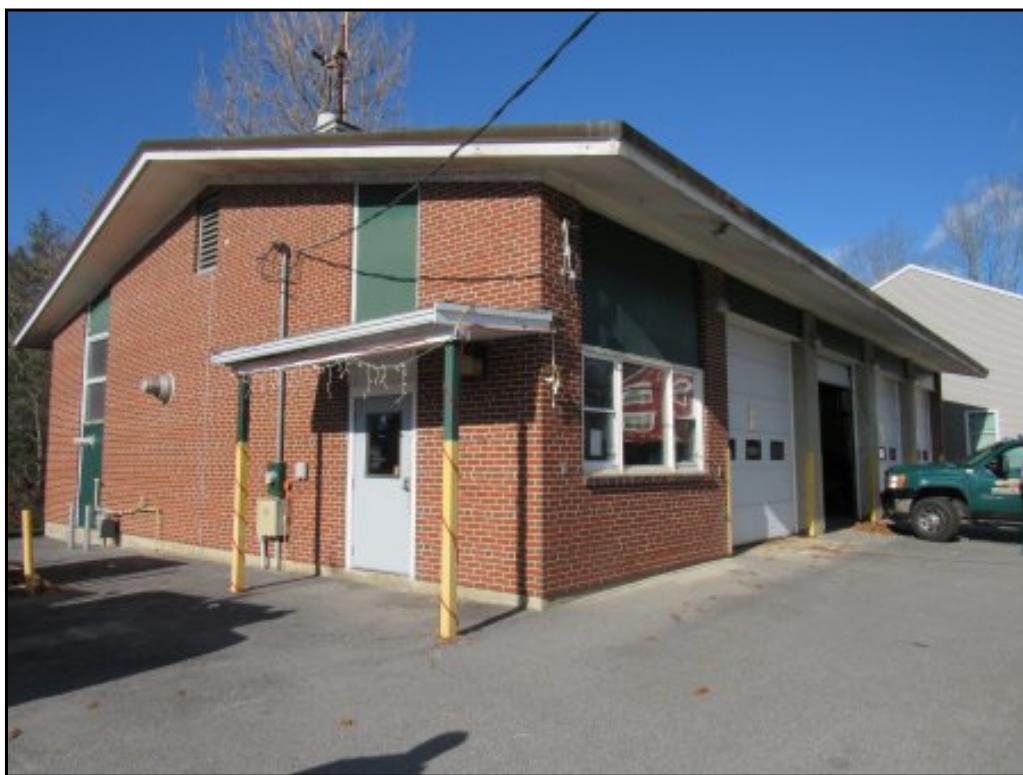
The site consists of one "service station" style structure. The 3,200 square foot, one-story building is constructed of reinforced concrete with a brick veneer, one-story buildings and paved parking areas. The building has four garage bays. A kitchen, bathroom, and office were observed within the building as well. A small boiler room is located as the southwestern portion of the building and is accessed by an exterior door.

View of the Site building from the southeast.

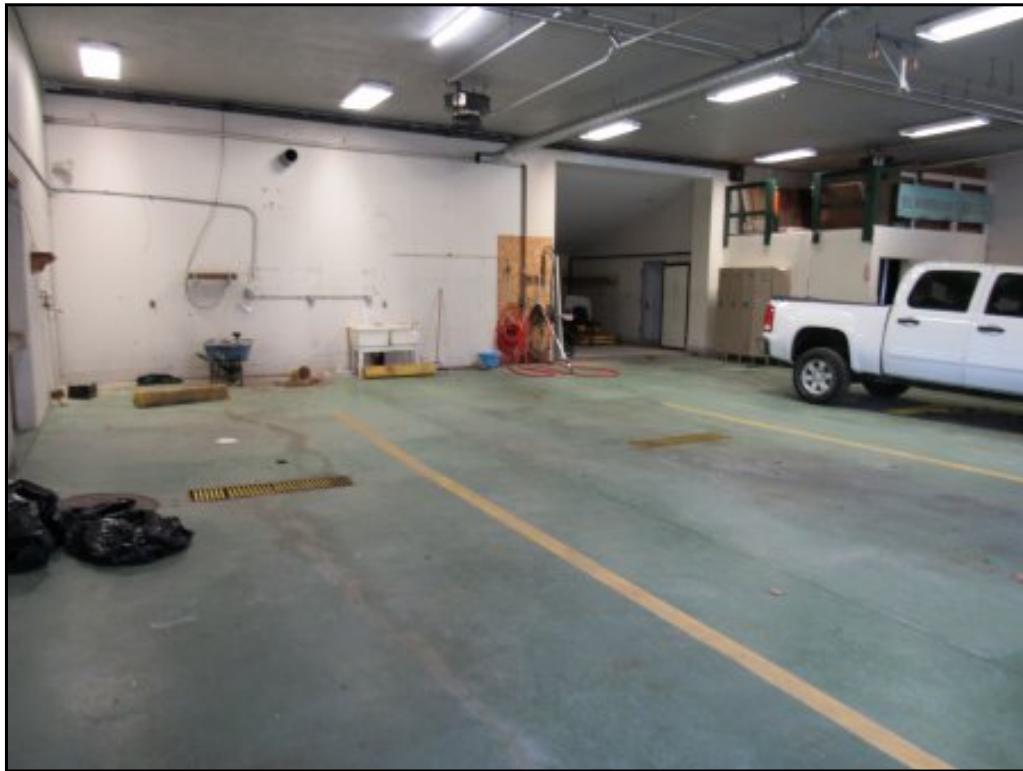
Discharge features (trench drains) were observed on the subject property during the site reconnaissance. These trench drains are connected to the municipal sewer.

View of the floor trenches in the garage bays.

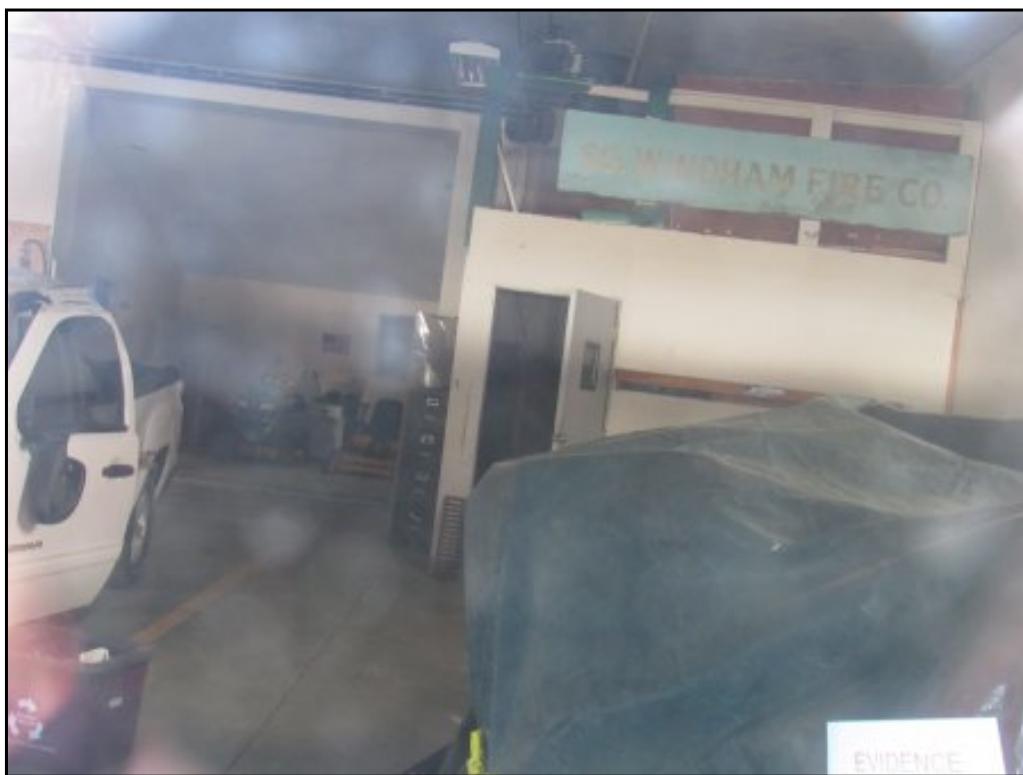
Interior staining was observed in the subject building during the site reconnaissance. It appears that one of the vehicles (a white truck) currently stored within the building was leaking fluids onto the floor. This liquid appeared to be making its way to the floor trenches and ultimately to the municipal sewer.

Beacon observed staining on the floor beneath an impounded truck.

View of the impounded vehicles within the building. The white truck on the left was leaking fluids.

Beacon recommends moving the impounded vehicles away from the trench drains and cleaning the floor to remove the residual impacts. The potential for contamination should be determined and the soil gas on the property should be sampled to determine if a potential indoor air threat exists. Samples of paint and caulking should be collected for analysis of PCBs and an ACM and LBP survey should be completed to document their potential for being within building components.

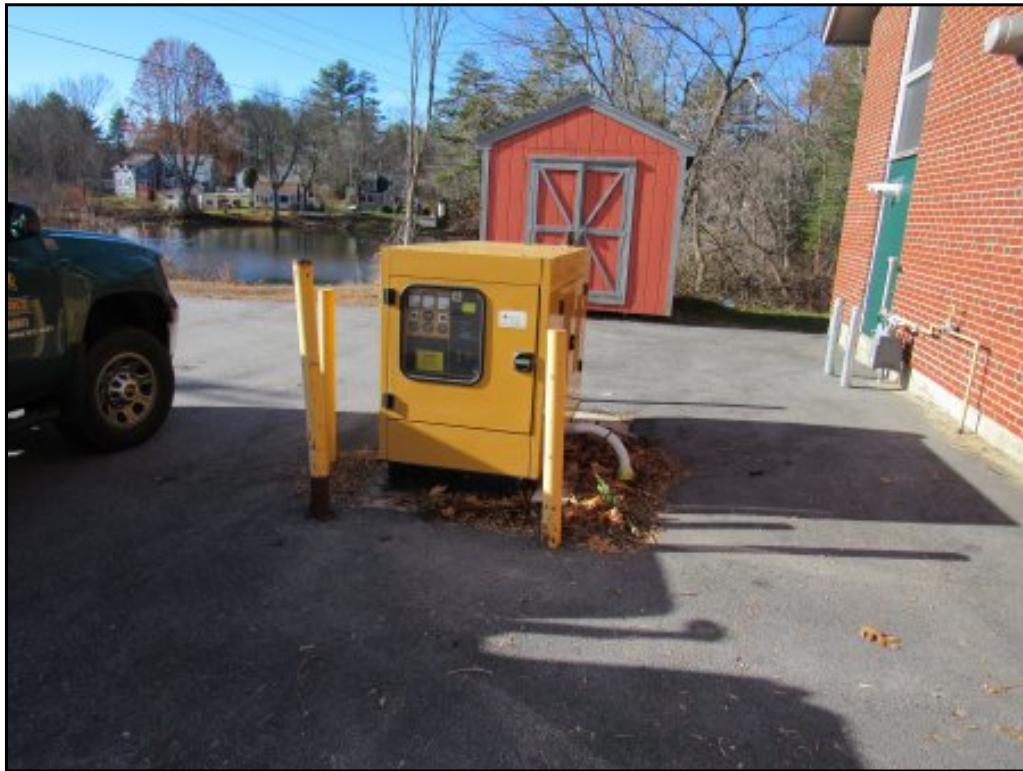
Generator to the south of the building.

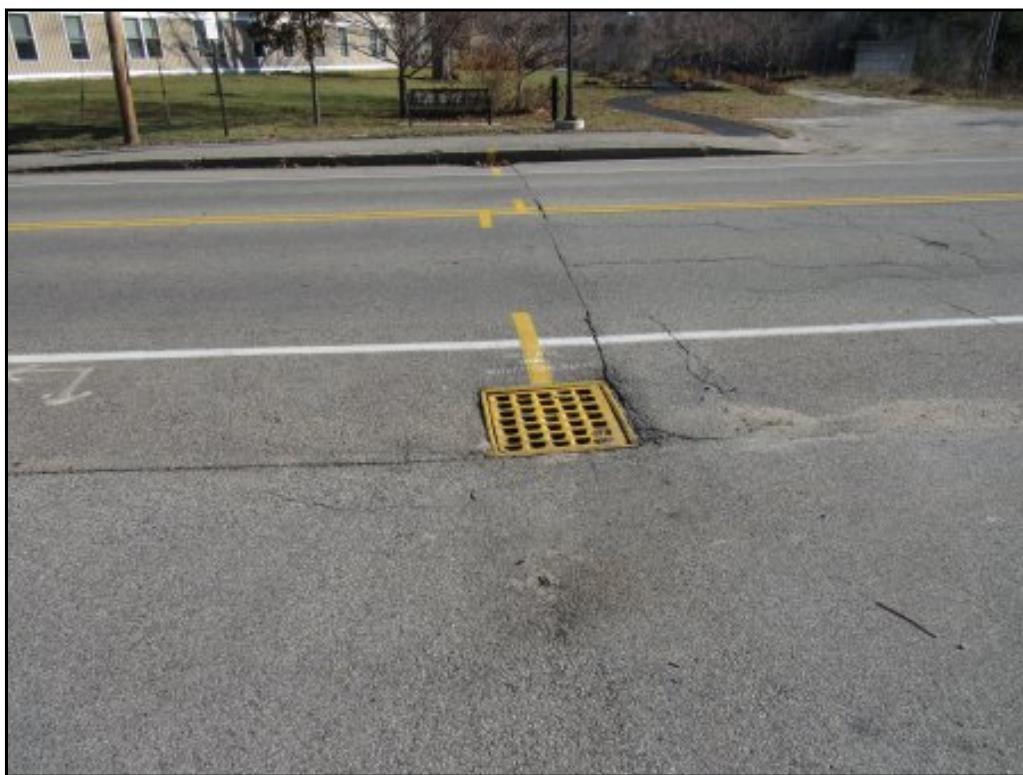
Storm drain in front of the building in Main Street.

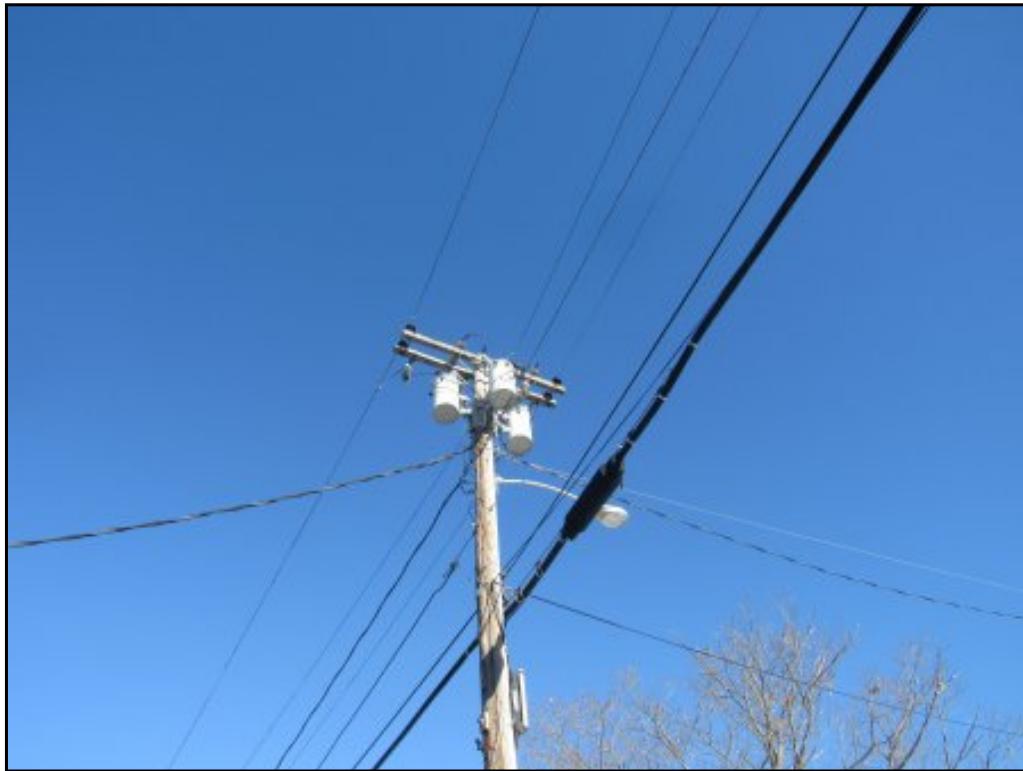
Three pole-mounted transformers located on the eastern portion of the Site.
