## 2016 Windham Watershed Protection Grant Final Report

# OTTER BROOK & BLACK BROOK

## 2016 WATER QUALITY REPORT

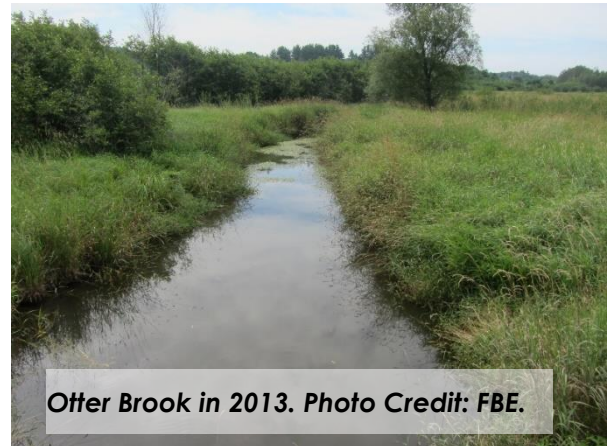
**Otter Brook in 2013. Photo Credit: FBE.**

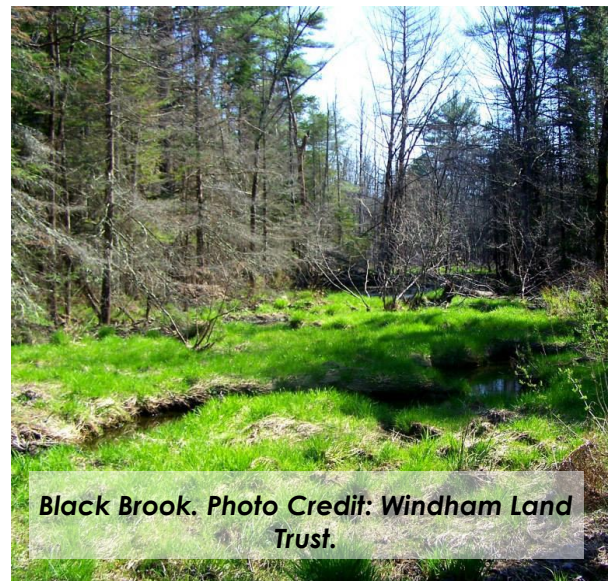
**Black Brook. Photo Credit: Windham Land Trust.**

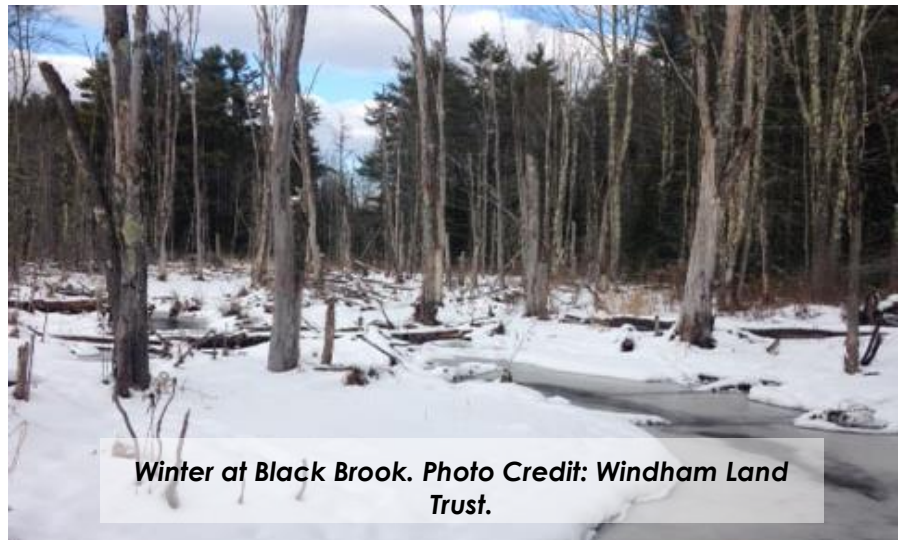
**Table 3.** Sampling location descriptions at Black Brook

Monitoring at Black Brook in 2016 was limited to two sites (BB – 1 and BB – 2, Table 3) for *E. coli*, DO, and temperature. The 2015 sampling season was the first bacteria sampling at Black Brook since 2011 by the VRMP. The VRMP sampled at the crossing of Black Brook with River Road (RBK) and 2015 sampling by the WLT was upstream at the headwaters off 302 (BB – 1) and at the crossing with Windham Center Road (BB – 2) (Table 3).

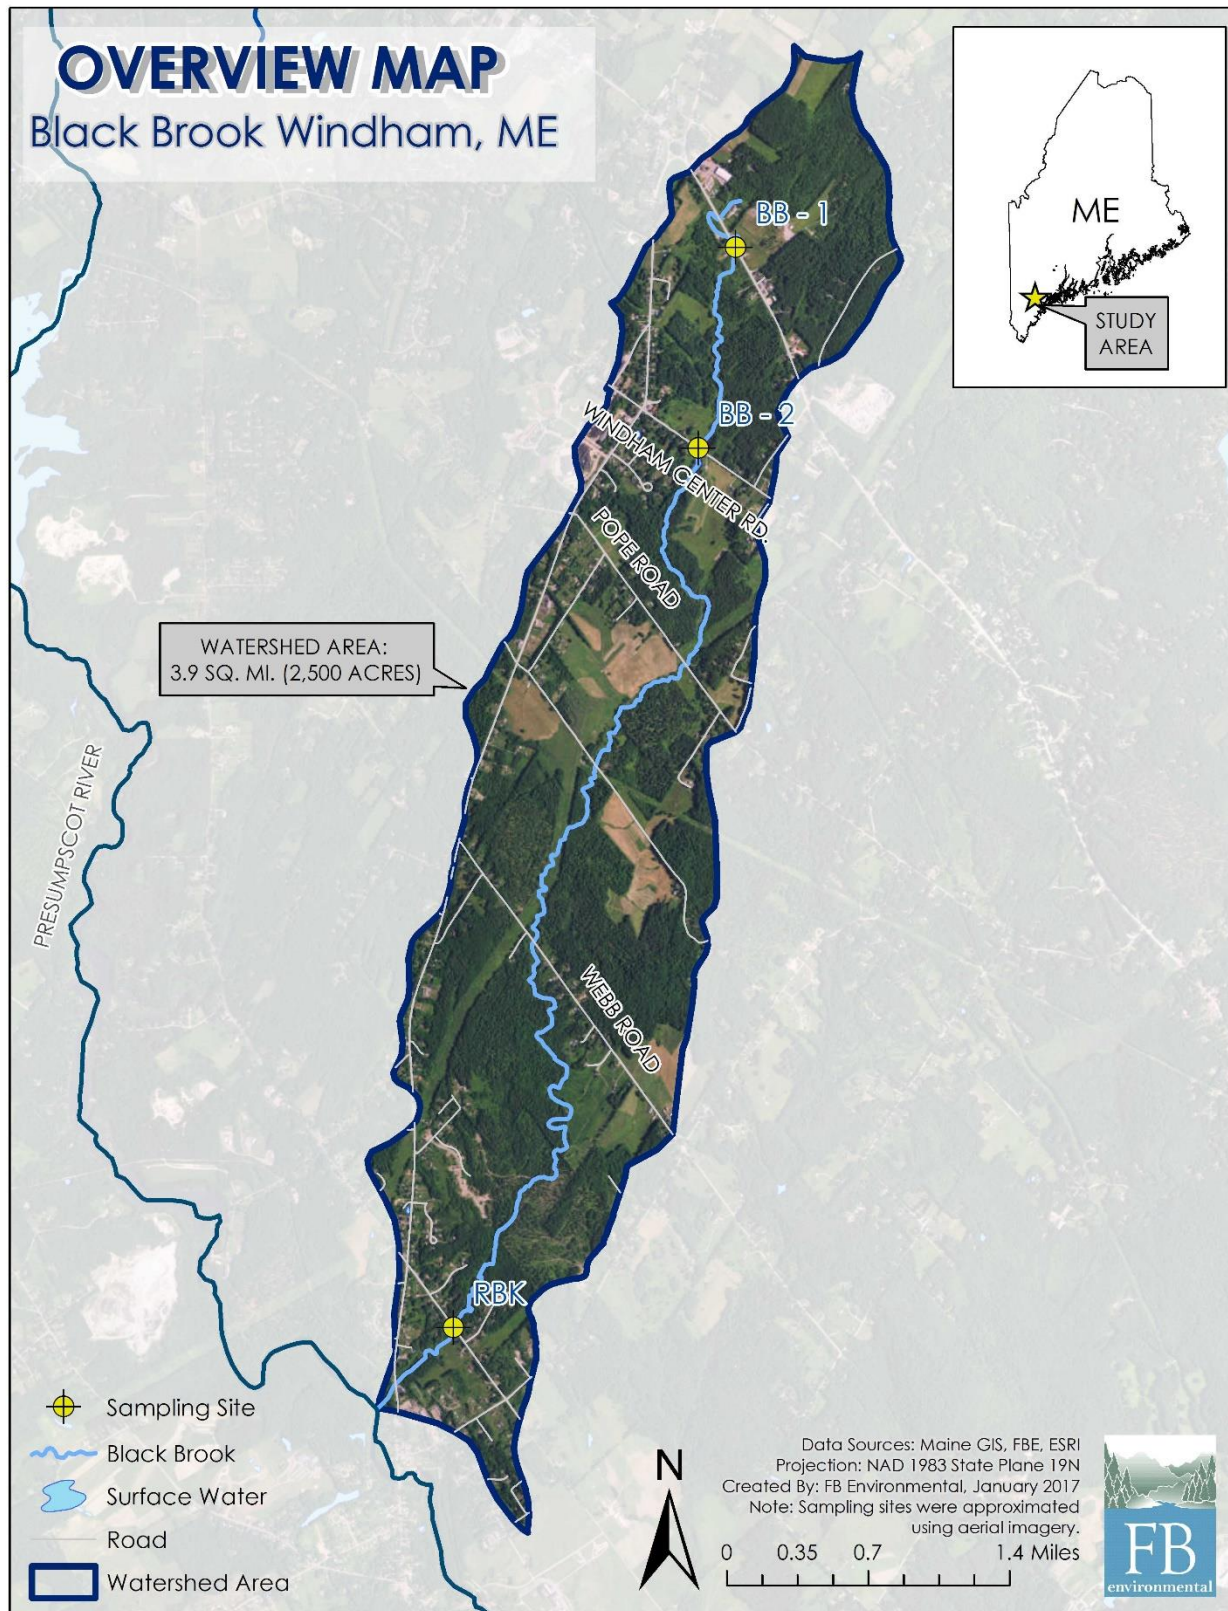
## APPENDIX II. Map of Black Brook

| SITE | DESCRIPTION |
|---|---|
| <b>BB - 1</b> | Located at the headwaters on 302 near Hawk Farmstand |
| <b>BB - 2</b> | Located off Windham Center Road near culverts |
| <b>RBK</b> | Located at River Road crossing |
