# WATERSHED PROTECTION PLAN

# FOREST LAKE

Prepared by CCSWCD for the  
Forest Lake Association  
January 2018

# **2017 Forest Lake Watershed Survey**

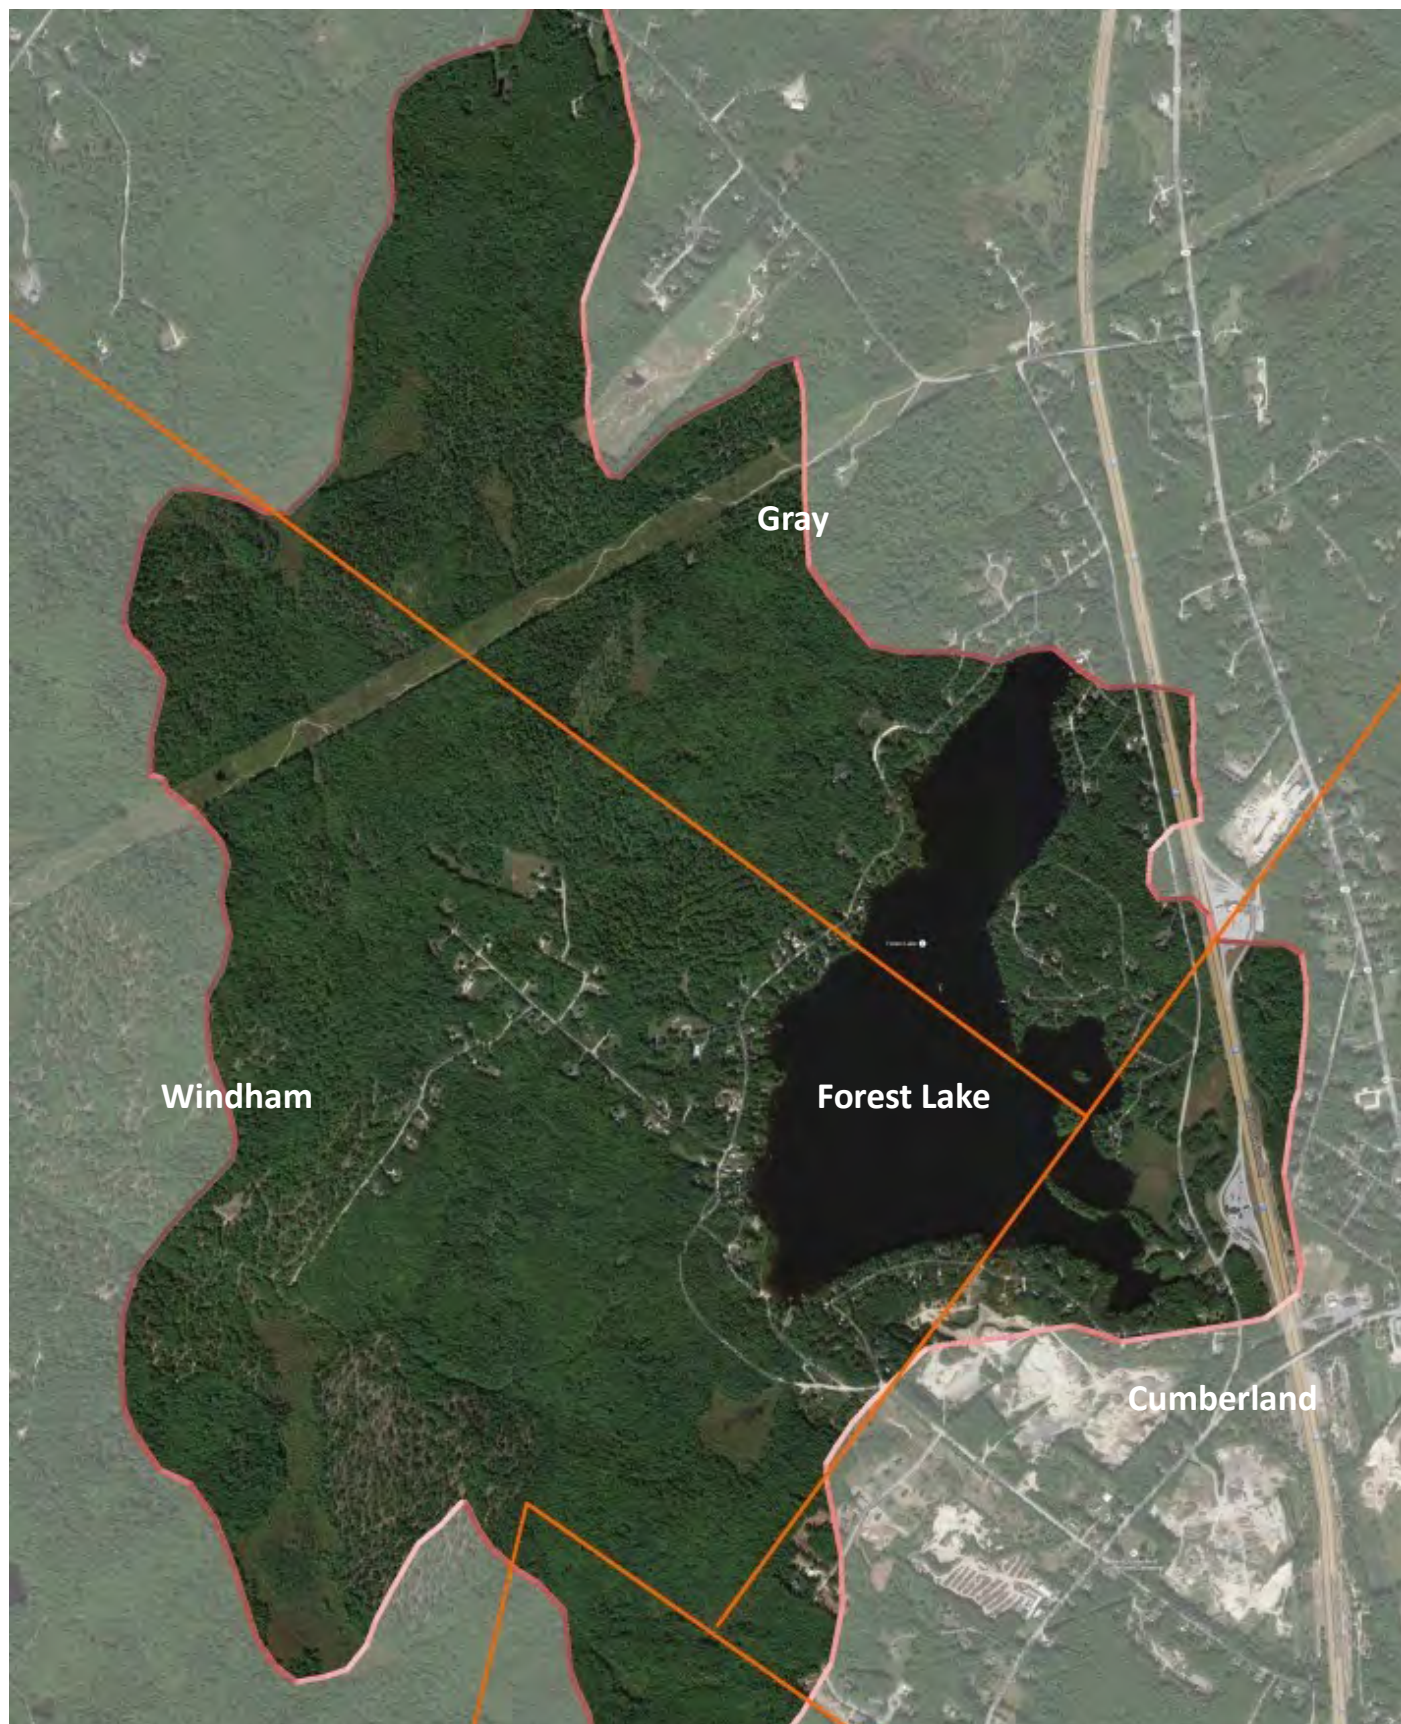
**Figure 1:** Forest Lake Watershed

The Forest Lake watershed is located in the Towns of Gray, Cumberland, and Windham in Cumberland County, Maine (**Figure 1**). The Lake has a surface area of 210 acres, a maximum depth of 38 feet, an average depth of 12 feet, and a flushing rate of 1.4 flushes per year<sup>2</sup>. The Lake’s immediate watershed covers three square miles and serves as the headwaters for the Piscataqua River, which then flows into the Presumpscot River and Casco Bay. Development within the watershed has been mostly residential with nearly 180 lakefront properties. Most recent development has been occurring along the western shore of the Lake.

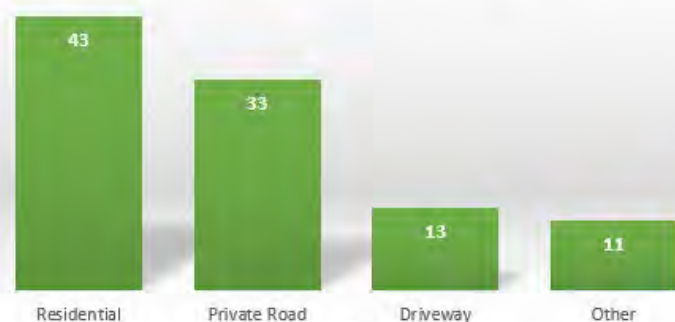
**Figure 3.** 2017 impact sites per residential land uses

Residential properties (43%), private roads (33%), and driveways (13%) accounted for most of the sites in the 2017 survey (**Figure 3**). This breakdown of sites by land use was surprisingly similar to the results of the 2002 survey, especially in regards to sites associated with private roads. The greatest changes from the 2002 survey are the decrease in number of sites associated with residential properties, which decreased by 28, and driveways, which decreased by 9. The 25 private road

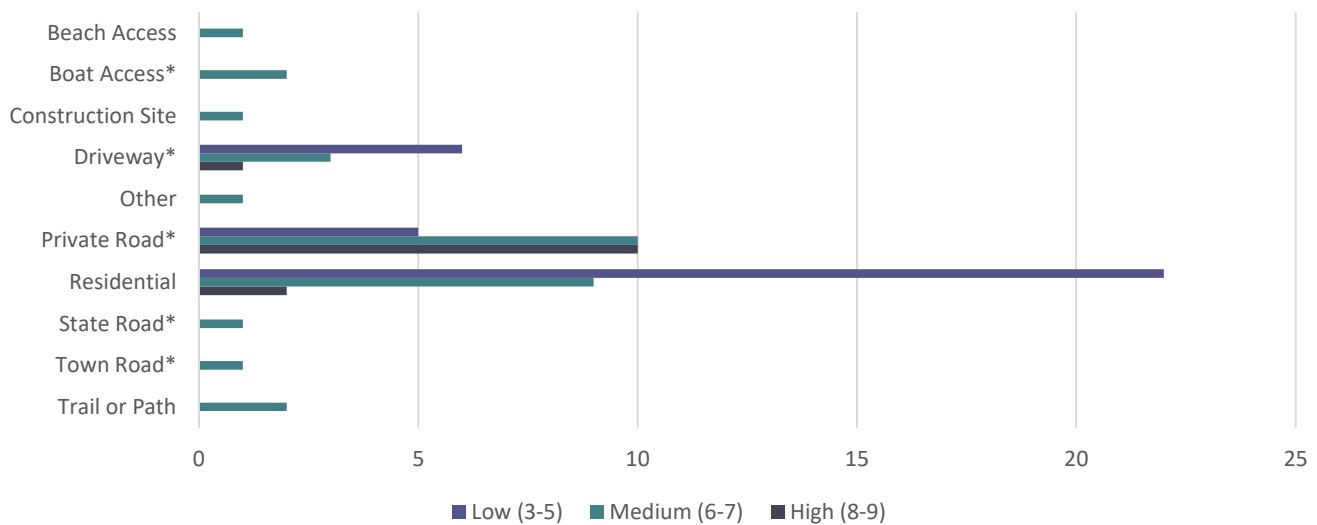
**CHART 3: IMPACT RATINGS OF EACH LAND USE CATEGORY**

Another way of looking at the data is to compare the number of the high, medium, or low sites for each land use category (Table 5). Private Roads contributed the most medium to high impact sites (20 total). Only Residential sites neared this number, with eleven (11) sites in the medium to high impact category. Although all sites are important in the overall picture of a healthy watershed, these two land uses predominate; only thirteen (13) sites fell into the medium to high impact category in all other land use/activity categories.

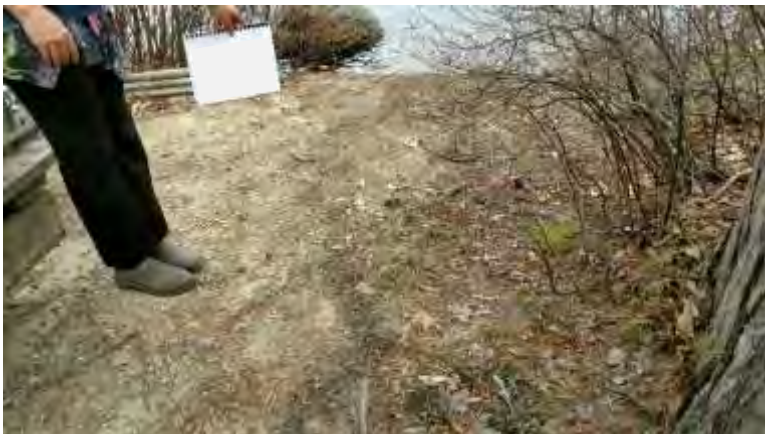
#### Bare Soil

Bare soil surfaces directly affect runoff rates, which increase because there is nothing to absorb the rain water. Conversely, vegetation allows for greater infiltration because the roots in the plants absorb the water and pulls it into the ground.

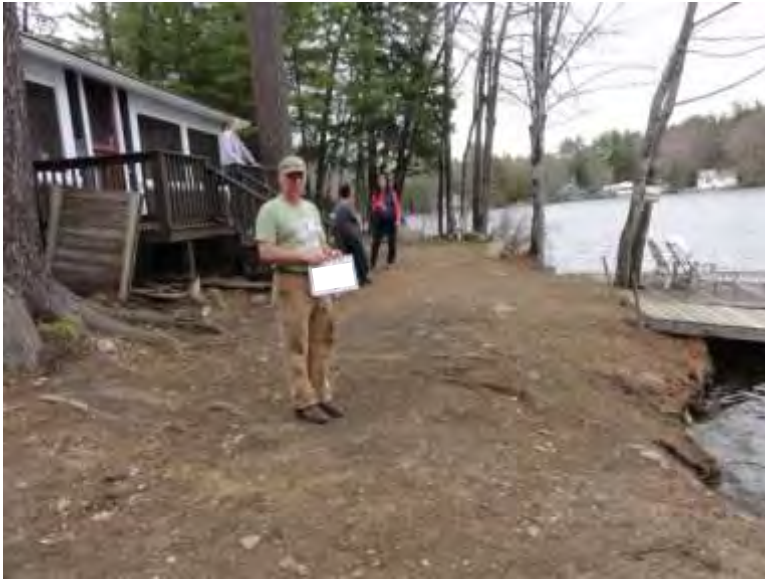
### **Sheet Erosion**

Sheet erosion occurs when a thin layer of topsoil is removed by water runoff.

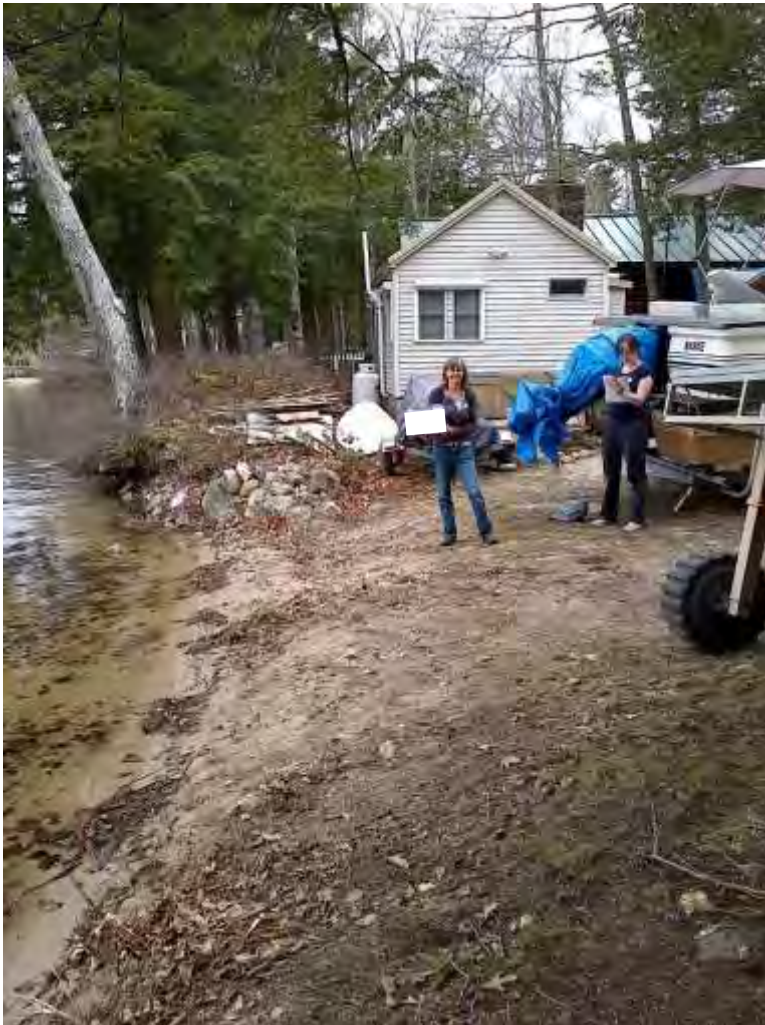
### **Lack of Shoreline Vegetation**

Native vegetation usually found at the shoreline strengthens its structural integrity and prevents the land from breaking apart. The deep roots of these plants bind the earth together while their foliage and branches protect from the erosion caused by rainfall and winds. Removing these plants can cause the shore to weaken and easily crumble into the water.

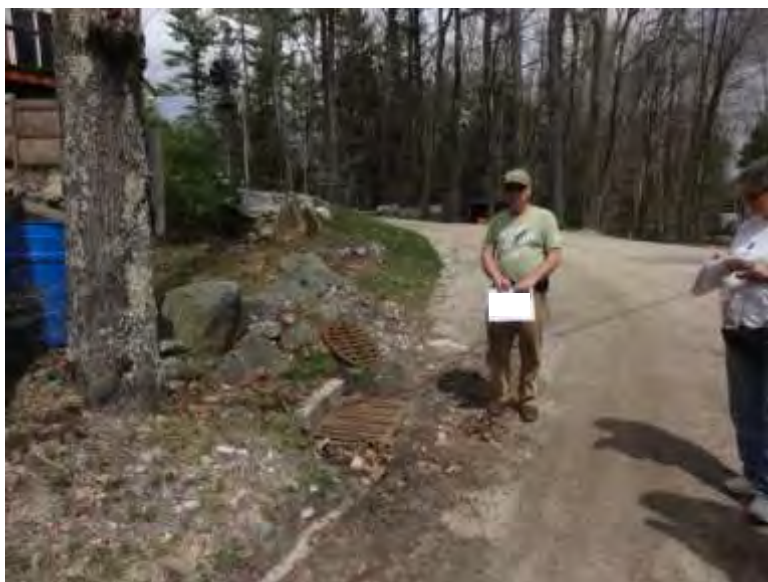
#### Surface Erosion: Rill

Rill erosion forms small channels, often only .3 cm deep. Rills are caused when water running across the surface of the ground gathers in a natural depression in the soil, and the concentrated water flows through and further erodes the depression.

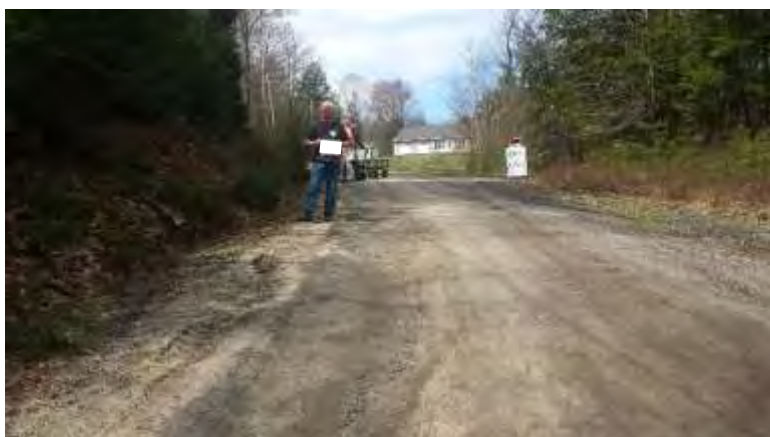
### Winter Sand

Phosphorus is attached to winter sand. Winter sand along the road shoulder can also interrupt the flow of stormwater and cause erosion of the road surface or shoulder. When grading the road, blade the edge of the shoulder to eliminate any build-up of sand and gravel.

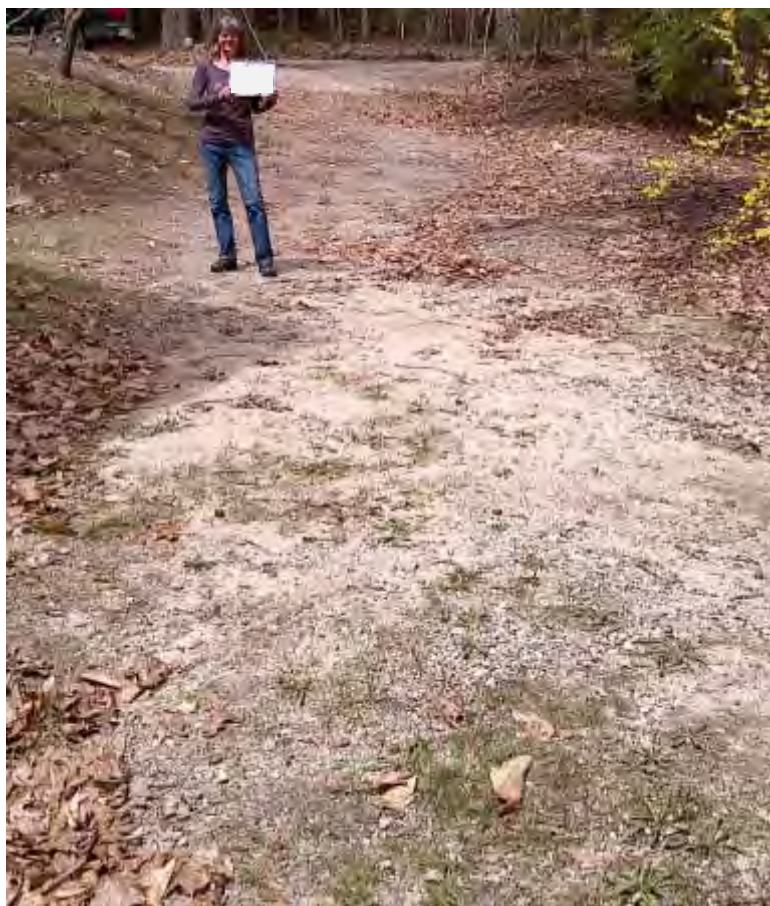
#### Surface Erosion: Rill

Rill erosion forms small channels, often only .3 cm deep. Rills are caused when water running across the surface of the ground gathers in a natural depression in the soil, and the concentrated water flows through and further erodes the depression.

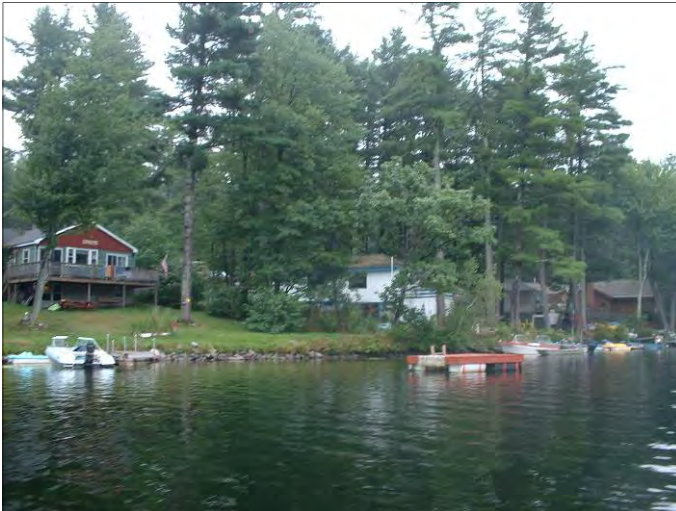
Numerous lakeshore properties were observed to have little or no **vegetated buffer** at the water's edge. These sites were not included in the survey results but it is important to note that buffers of shrubs and trees do a much more effective job than bare ground or grass at keeping polluted runoff from entering lakes. The deep roots of shrubs and trees also help stabilize the shoreline.

Buffers can be installed inexpensively. You can stop mowing and raking at the water's edge and let plants grow up naturally. Or you can plant the area with native trees and shrubs.

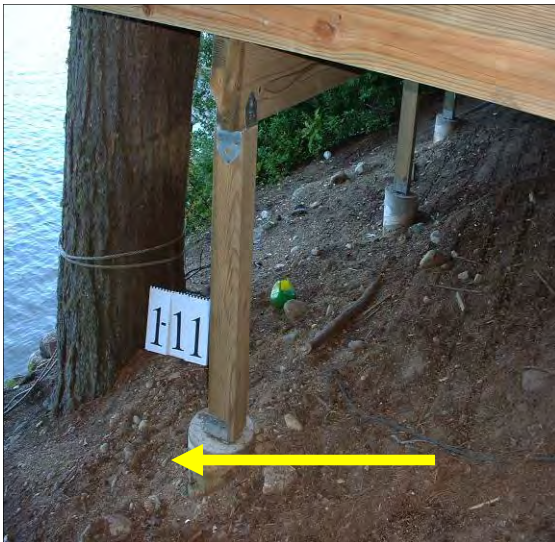
### Problems:

- Lack of silt fence
- Bare soil with direct flow to lake
- Lack of vegetated buffer

### Recommended Solutions:

- Seed and mulch bare soil
- Establish or enhance vegetated buffer
- Limit foot traffic in eroding areas
- Install dripline trench to catch roof runoff
- Install silt fence around construction sites
- Install waterbar, open-top culvert, rubber razor or other runoff diverter
- Place mulch or stone on footpaths

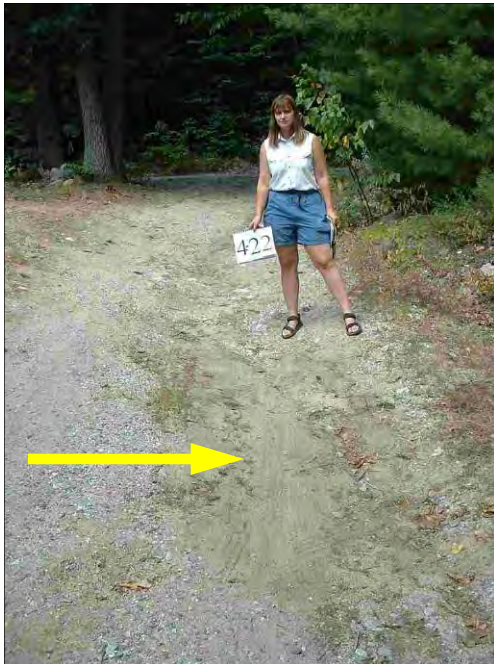
### Problems

- Poor driveway shaping and ruts cause water to concentrate and erode the surface
- Direct flow of sediment to lake

### Recommended Solutions:

- Crown driveway so that water flows to either side
- Install diverters such as waterbars, open top culverts or rubber razors to get water off road
- Install turnouts to direct water into wooded depressions

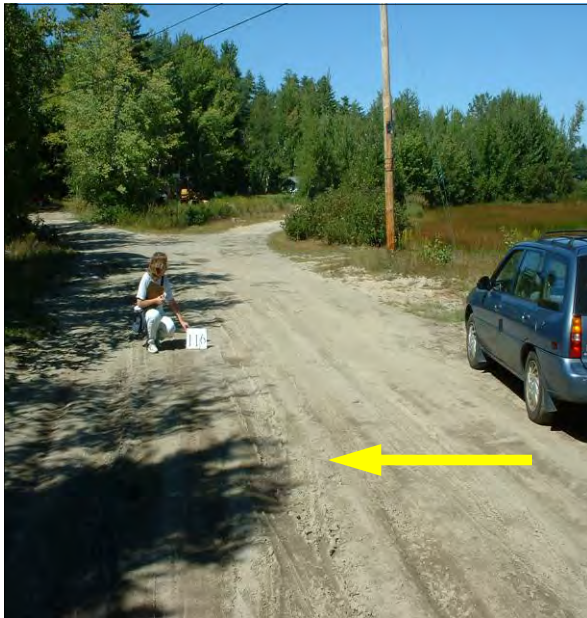
### Problems:

- ◆ Lack of ditches
- Moderate surface erosion
- Poor surface material

### Recommended Solutions:

- Crown and reshape road to get water off road
- Install diverters such as waterbars, open top culverts or rubber razors to get water off road
- Build up road with cohesive surface material
- Clean out culverts
- Clean, reshape and armor ditches with stone rip rap or plant grass
- Remove grader berms and winter sand to allow proper drainage
- Install culverts and stabilize ends with stone

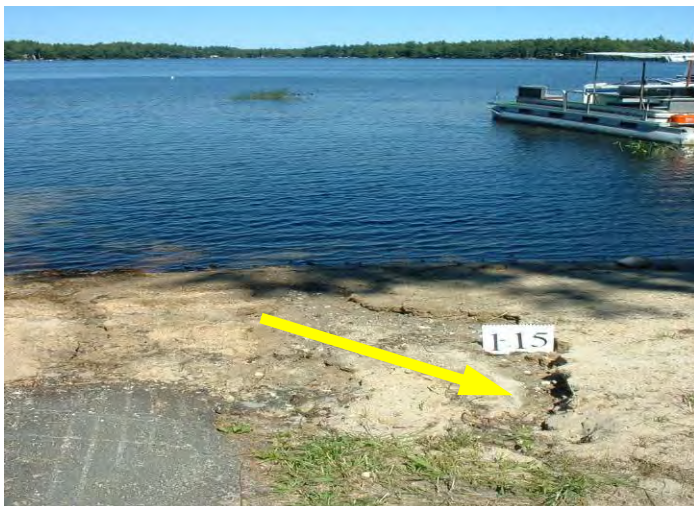
### Problems:

- Severe erosion
- Direct flow of sediment and winter sand into lake

### Solutions:

- Install tri-lock blocks to create swale
- Install rubber razor blade
- Install runoff diverter at top of boat access to trap sediment before it reaches the lake

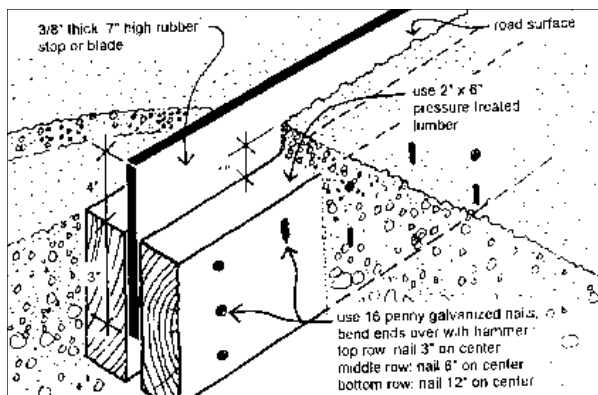
**Rubber Bar**—Structure that protrudes above the road surface high enough to intercept and collect water, while allowing traffic to pass over it. It is generally used on seasonal roads and driveways because of the likelihood of plow damage. Install at a 30° angle to the road and direct the outlet into a stable buffer. The rubber conveyor belts can be purchased at some hardware stores or Augusta Rubber (582-6200).

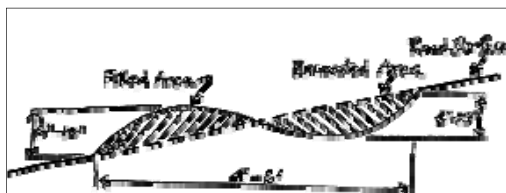
**Waterbar**—Ridge (like a speed bump) that runs diagonally across a road, driveway or path, typically at a 30° angle. Stops water from running down the road and diverts it to the side. Easy to construct and most appropriate for roads with low traffic volume. Needs to be rebuilt periodically.
