From: Jonathan R. Earle
Sent: Friday, June 01, 2018 10:58 AM
To: Christopher S. Hanson; Amanda L. Lessard
Cc: Charles Daigle
Subject: Sabatus Lane Inspection 6-1-2018
Attachments: IMG_0775.jpg; IMG_0777.jpg; IMG_0779.jpg

Below is a summary of a field inspection done by Chris and I this morning for the Sabatus Lane Subdivision project along with attached photos:

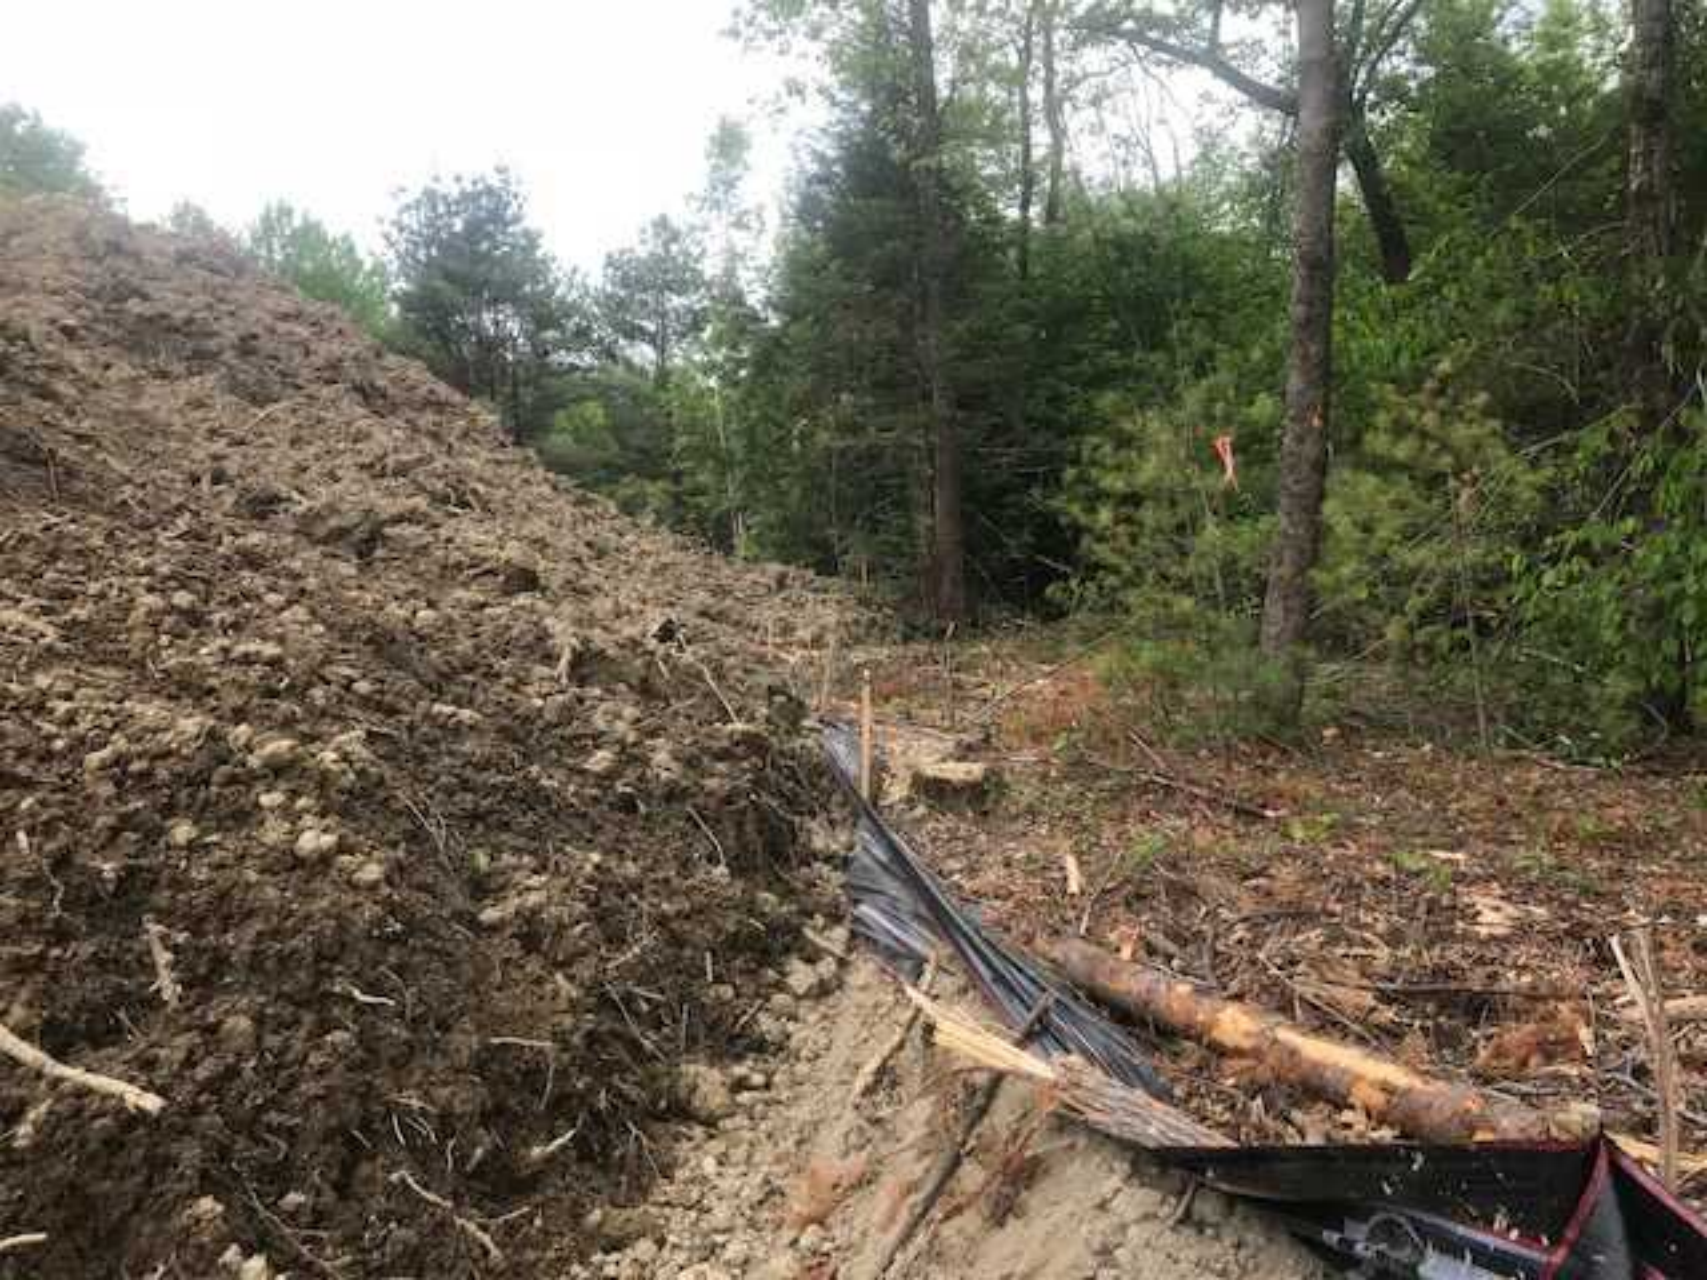
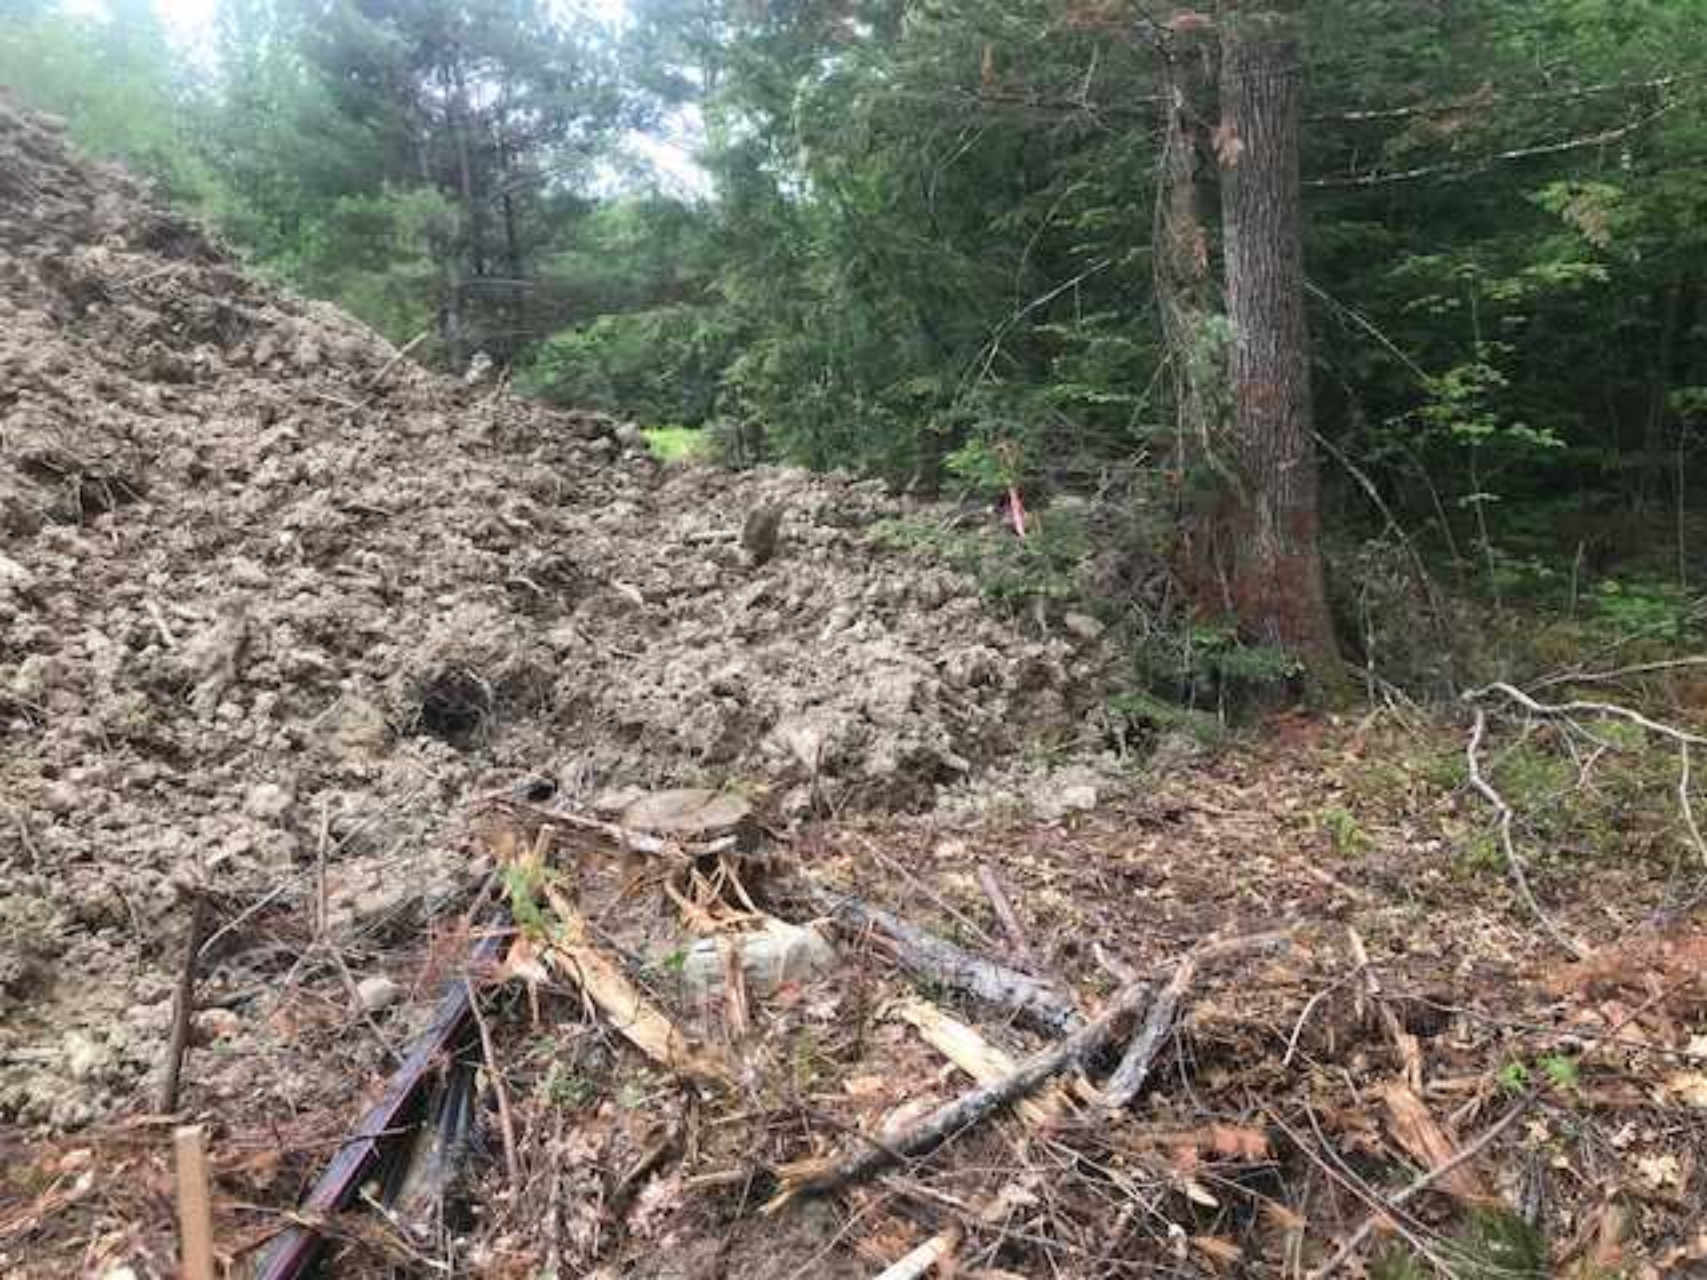
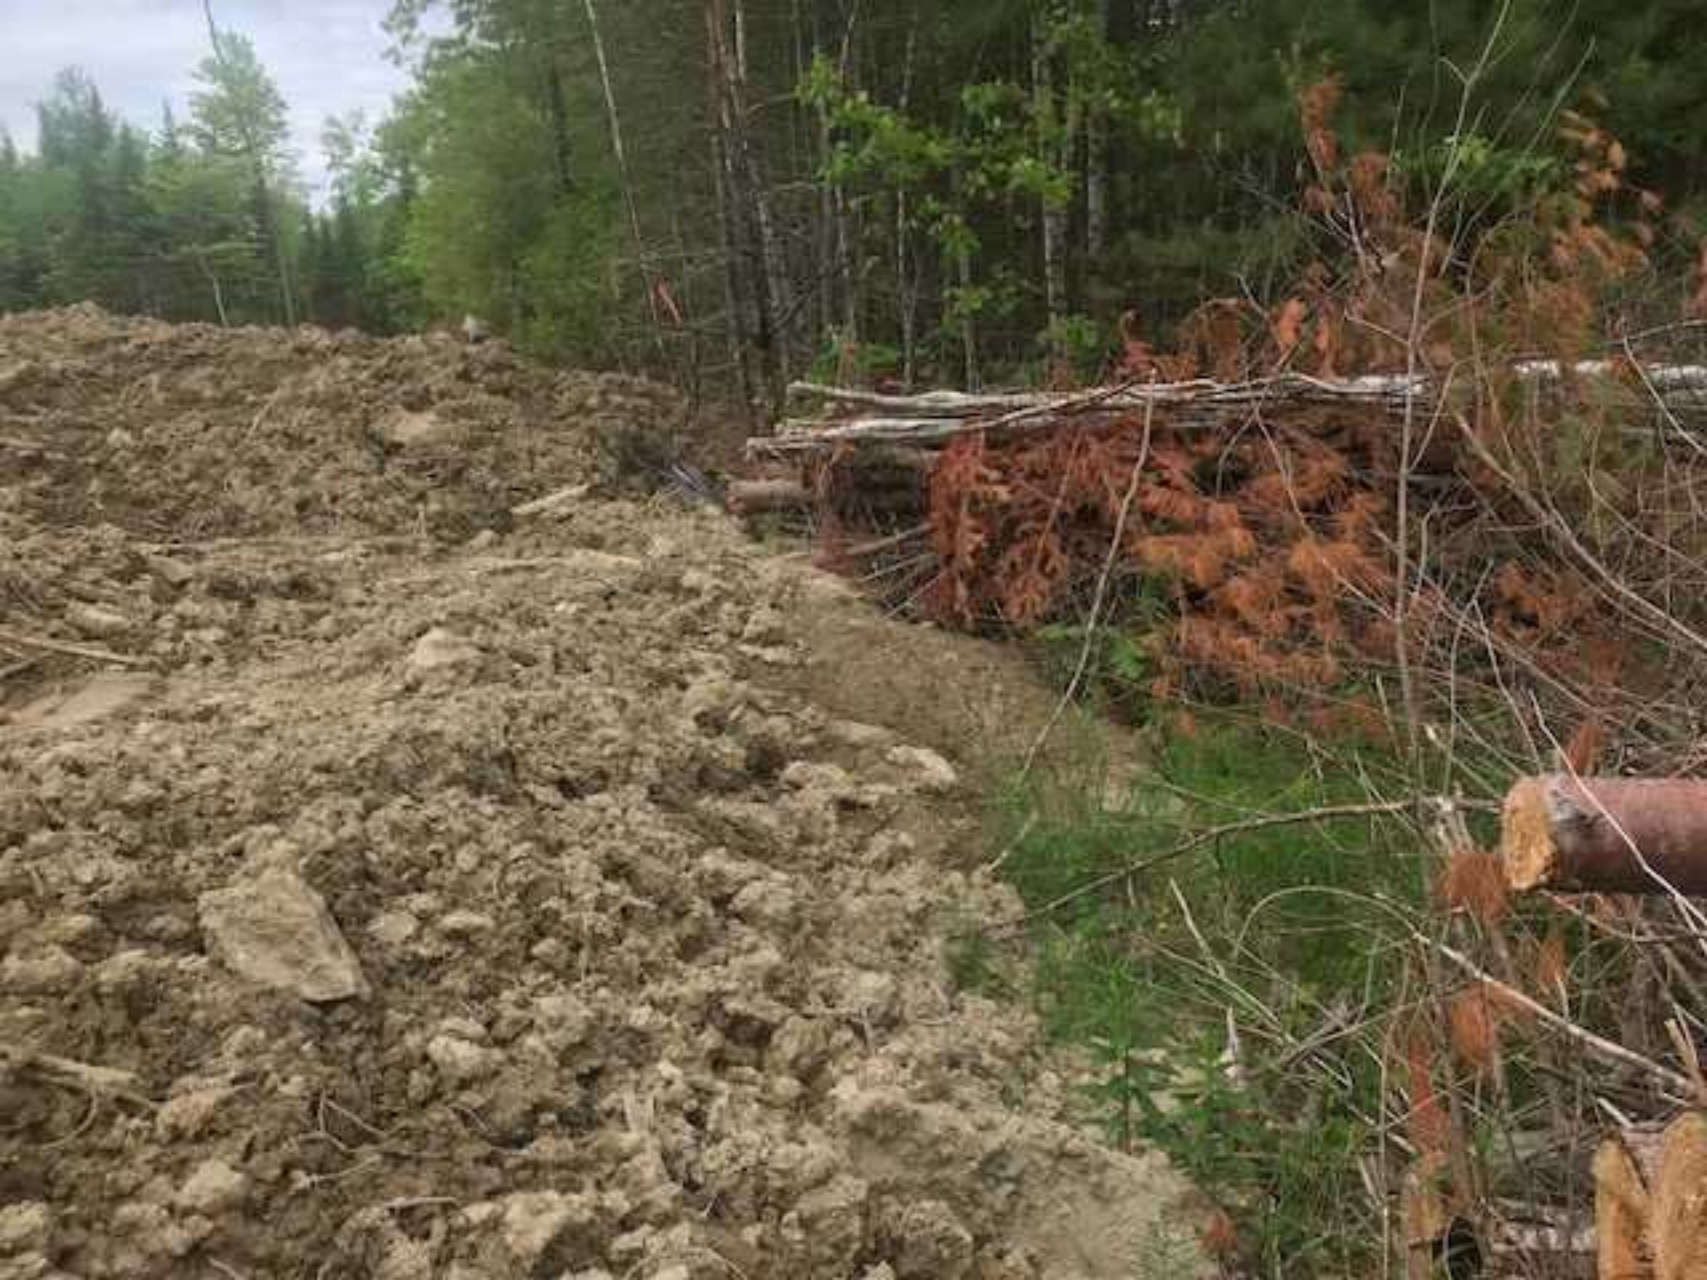
- c. Perimeter silt fence in good condition with the exception of behind the loam, clay, & stump stockpile (see attached photos). Specifically, the stockpile has breached the silt fence in 3 locations and should be repaired as soon as possible prior to the next rain event.
