Recommendations Developed by the Cumberland County Soil & Water Conservation District

Forest Lake NPS Sites on Lakeside Drive

Town of Windham

Report Date: August 20, 2018

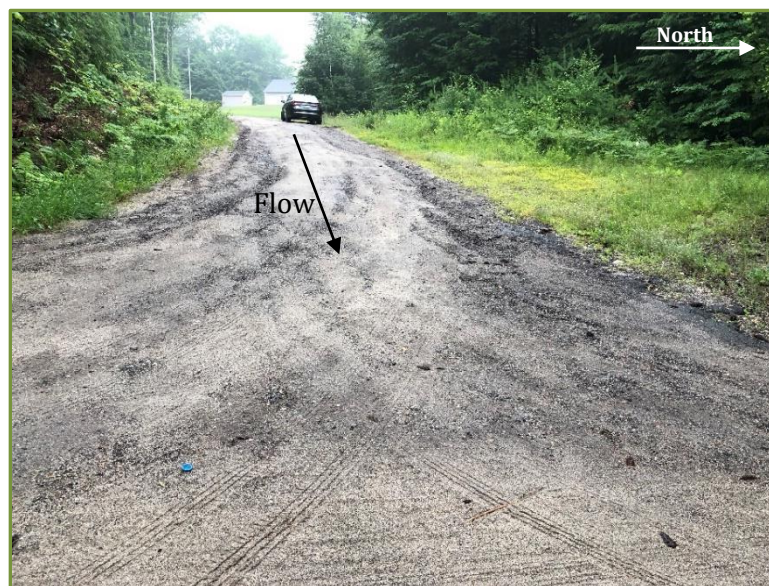
1. Cypress Hill Drive is in poor condition toward the bottom of the hill, near the intersection. Stormwater runoff appears to have eroded sections of the road, causing channelized flow to develop toward the bottom of the hill (**Figure 2**).
2. The channelized flow from Cypress Hill Drive crosses Lakeside Drive and discharges onto the driveway of the property opposite Cypress Hill Drive. There are channels forming in Lakeside Drive perpendicular to Cypress Hill Road because of this flow (**Figure 3**).
3. There appears to be informal ditching on the southern side of Cypress Hill Drive. This ditching is grown in with vegetation. The northern side of Cypress Hill Drive is vegetated open area.

Figure 2. Evidence of channelized runoff coming off Cypress Hill Drive at Site 5-1 (facing west).

1. Cypress Hill Drive should be reestablished and regraded to send all sheet flow to the vegetated southern side of the road (i.e., no longer be crowned).
2. Speed bumps (either gravel or temporary plastic) should be installed on the road to direct runoff from the road into the vegetated area on the southern side of the road (**Figure 4**).
3. If erosion is observed in the vegetated area on the southern side of the road because of the increased runoff, consider installing riprap check dams in the vegetated area.

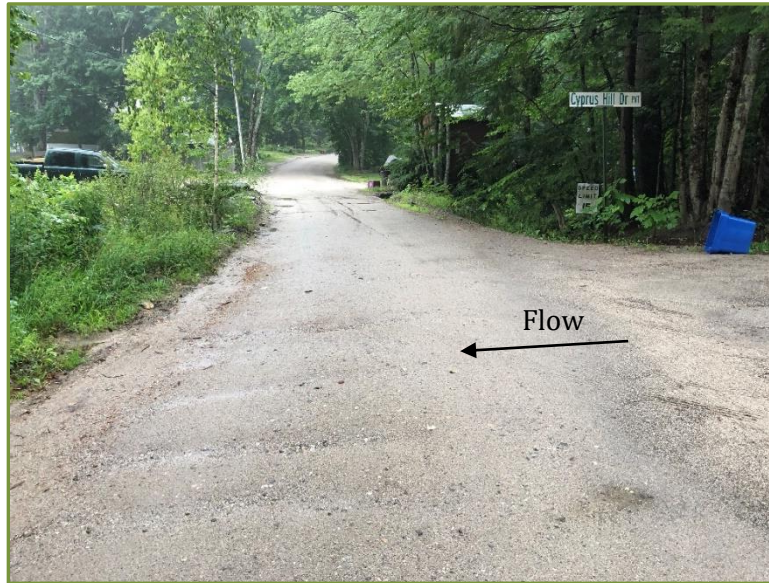
Figure 3. Evidence of channelized flow on Lakeside Drive (left to right) from Cypress Hill Drive, at Site 5-1 (facing south).

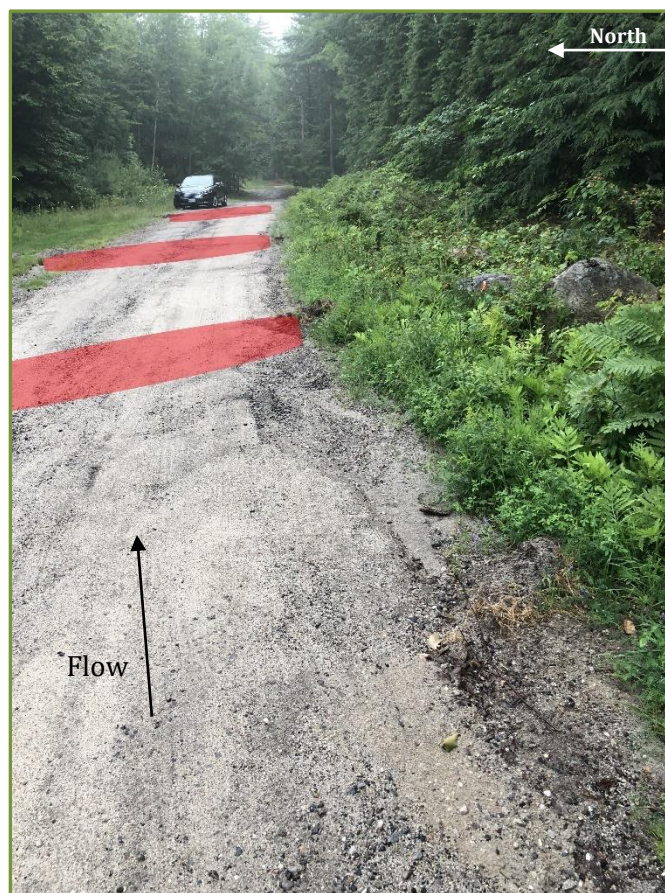
Figure 4. Red areas indicate orientation and potential locations of temporary speed bumps at Site 5-1 (facing east).

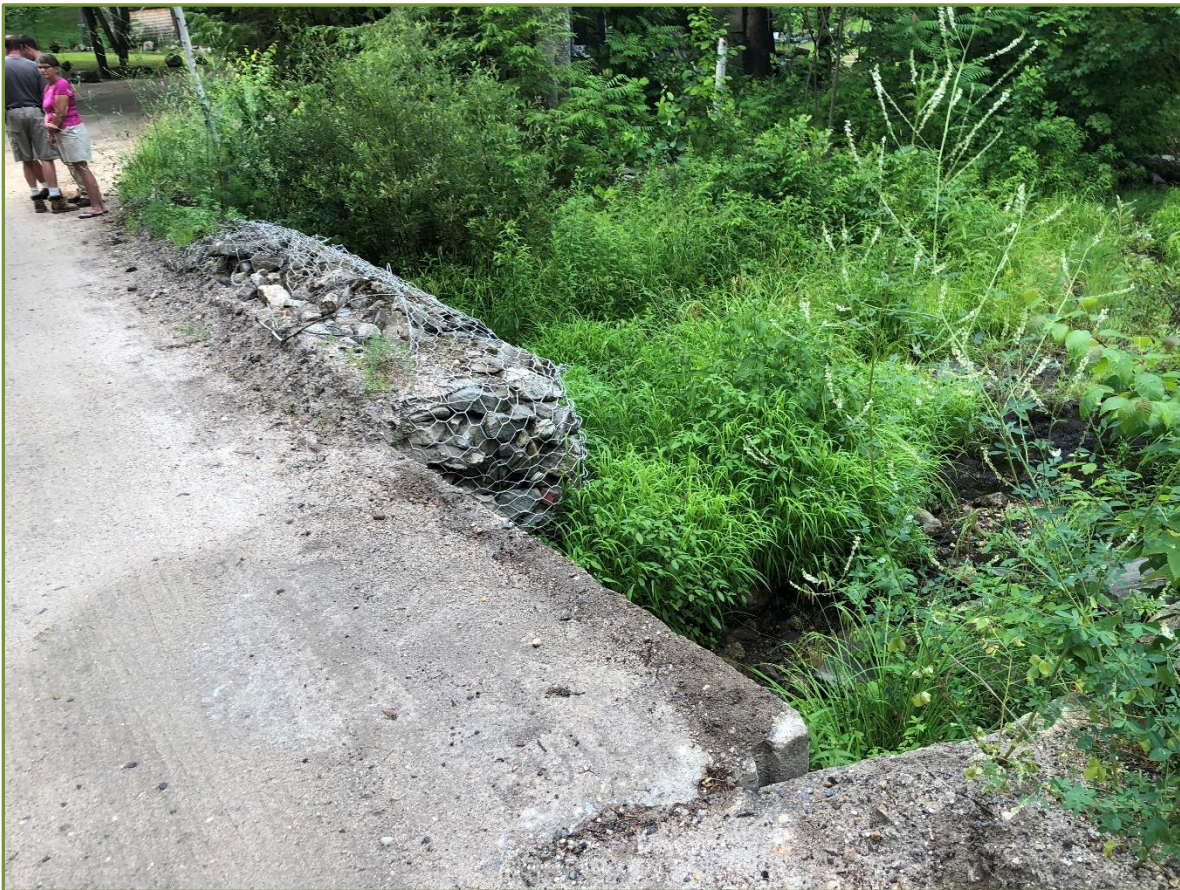
1. The crossing appears to be in good condition. Residents reported that there had not been any flooding at the crossing since the installation.
2. The gabion baskets seem to be filled with sediment from the road, and there is vegetation beginning to grow out of them. The top of the basket is open in some areas (**Figure 5**).

Figure 5. Gabion baskets at Site 5-2 are open, filled with sediment, and have vegetation growing.

1. The gabion baskets could benefit from being cleaned out, refilled with stone of appropriate size (if there are voids), and the wire re-secured. This will ensure that the stones will remain in the basket as designed.

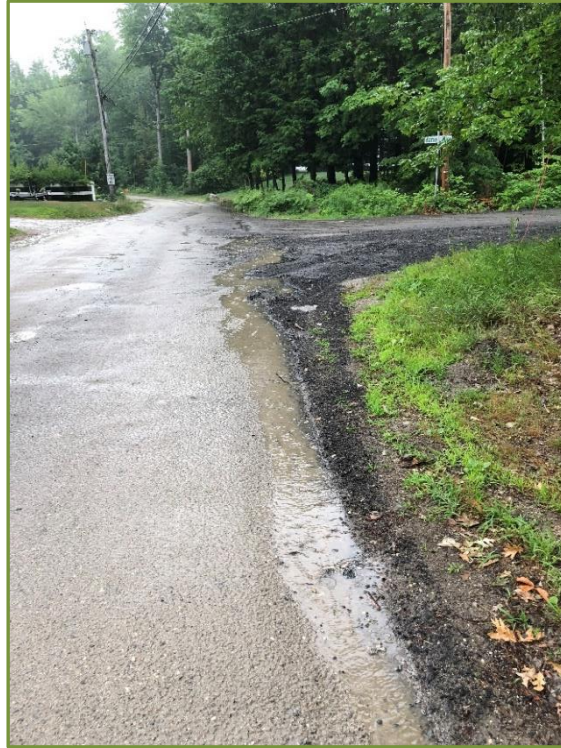
1. Runoff from Lakeside Drive is channelizing and causing significant erosion along the road edges at the intersection of James Way and Lakeside Drive (**Figure 6**).

Figure 6. Channelized runoff flowing south along the eastern side of Lakeside Drive toward the James Way intersection at Site 5-5.

1. Two NDS 24" deep "dry well" catch basins should be installed on either side of Lakeside Drive just north of where Lakeside Drive intersects with James Way (**Figures 9-11**) (**Exhibits A & B**). The catch basins should be configured to drain into subsurface soils by drilling out "weep holes" in the bottom. These catch basins should each be installed with a 24-inch vertical riser, depending on the subsurface conditions and the ability for the Road Association to perform maintenance, making them four (4) feet deep, overall. A deeper catch basin will be more effective at storing sediment but will be more difficult to maintain by hand.

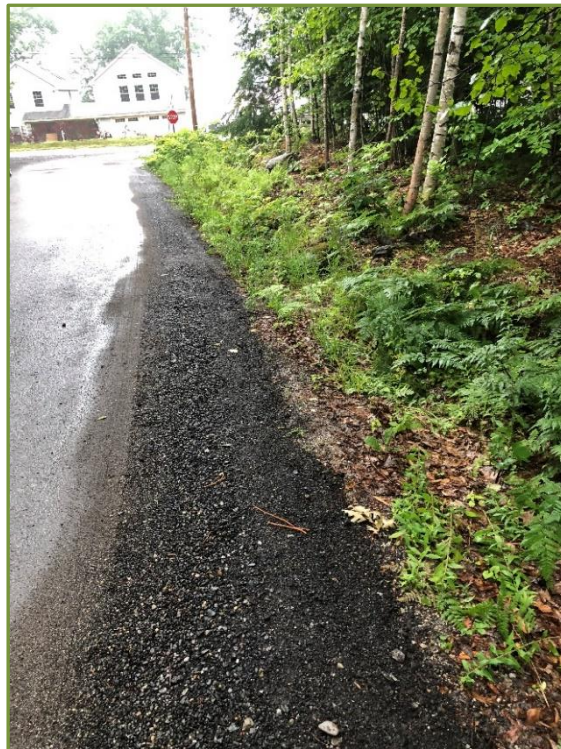
2. The southern side of James Way directs runoff into a roadside ditch that terminates at the intersection (**Figure 7**).
3. The northern side of James way is bermed at the top of the hill until it reaches the driveway nearest the intersection. Runoff flows along the driveway into a small vegetated area that appears to contain the runoff in small storms.

Figure 7. Ditching on southern side of James Way at Site 5-5, facing Lakeside Drive.

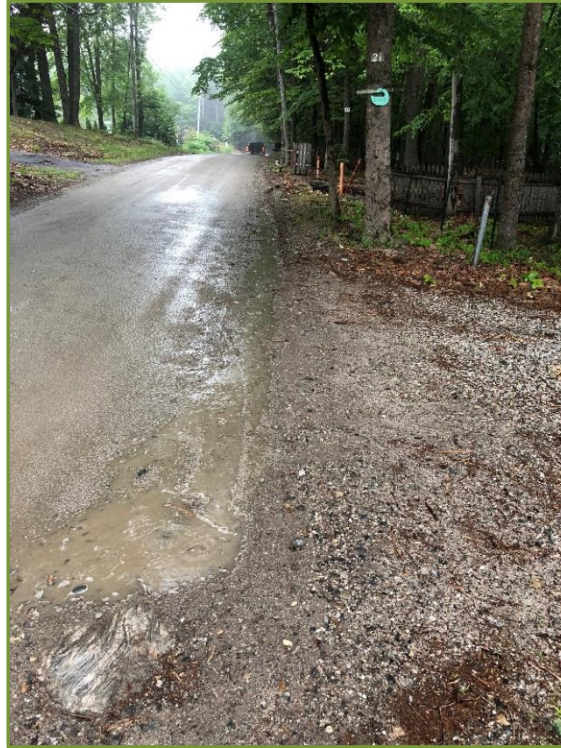
4. On Lakeside Drive north (uphill) of the intersection with James Way, the western side of the road is bermed and the properties are downhill toward the lake. The only runoff contributions from this side of the road appear to be from the road itself (**Figure 8**).

Figure 8. Channelized runoff flowing south along the eastern side of Lakeside Drive at Site 5-5.

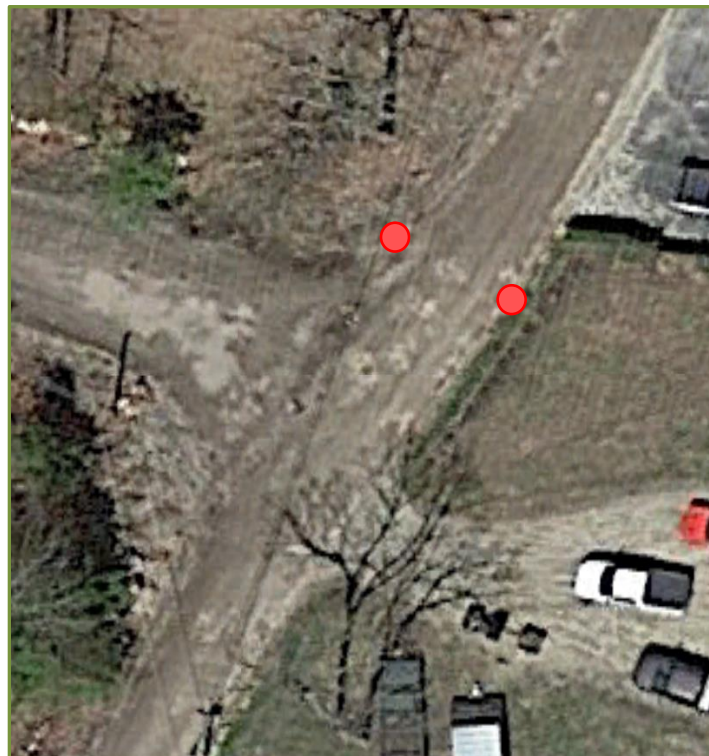
Figure 9. Proposed locations for two NDS 24" deep "dry well" catch basins on Lakeside Drive at Site 5-5 shown in red.

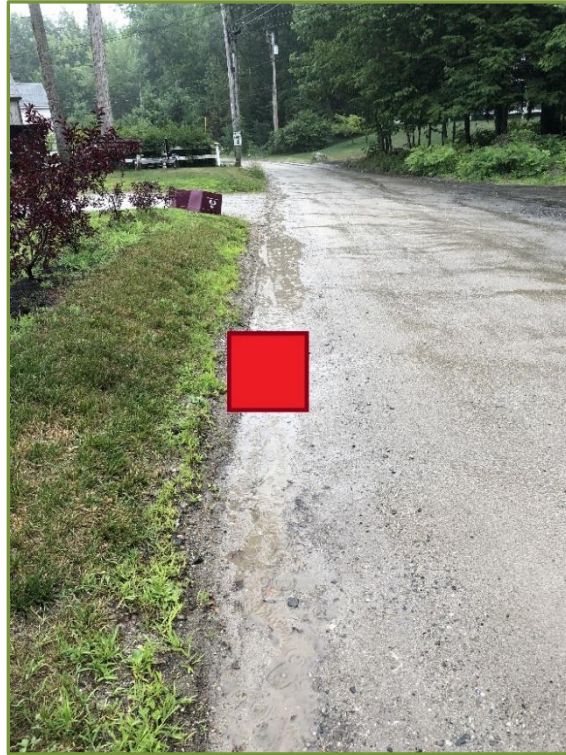
Figure 10. Proposed location of NDS 24-inch deep catch basin on east side of Lakeside Drive at Site 5-5.

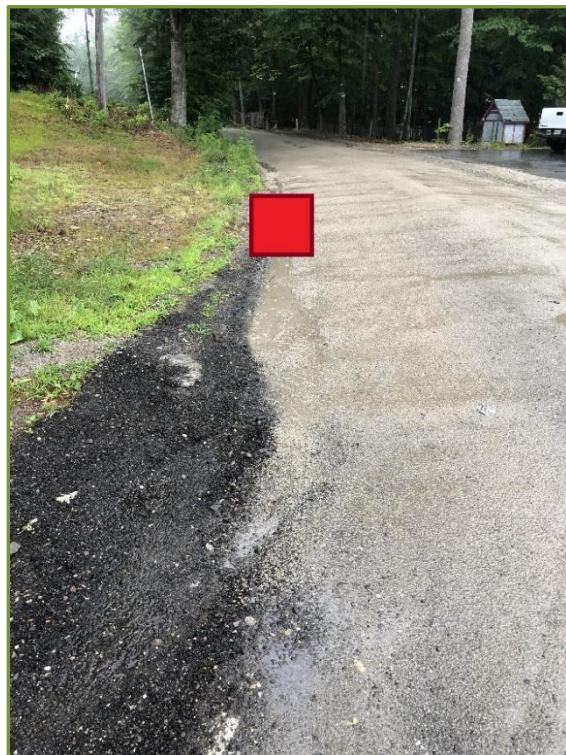
Figure 11. Proposed location of NDS 24-inch deep catch basin on west side of Lakeside Drive at Site 5-5.

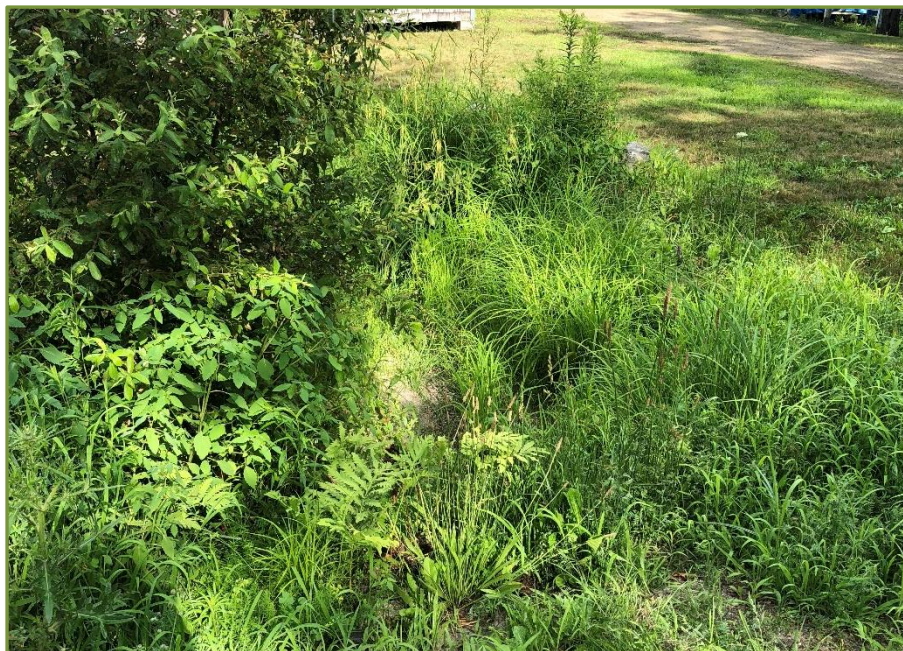
1. The inlet of the culvert is difficult to see due to the vegetation growth around it, but there are signs of sediment deposits leading to it and immediately upstream of it.
2. It appears the plunge pool has not been maintained for quite some time (**Figure 12**).
3. Runoff from the western side of Lakeside Drive turns out toward the culvert inlet. There are significant sediment deposits in the vegetation leading toward the culvert inlet (**Figure 13**).

Figure 12. Plunge Pool at Site 5-6.

1. Clearing the vegetation around the inlet of the culvert would allow for easier inspection of the culvert's condition.
2. The sediment running off the road toward the culvert inlet should be cleaned out and disposed of after rain events. This will prevent the sediment from reaching the lake.
3. The plunge pool requires routine maintenance to function as designed. The Road Association should coordinate with the landowner to acquire a maintenance easement so that the required maintenance can occur.

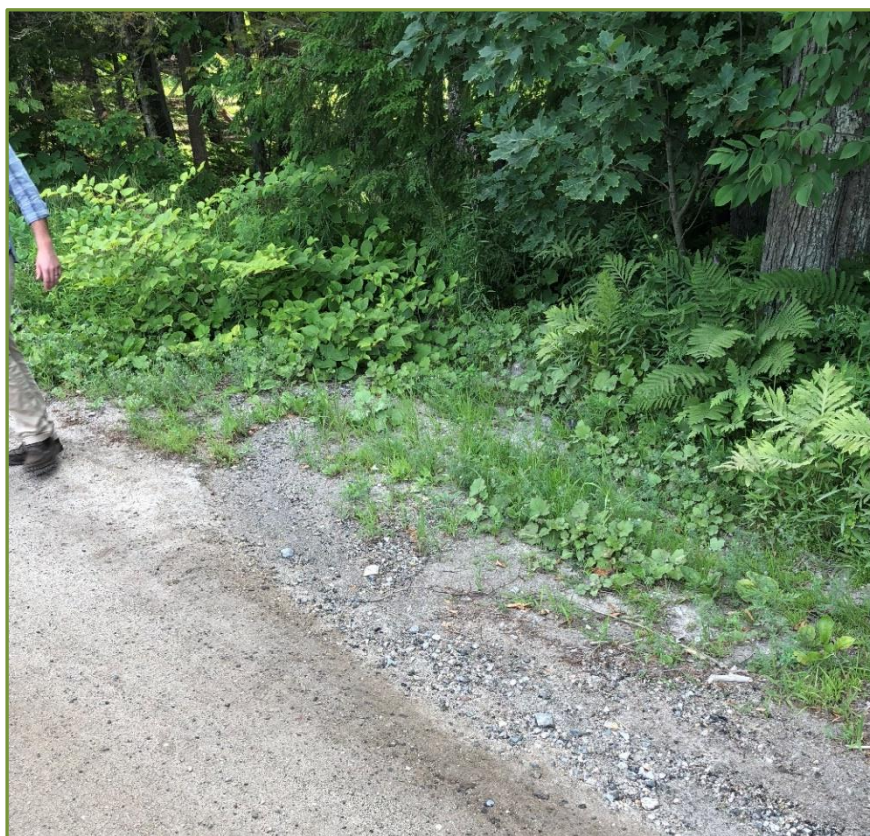
Figure 13. Runoff from Lakeside Drive enters the culvert inlet at Site 5-6.

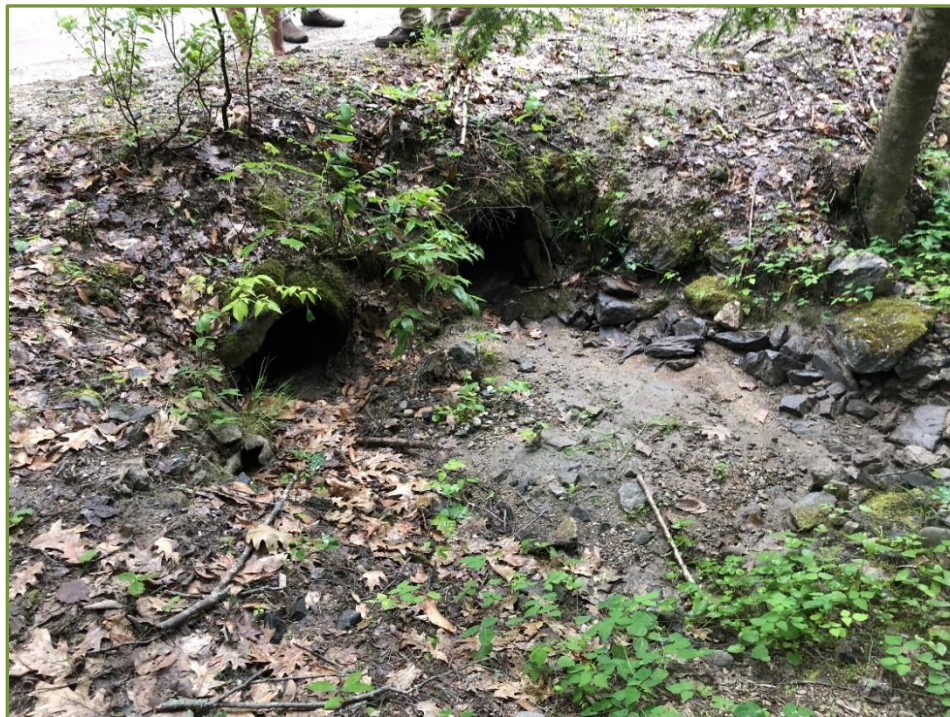
1. The culverts appear to be in good condition structurally.
2. The plunge pools and surrounding areas could benefit from routine maintenance. There are significant sediment deposits in each plunge pool and vegetation growing on either side of the culverts (**Figure 14**).
3. There is ditching on the west side of Lakeside Drive leading to the crossing, but not on the east side. Sediment deposits can be seen along the road and into the wooded area where runoff is pushing road material downhill (**Figure 15**).

Figure 14. Sediment deposit in the downstream plunge pool at Site 5-11.

1. Implement routine maintenance at the culvert crossing to remove vegetation and sediment. The plunge pools should be restored to their original shape and function and be regularly maintained.
2. Monitor the sediment deposits on the eastern side of the site to make sure the sediment is not transported to a third culvert downstream, on Glendale Road. If sediment begins to reach the the Glendale Road culvert, contact CCSWCD for further recommendations.

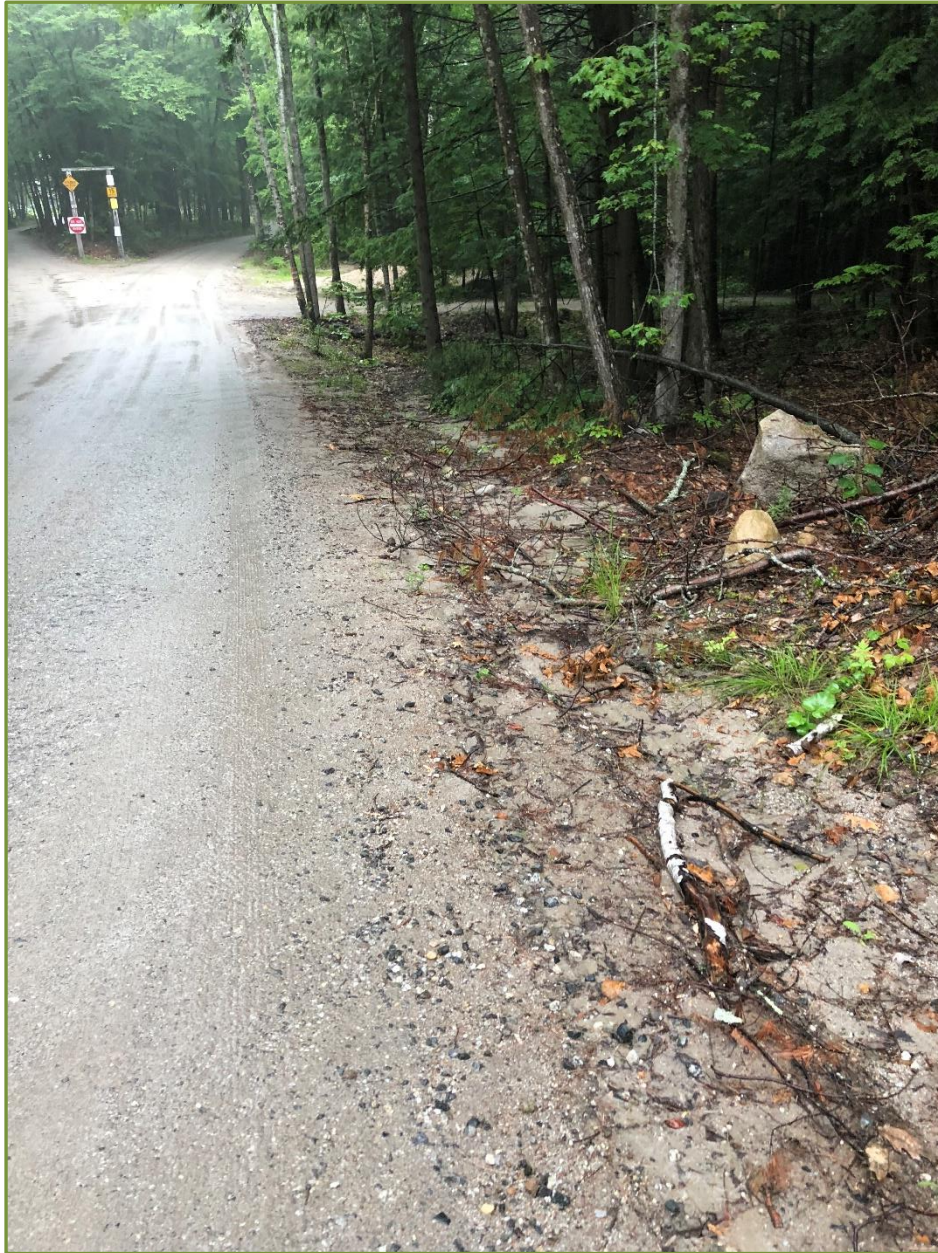
Figure 15. Sediment is being transported along the eastern side of Lakeside Drive as the road approaches Site 5-11.

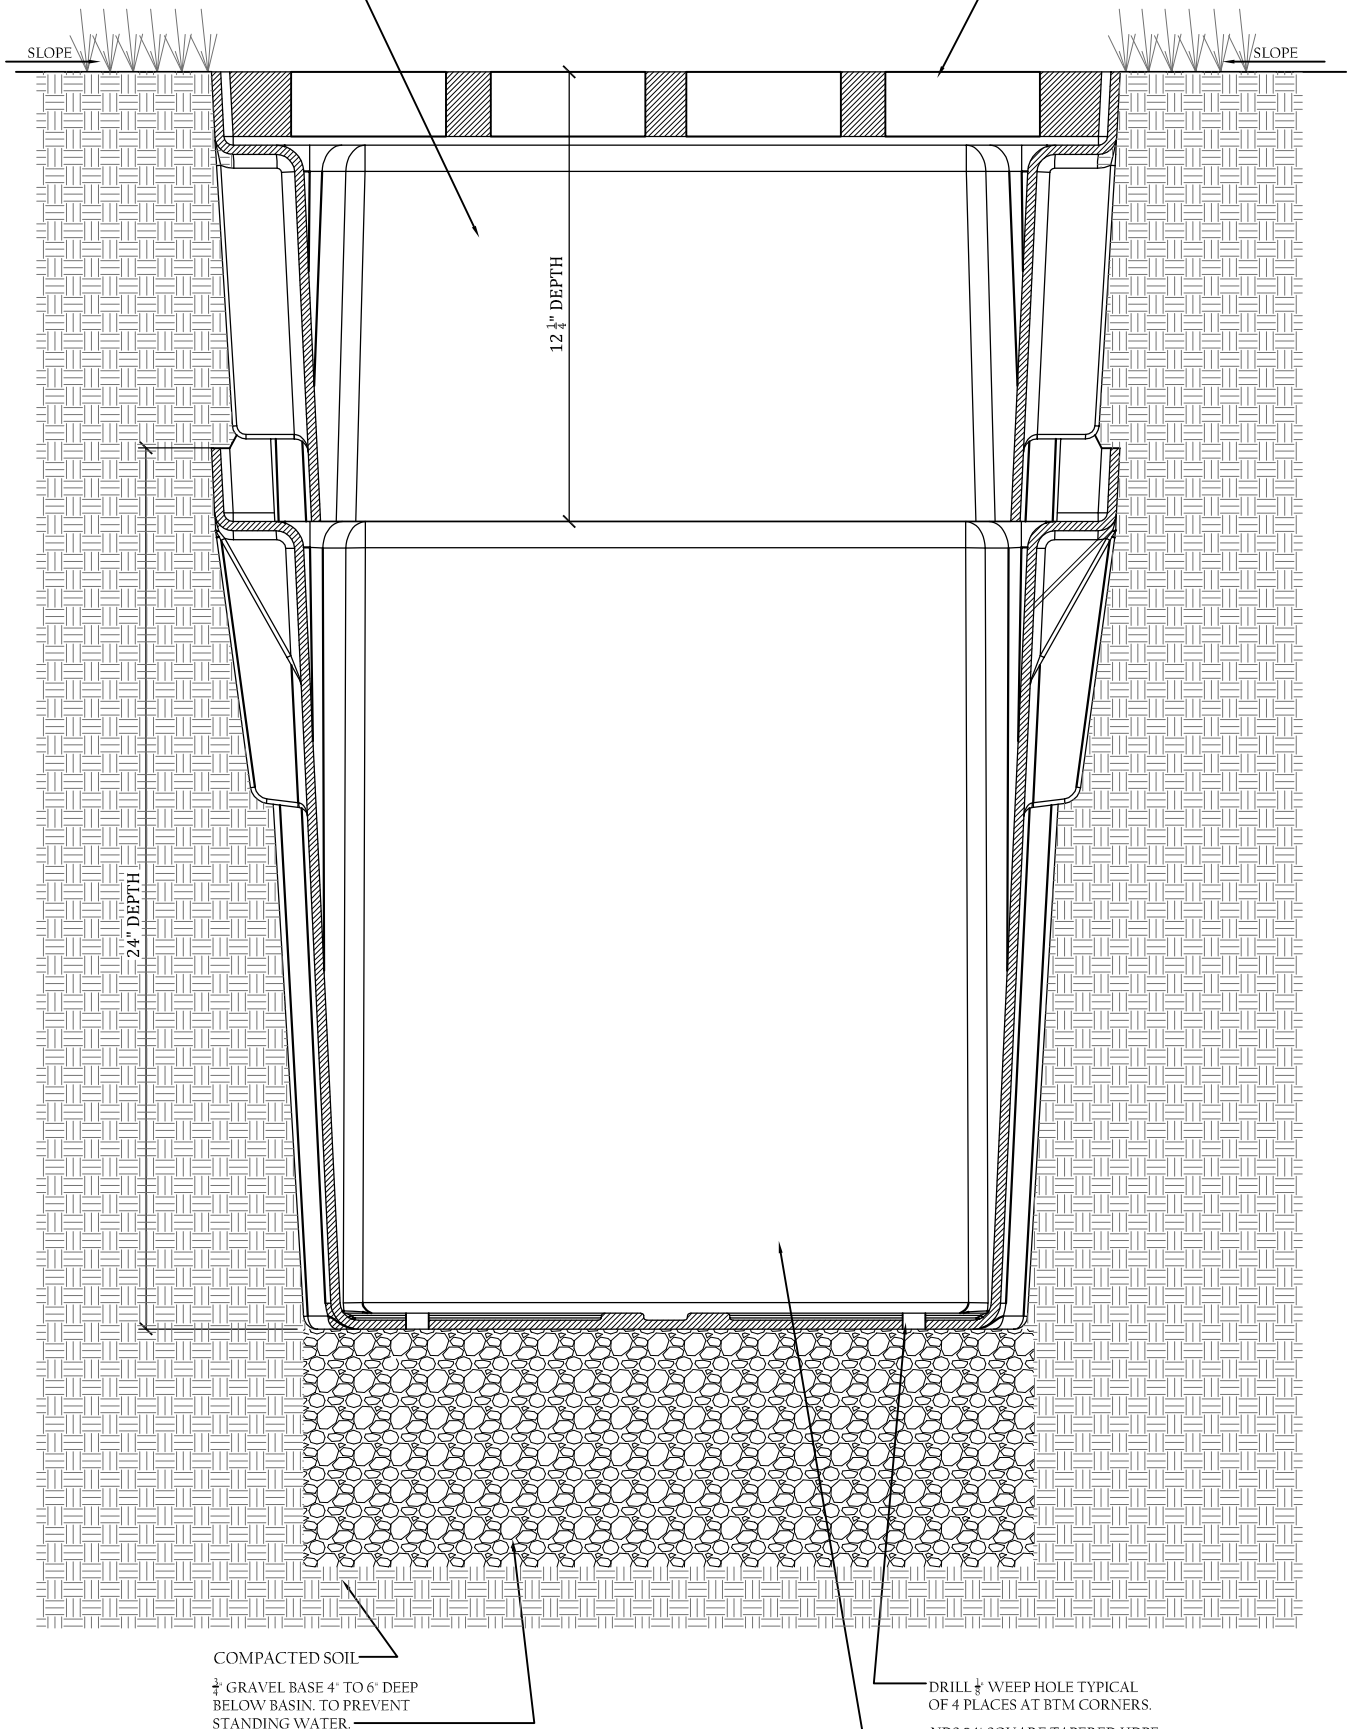
NDS 24" TM SQ. CATCH BASIN WITH RISER INSTALLATION.
LANDSCAPE APPLICATION.

NDS 24" SQUARE TAPERED HDPE
CATCH BASIN (RISER) W/ U.V.
INHIBITORS.

NDS 24" SQUARE POLYOLEFIN
GRATE W/ U.V. INHIBITORS.

COMPACTED SOIL

$\frac{3}{4}$ " GRAVEL BASE 4" TO 6" DEEP
BELOW BASIN. TO PREVENT
STANDING WATER.

DRILL $\frac{1}{8}$ " WEEP HOLE TYPICAL
OF 4 PLACES AT BTM CORNERS.

NDS 24" SQUARE TAPERED HDPE
CATCH BASIN W/ U.V.
INHIBITORS.
