# PLEASANT RIVER

## WATERSHED MANAGEMENT PLAN

Cumberland County Soil & Water Conservation District

Prepared by Heather True  
June 2011

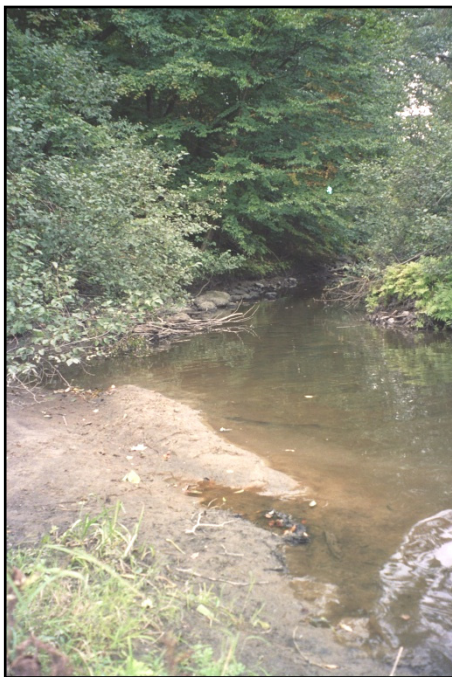
Sediment delta along stretch of Pleasant River in which Brook Floater habitat has been documented. Photo Credit: Maine Dept. IF&W

A follow-up survey by IF&W in the summer of 2010 found only six live brook floaters in two days of surveying. Surveyors noted that turbidity was so high that it was nearly impossible to conduct visual surveys in water more than 1 ½ feet deep throughout most of the upper river. Unfenced cattle and horse access to the stream was noted to damage stream banks. The stream banks appeared to have suffered a tremendous amount of additional damage from recent floods, with some of the turbidity likely related to natural clays, tannins and algal production.
