LITTLE SEBAGO LAKE WATERSHED

PROTECTION PLAN

Cumberland County Soil & Water Conservation District

Prepared by Heather True, CCSWCD
June 2013

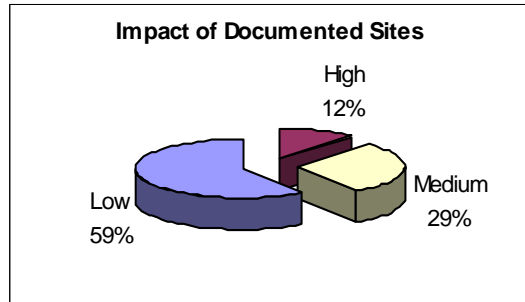
Figure 4.

Impact was based on slope, soil type, amount of soil that's eroding, proximity to water or buffer, and size of buffer.

- “Low” impact eroding sites are those with limited soil transport off-site.
- At “medium” impact sites, sediment is transported off-site, but the erosion doesn't reach a high magnitude.
- “High” impact sites are large sites where there is significant erosion that flows directly into a stream, lake or ditch.

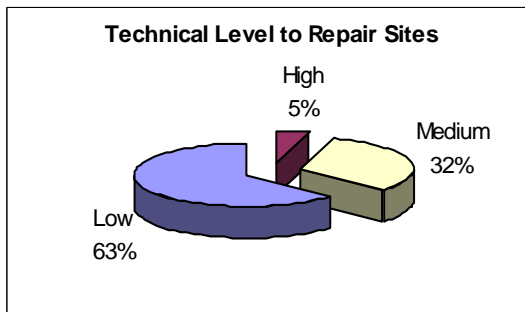
Figure 5.

- A “low” tech level requires little or no specific technical assistance. For example, seeding and mulching an area of bare soil would require little technical expertise.
- Sites with a “medium” tech level need to be visited by a technical expert who can make detailed recommendations.
- A “high” tech level requires an engineered design.

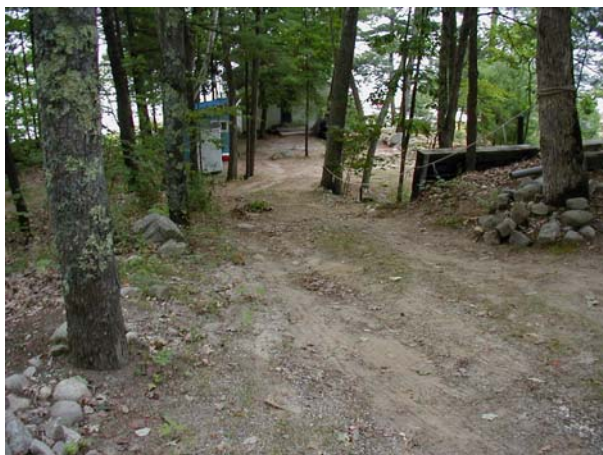
Problems

- Moderate surface erosion.
- Poor driveway shaping and ruts cause water to concentrate and erode the surface.

Preserve water quality and save time, money, and wear and tear on your vehicle by having a well crowned driveway. Use adequate surface material and add diversions to direct runoff into buffers.

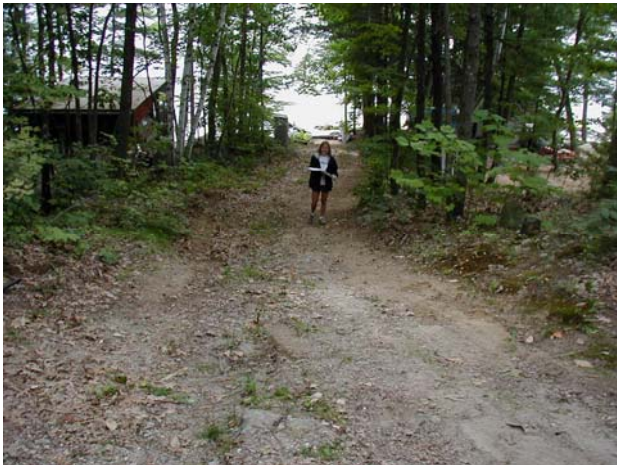
Problems:

- Moderate surface erosion.
- Direct flow of sediment and winter sand into stream.

- Add better surface material
- Reshape or crown if used for vehicular traffic
- Install runoff diverters, such as waterbars, open-top culverts, or rubber razor blades.
- Stop raking
- Establish or enhance shoreline buffer
