# Town of Windham

## Municipal Facilities Space Needs Study And Master Plan

## Final Report

September 5, 2014  
SMRT Project No. 13137

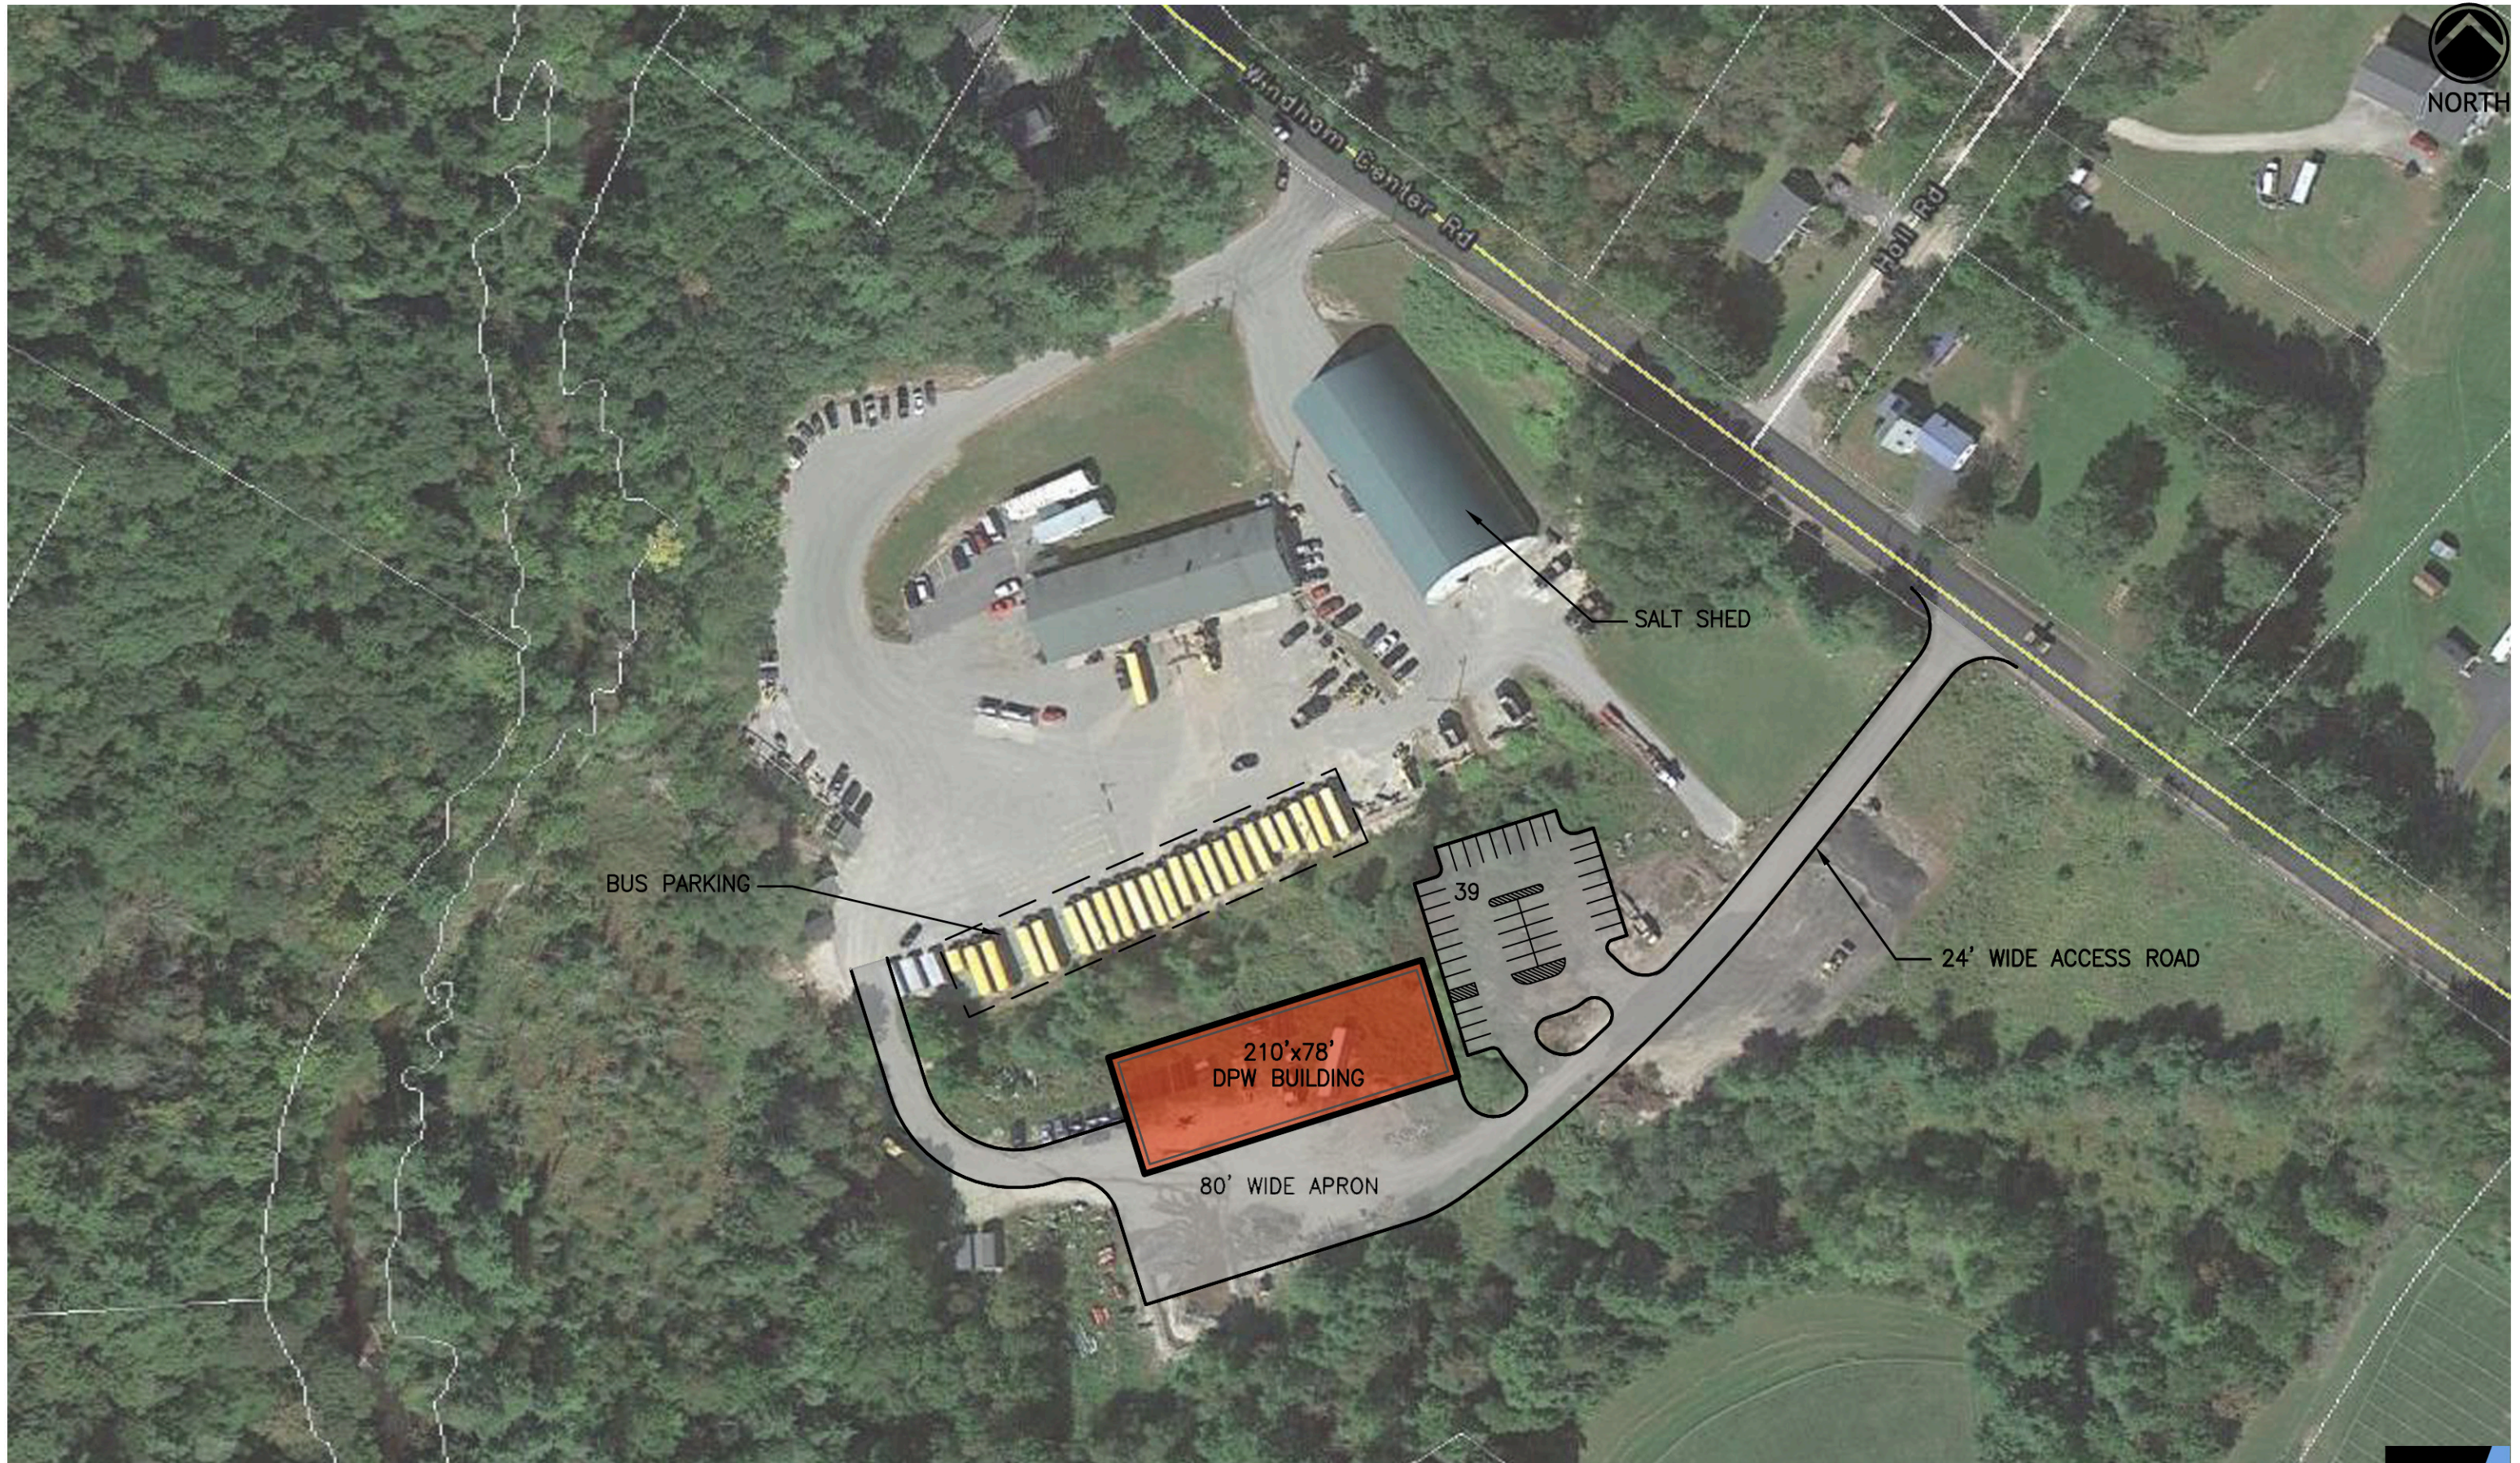
**DEPARTMENT OF PUBLIC WORKS SITE PLAN**  
PUBLIC WORKS OPTION 'B' - 210'x78' BUILDING, NEW ACCESS ROAD

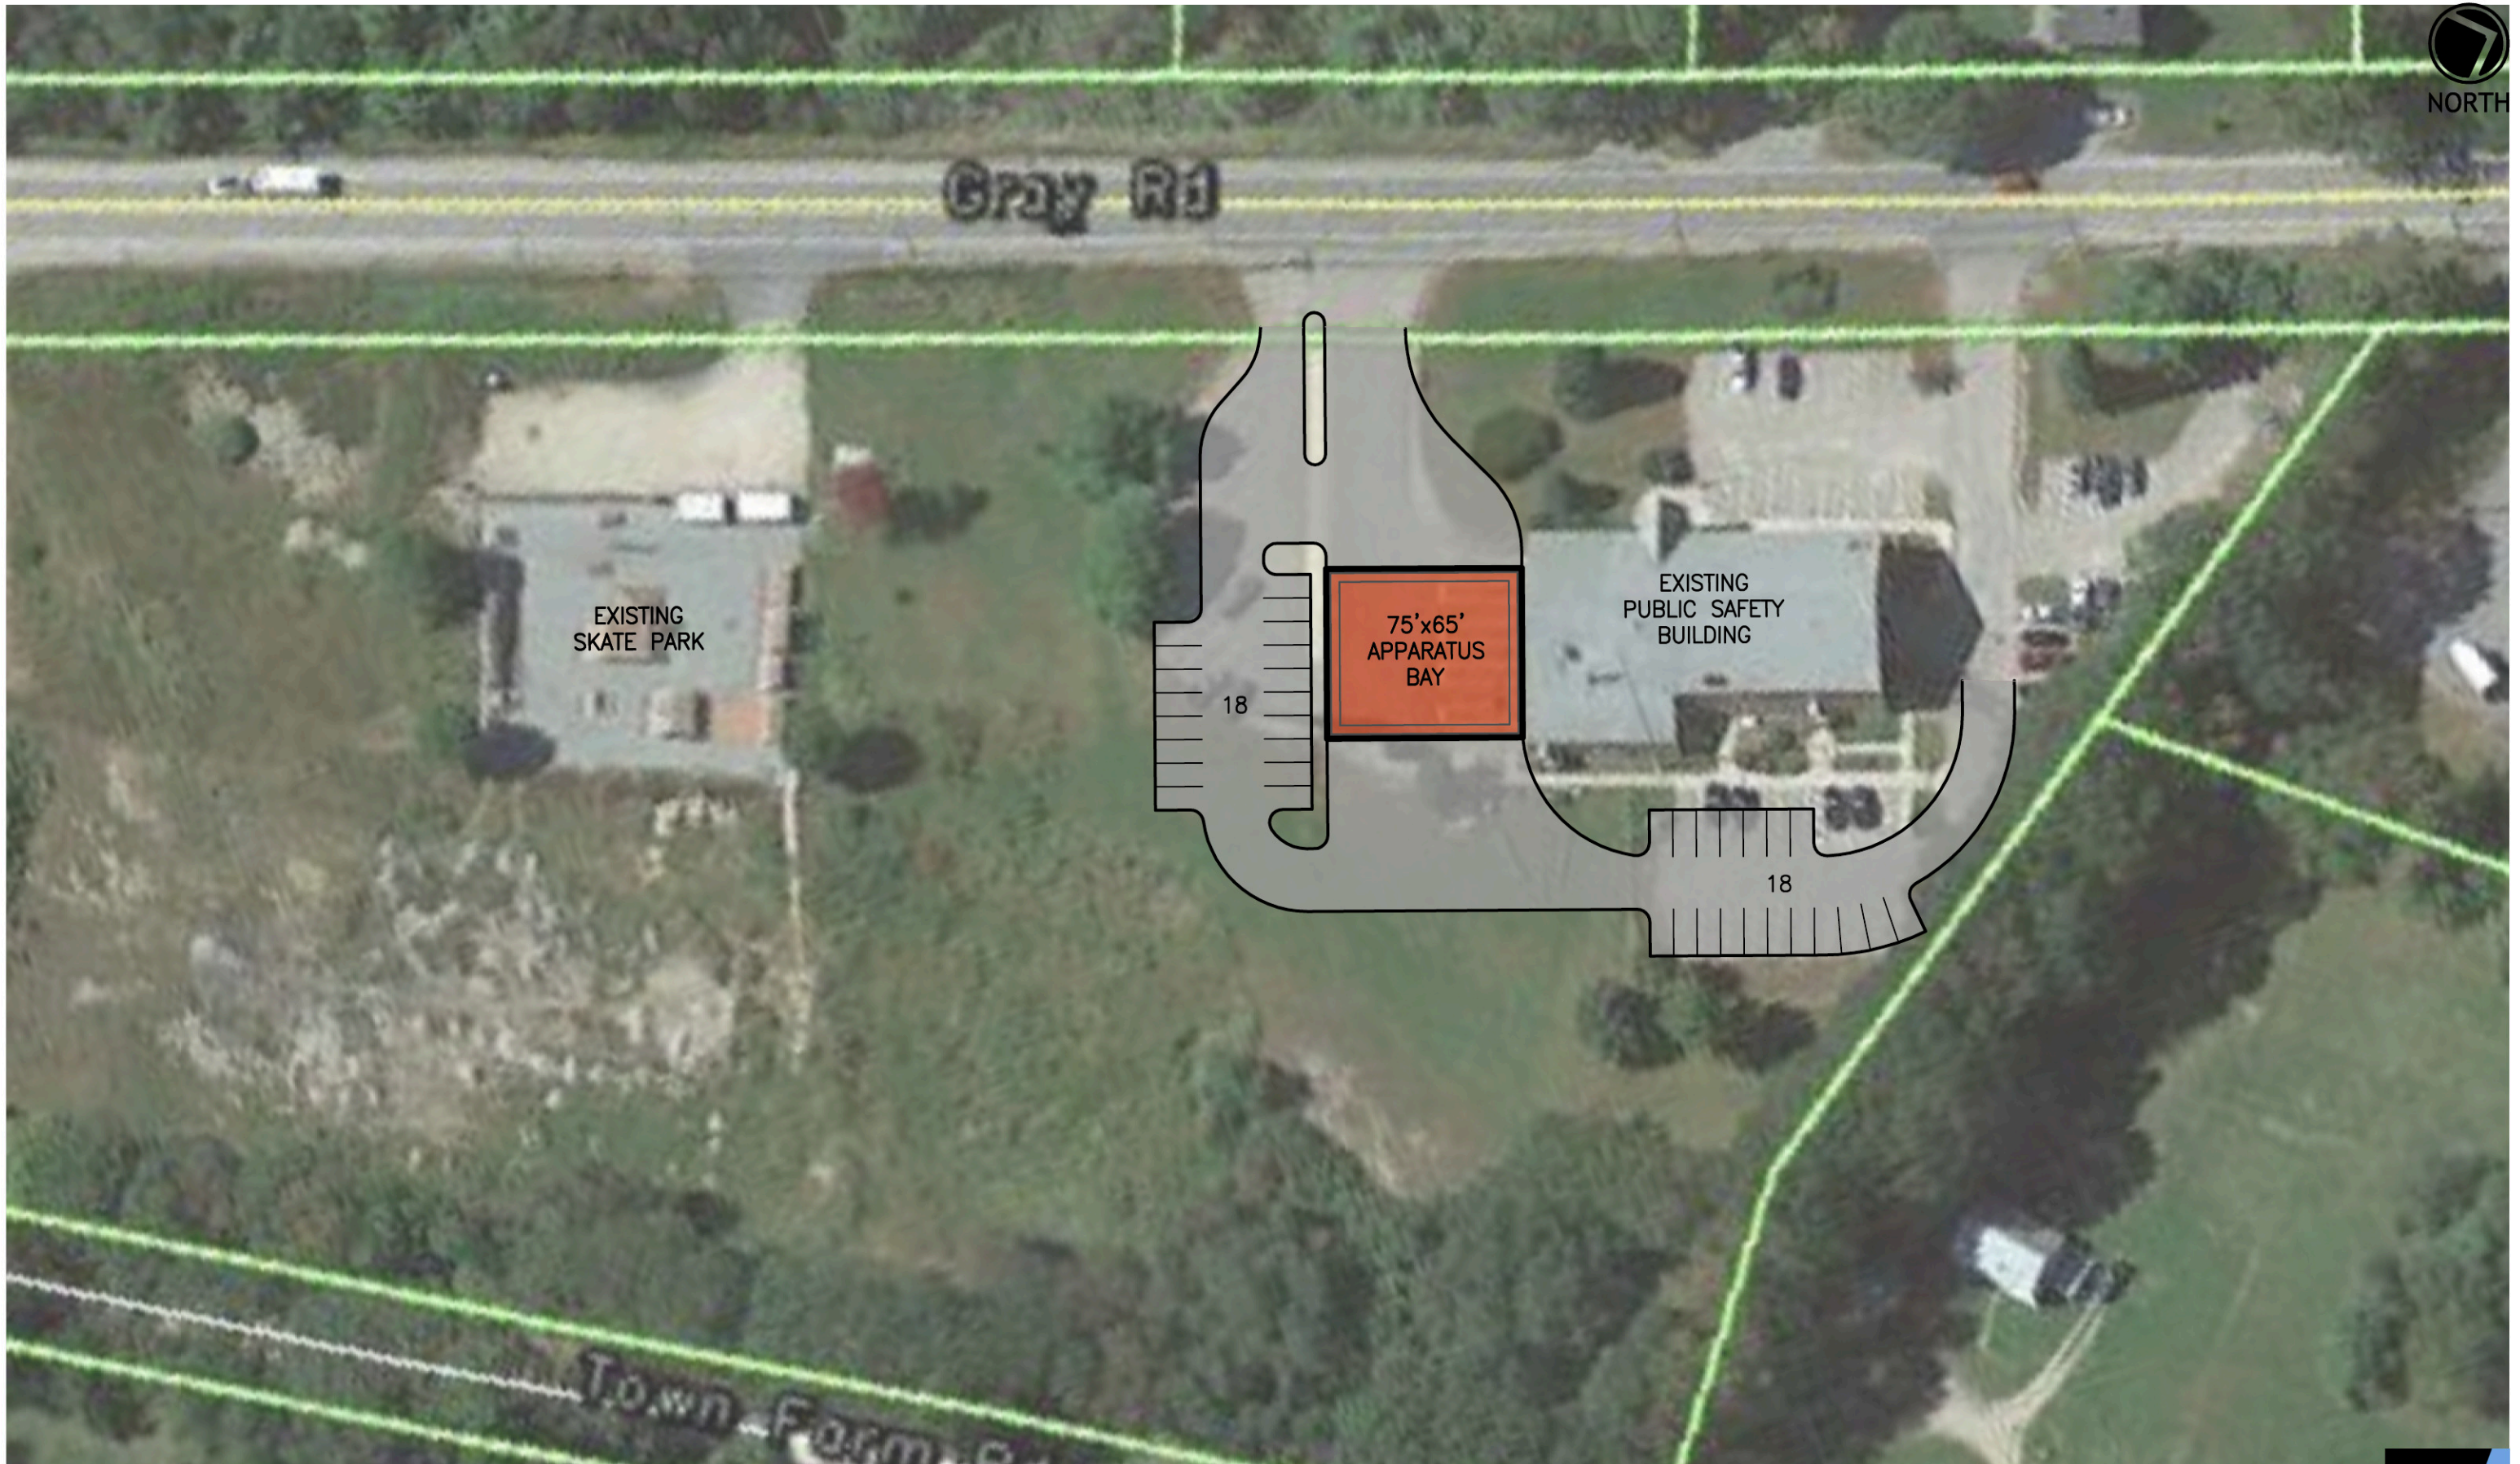
**FIRE STATION SITE PLAN**  
PUBLIC SAFETY OPTION 'B' - 75'x65' ADDITION

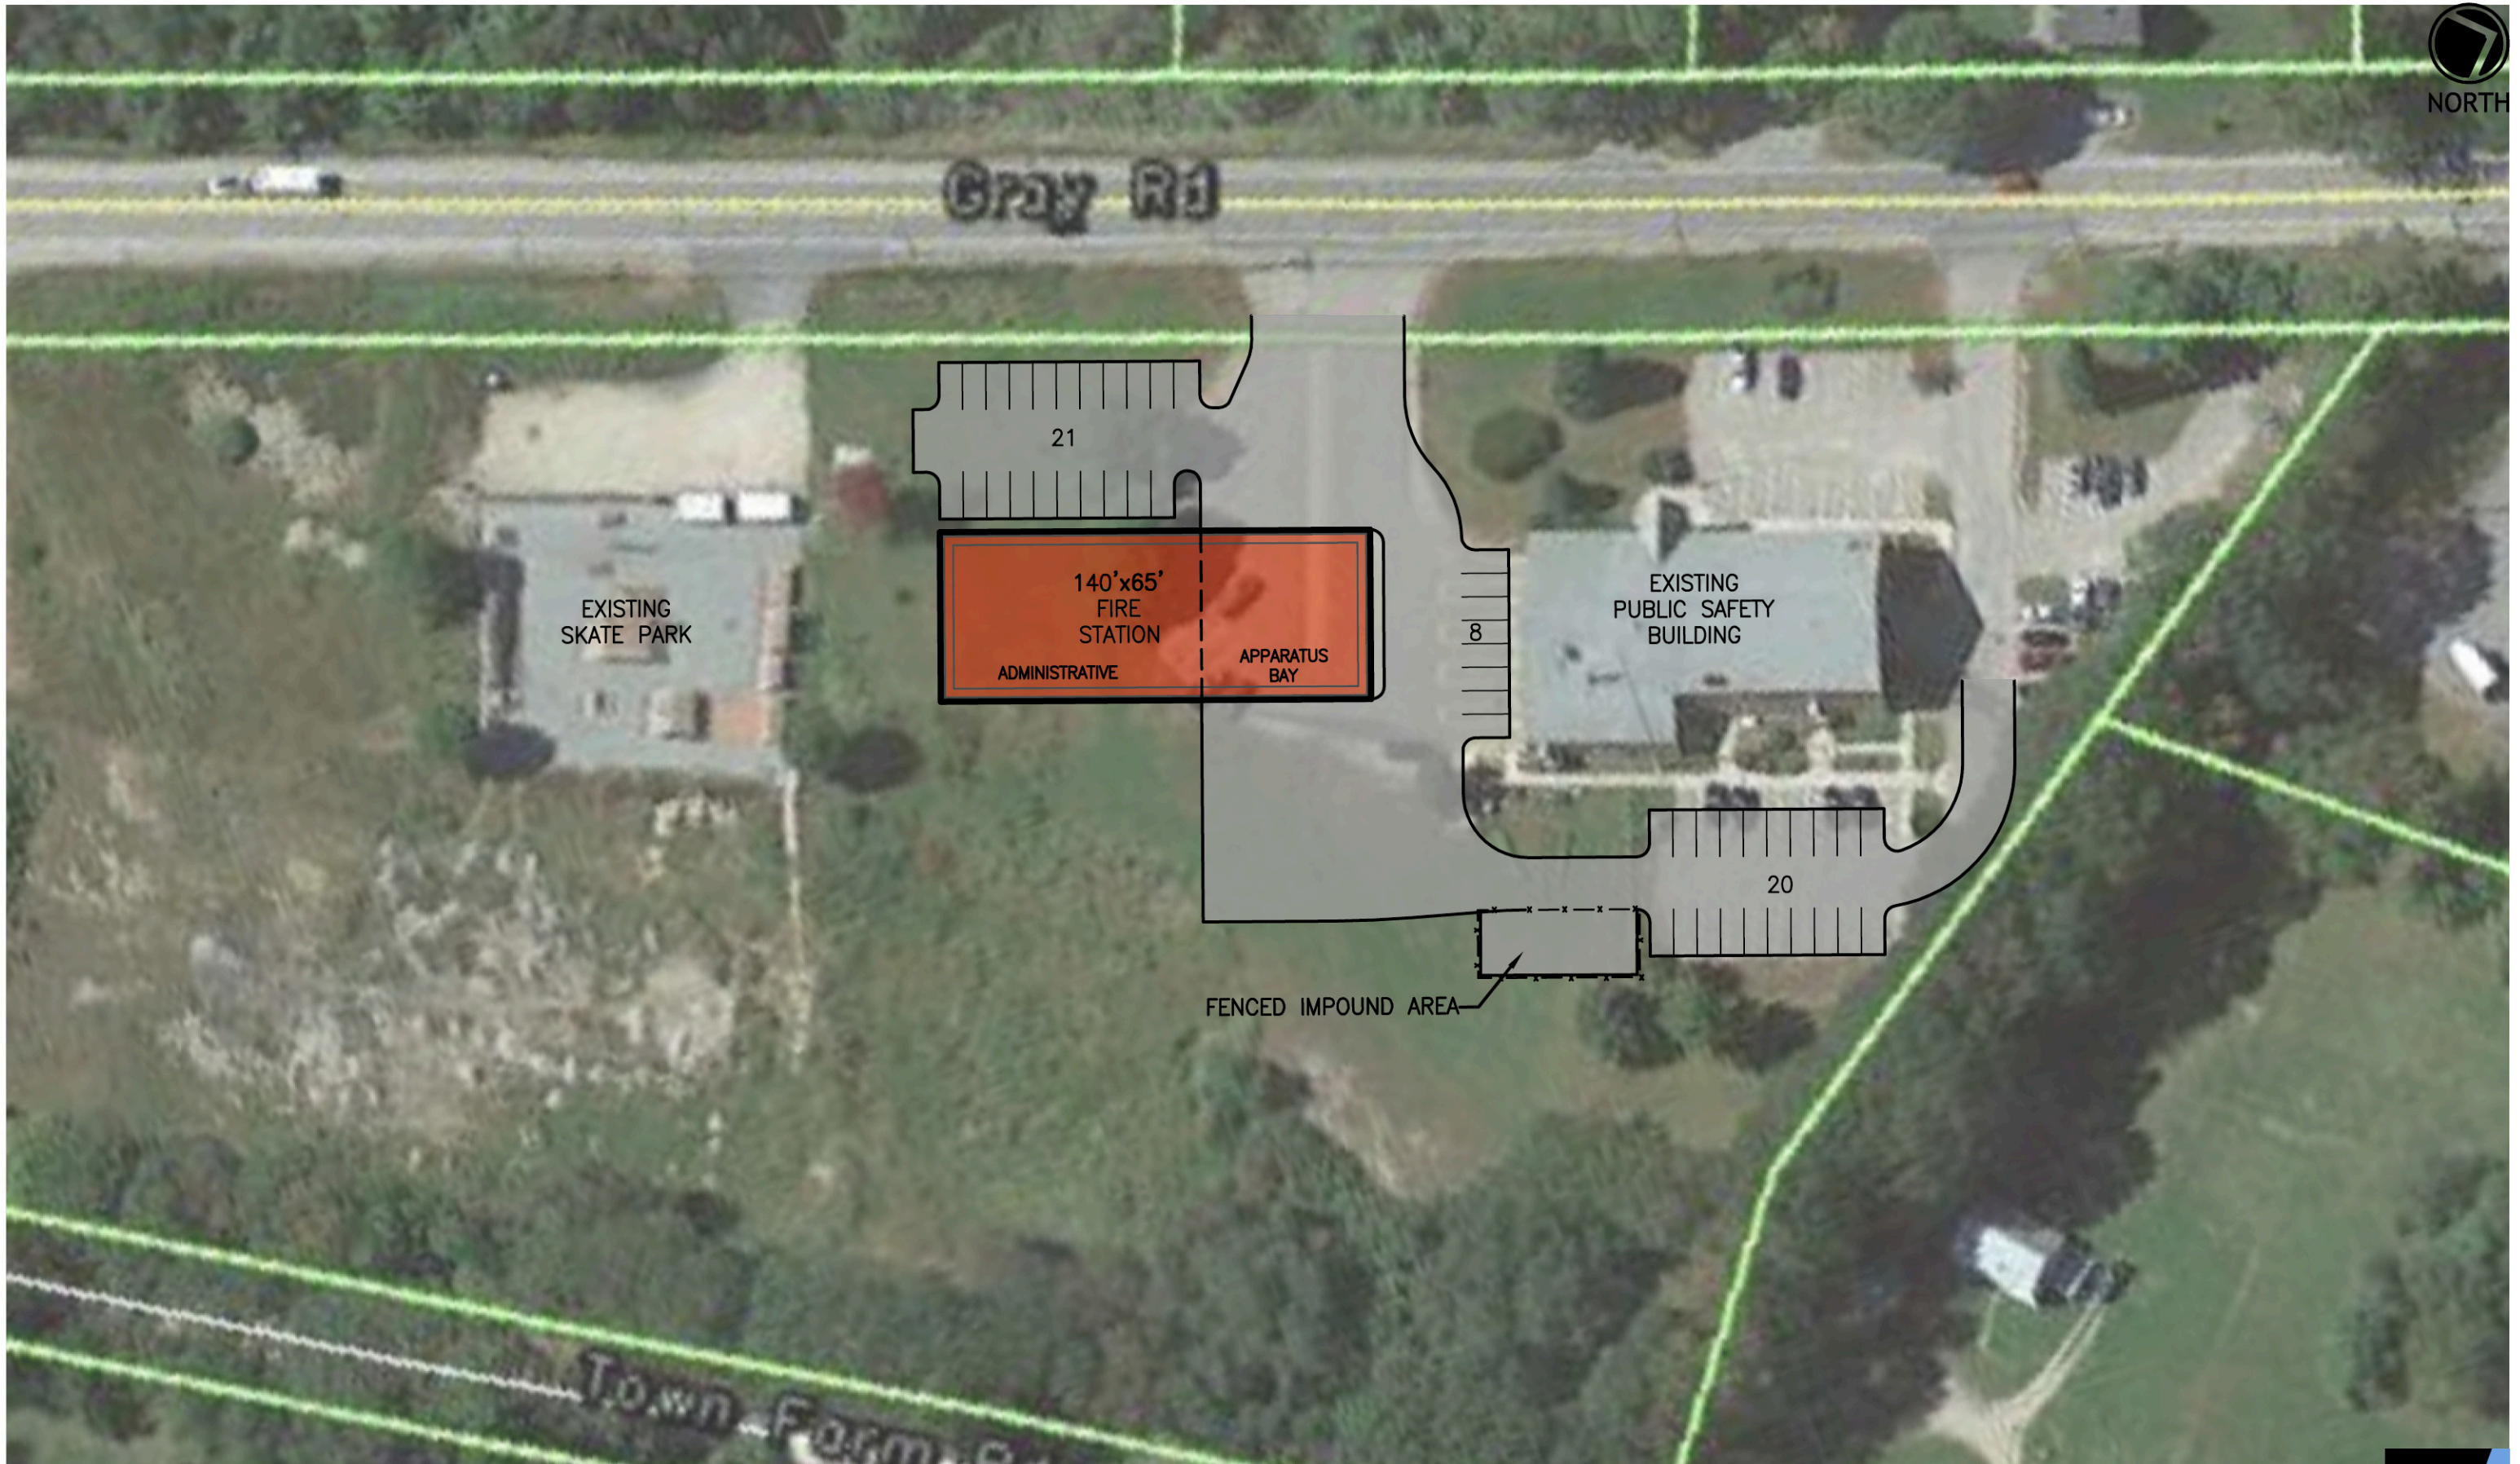
**FIRE STATION SITE PLAN**  
 PUBLIC SAFETY OPTION 'C' - NEW FIRE STATION

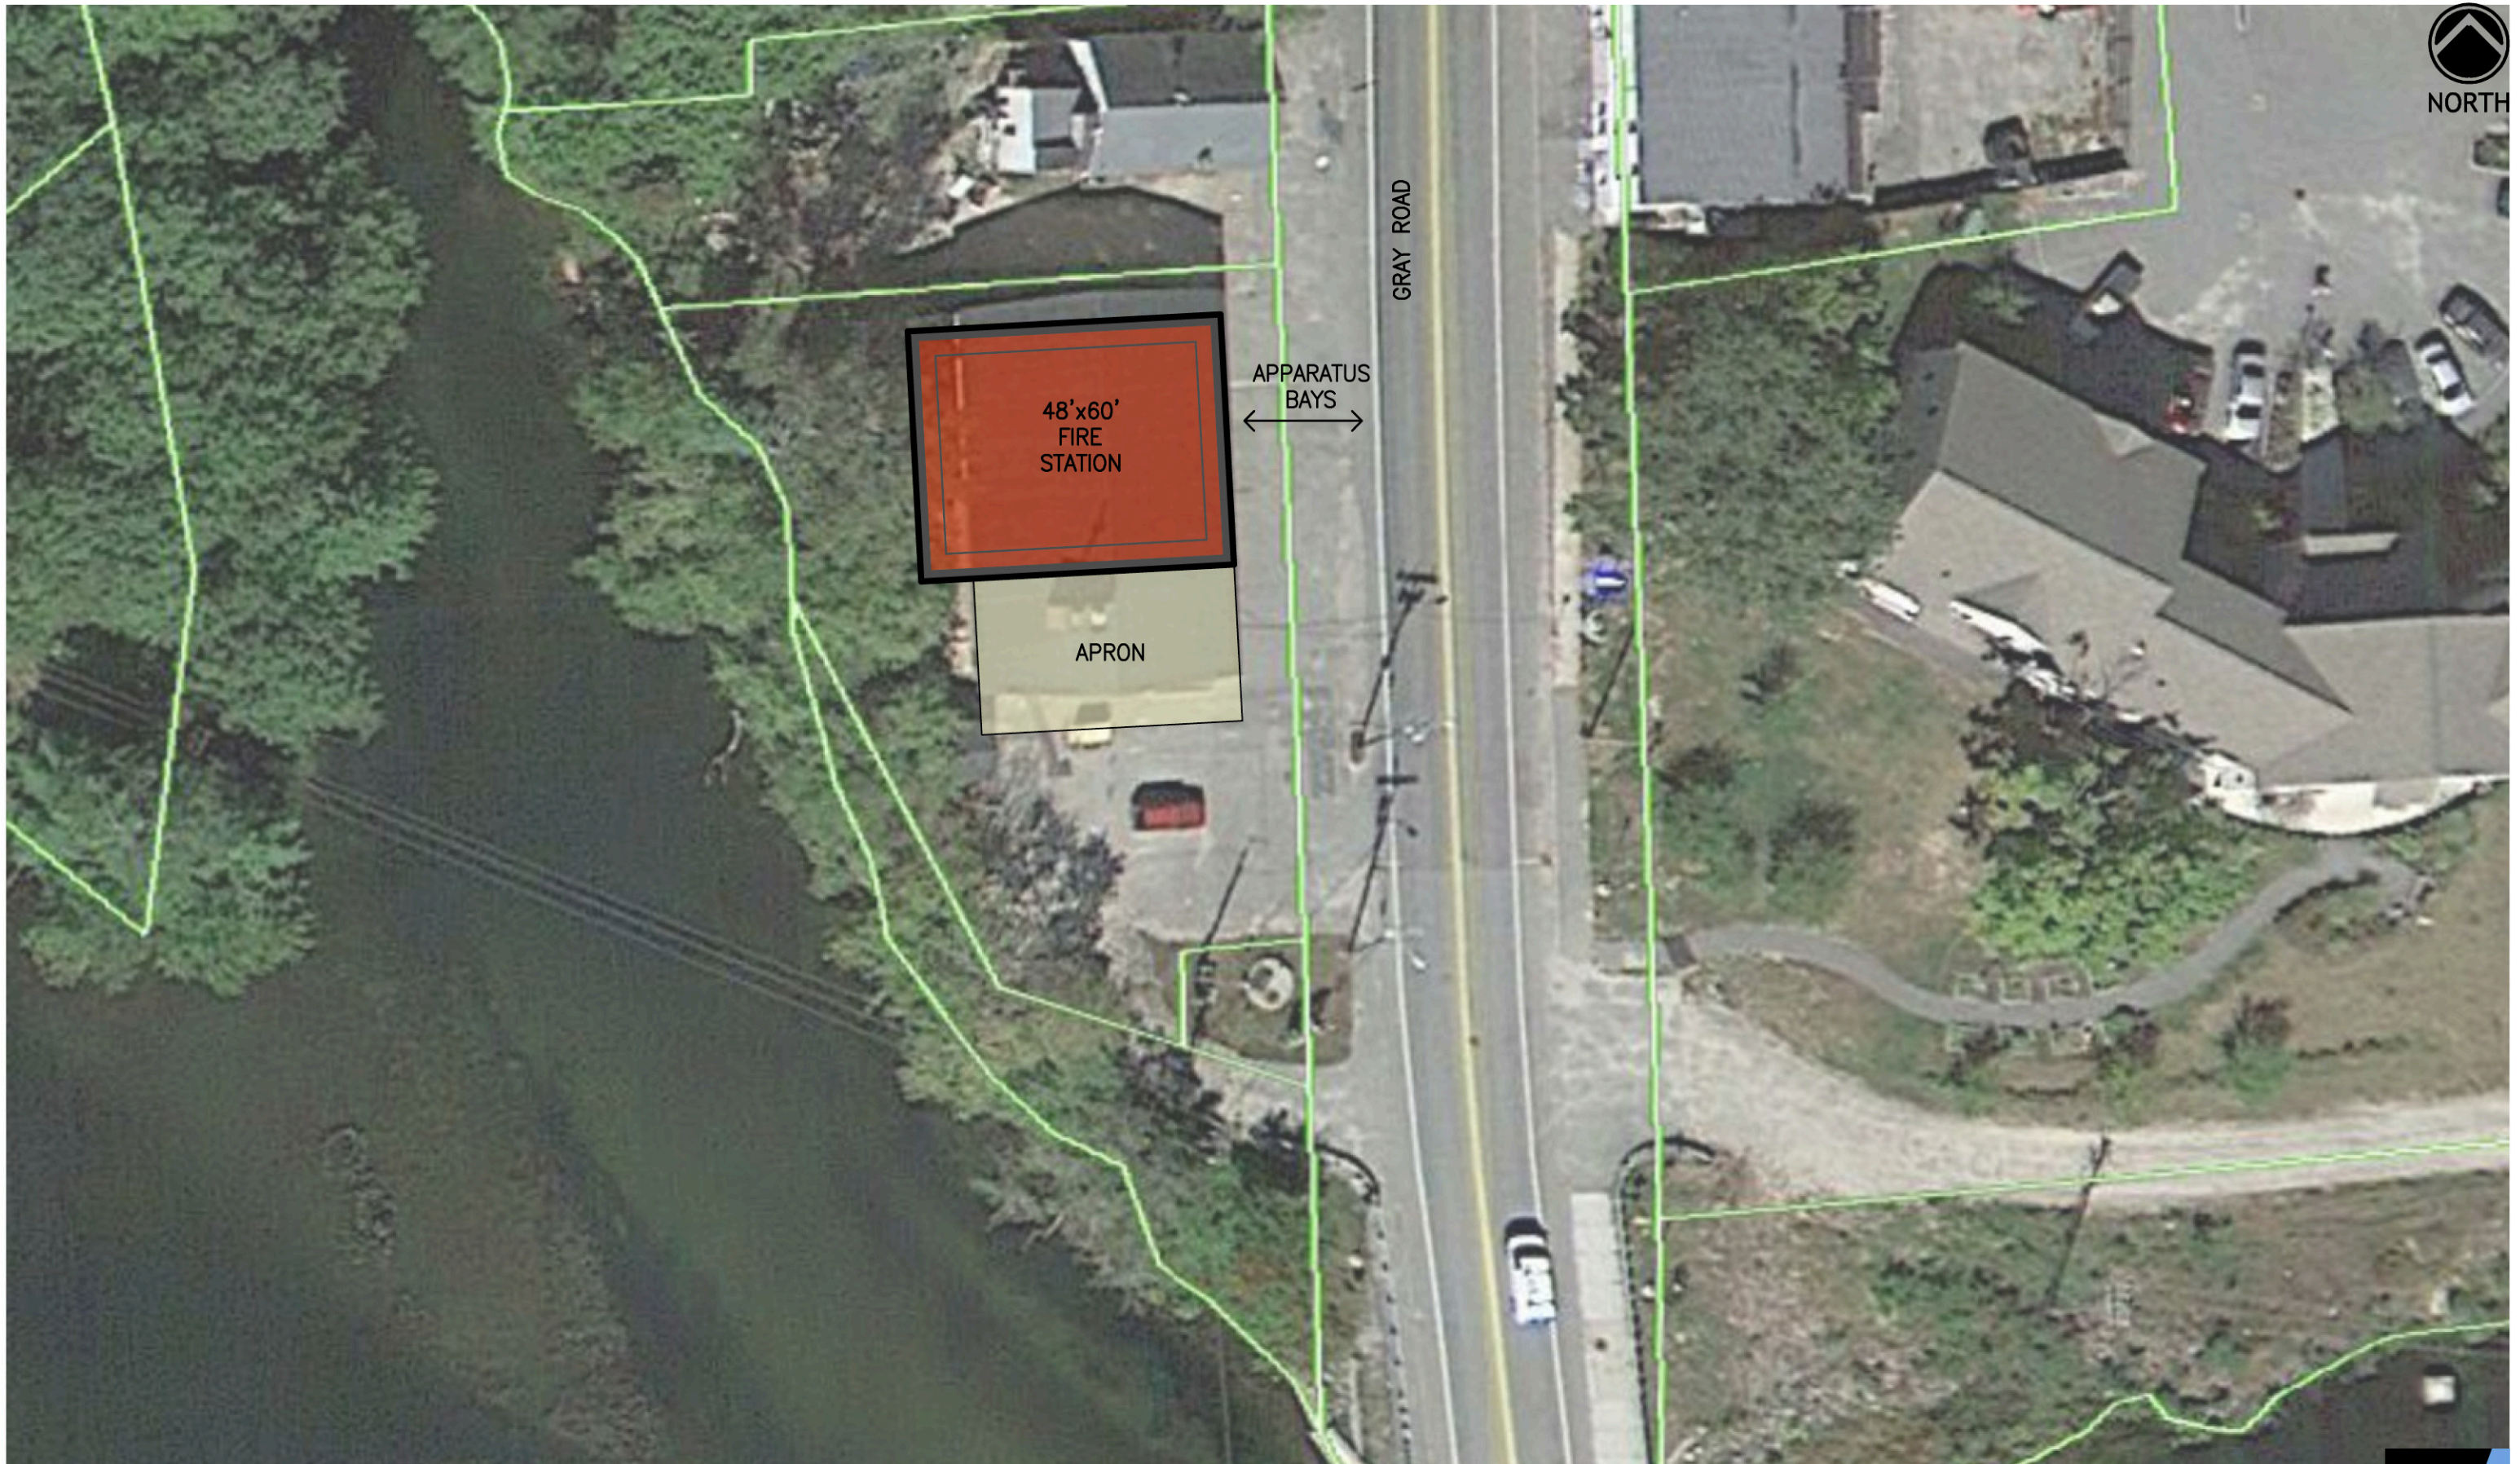
**SOUTH WINDHAM FIRE STATION SITE PLAN**  
SOUTH WINDHAM OPTION 'A' - 48'x60' NEW BUILDING

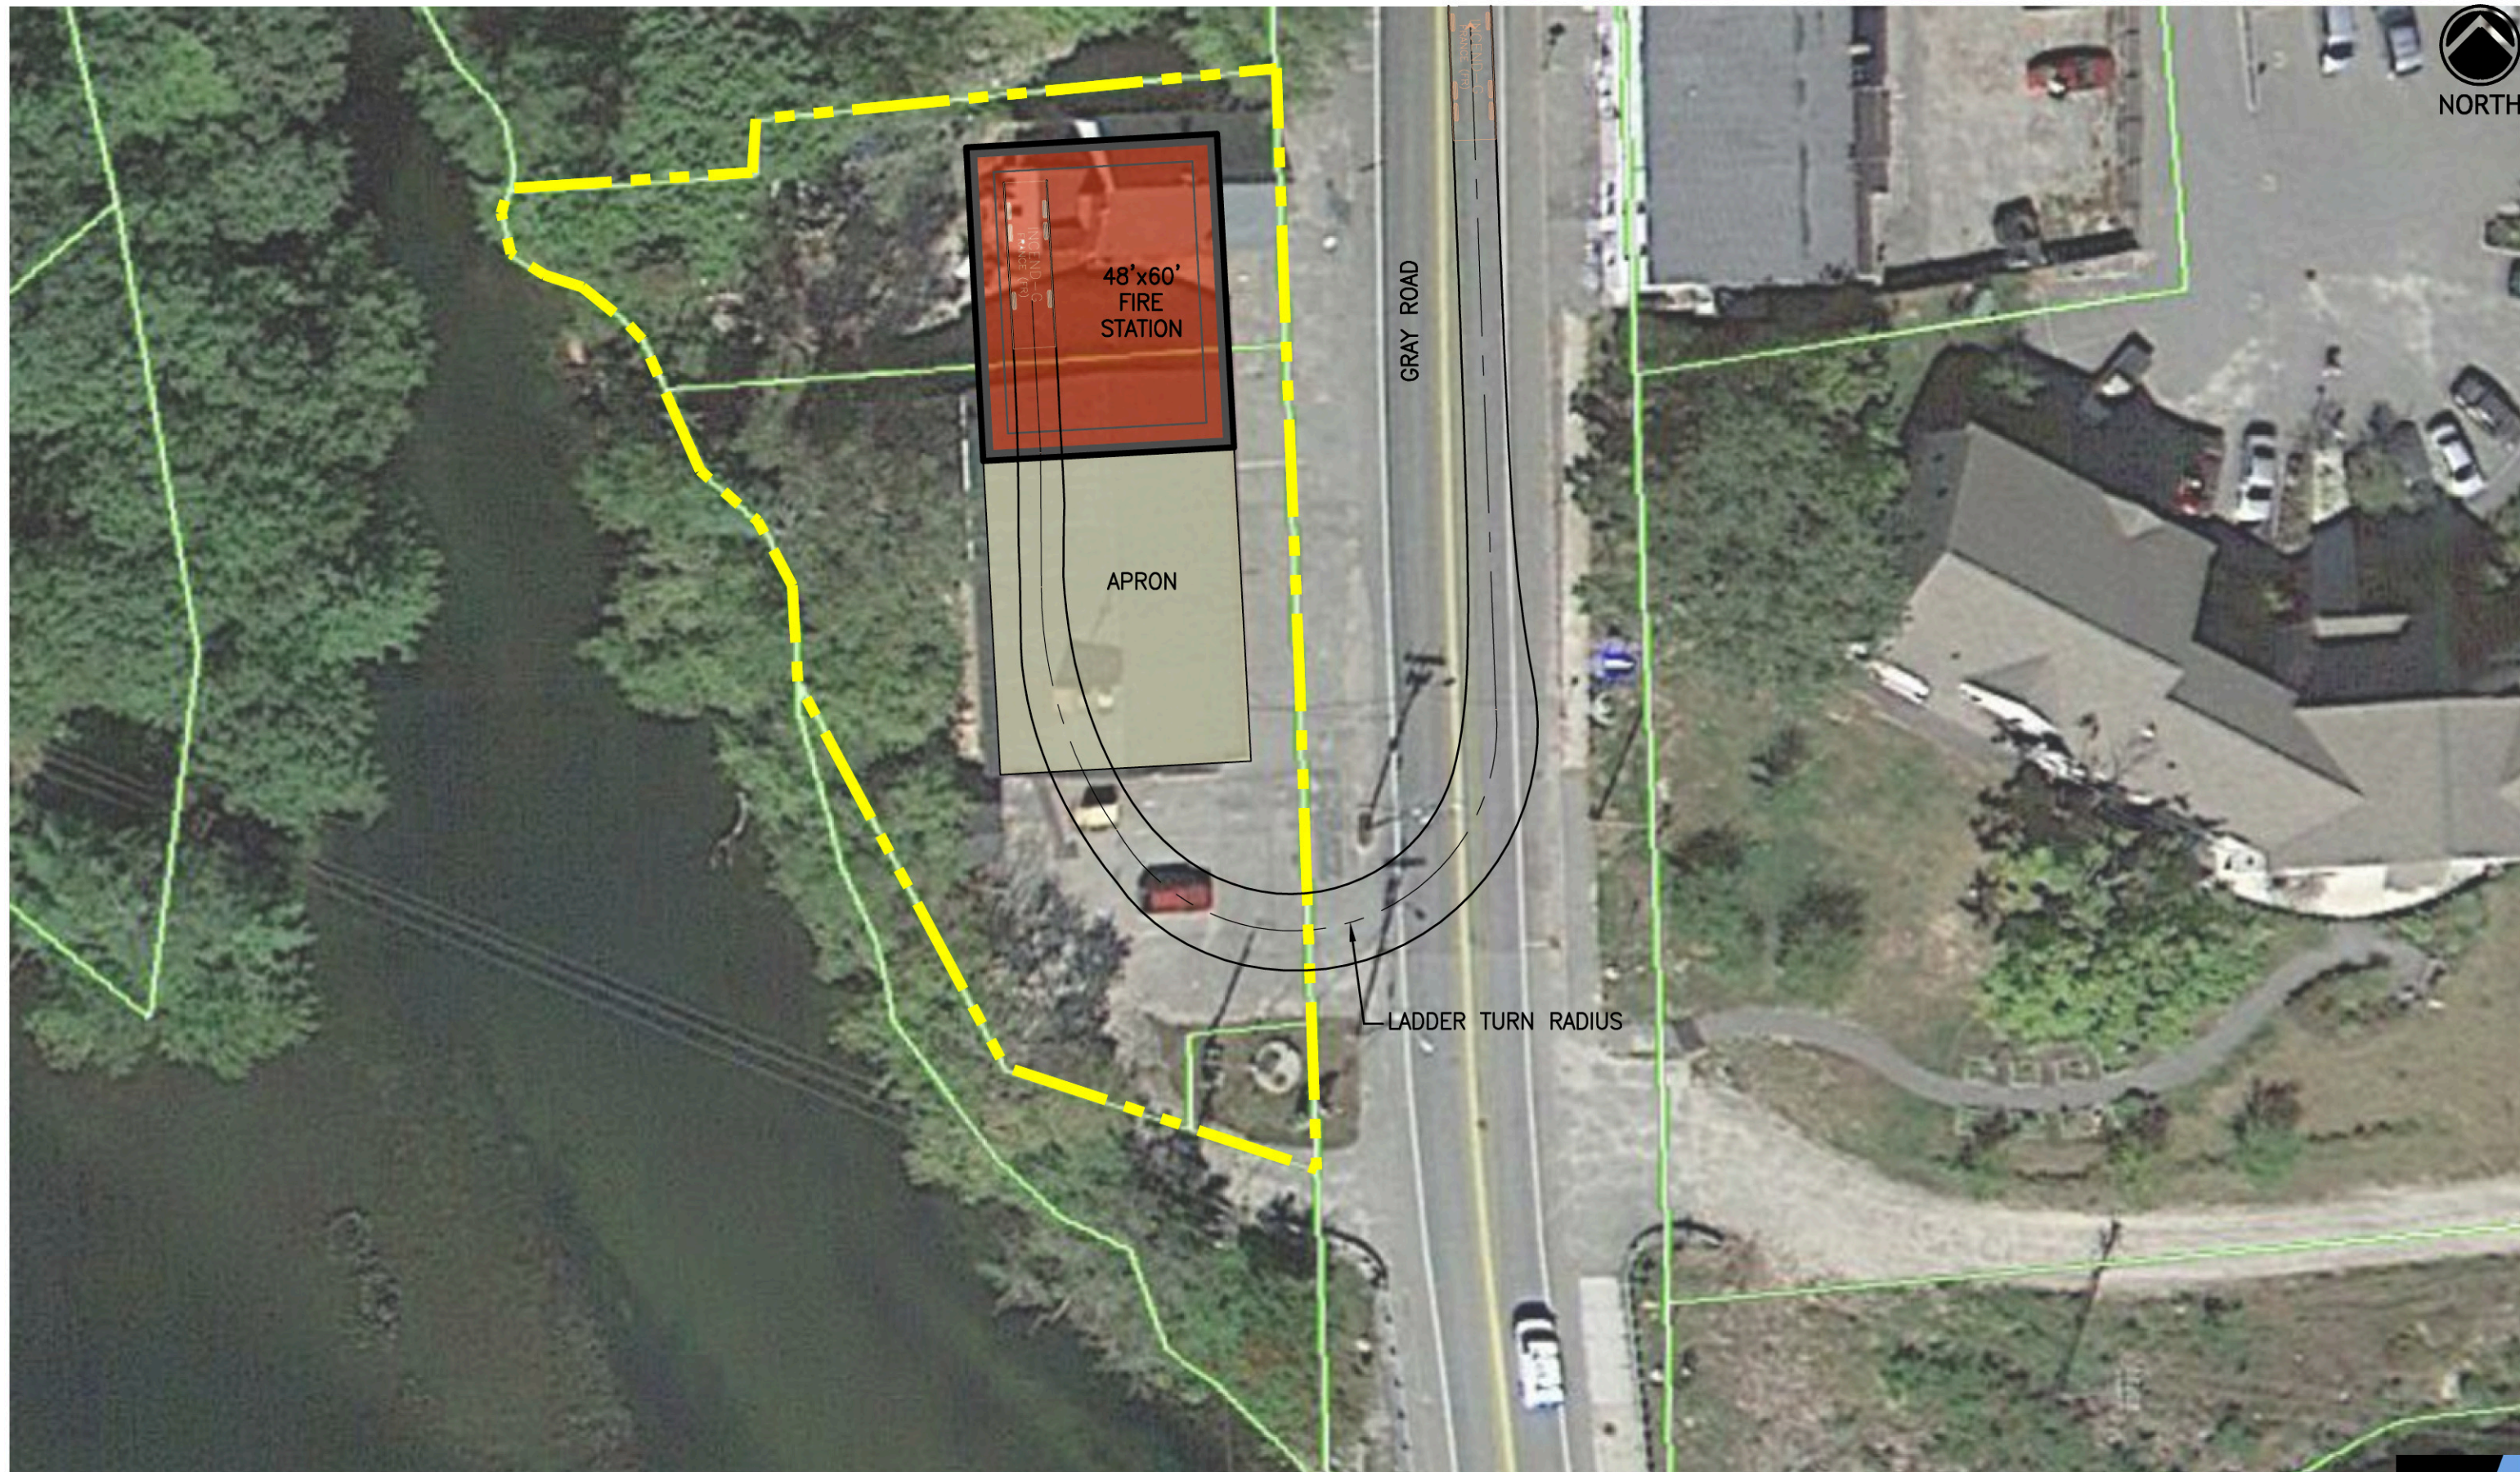
**SOUTH WINDHAM FIRE STATION SITE PLAN**  
 SOUTH WINDHAM OPTION 'B' - 48'x60' NEW BUILDING ON EXPANDED LOT

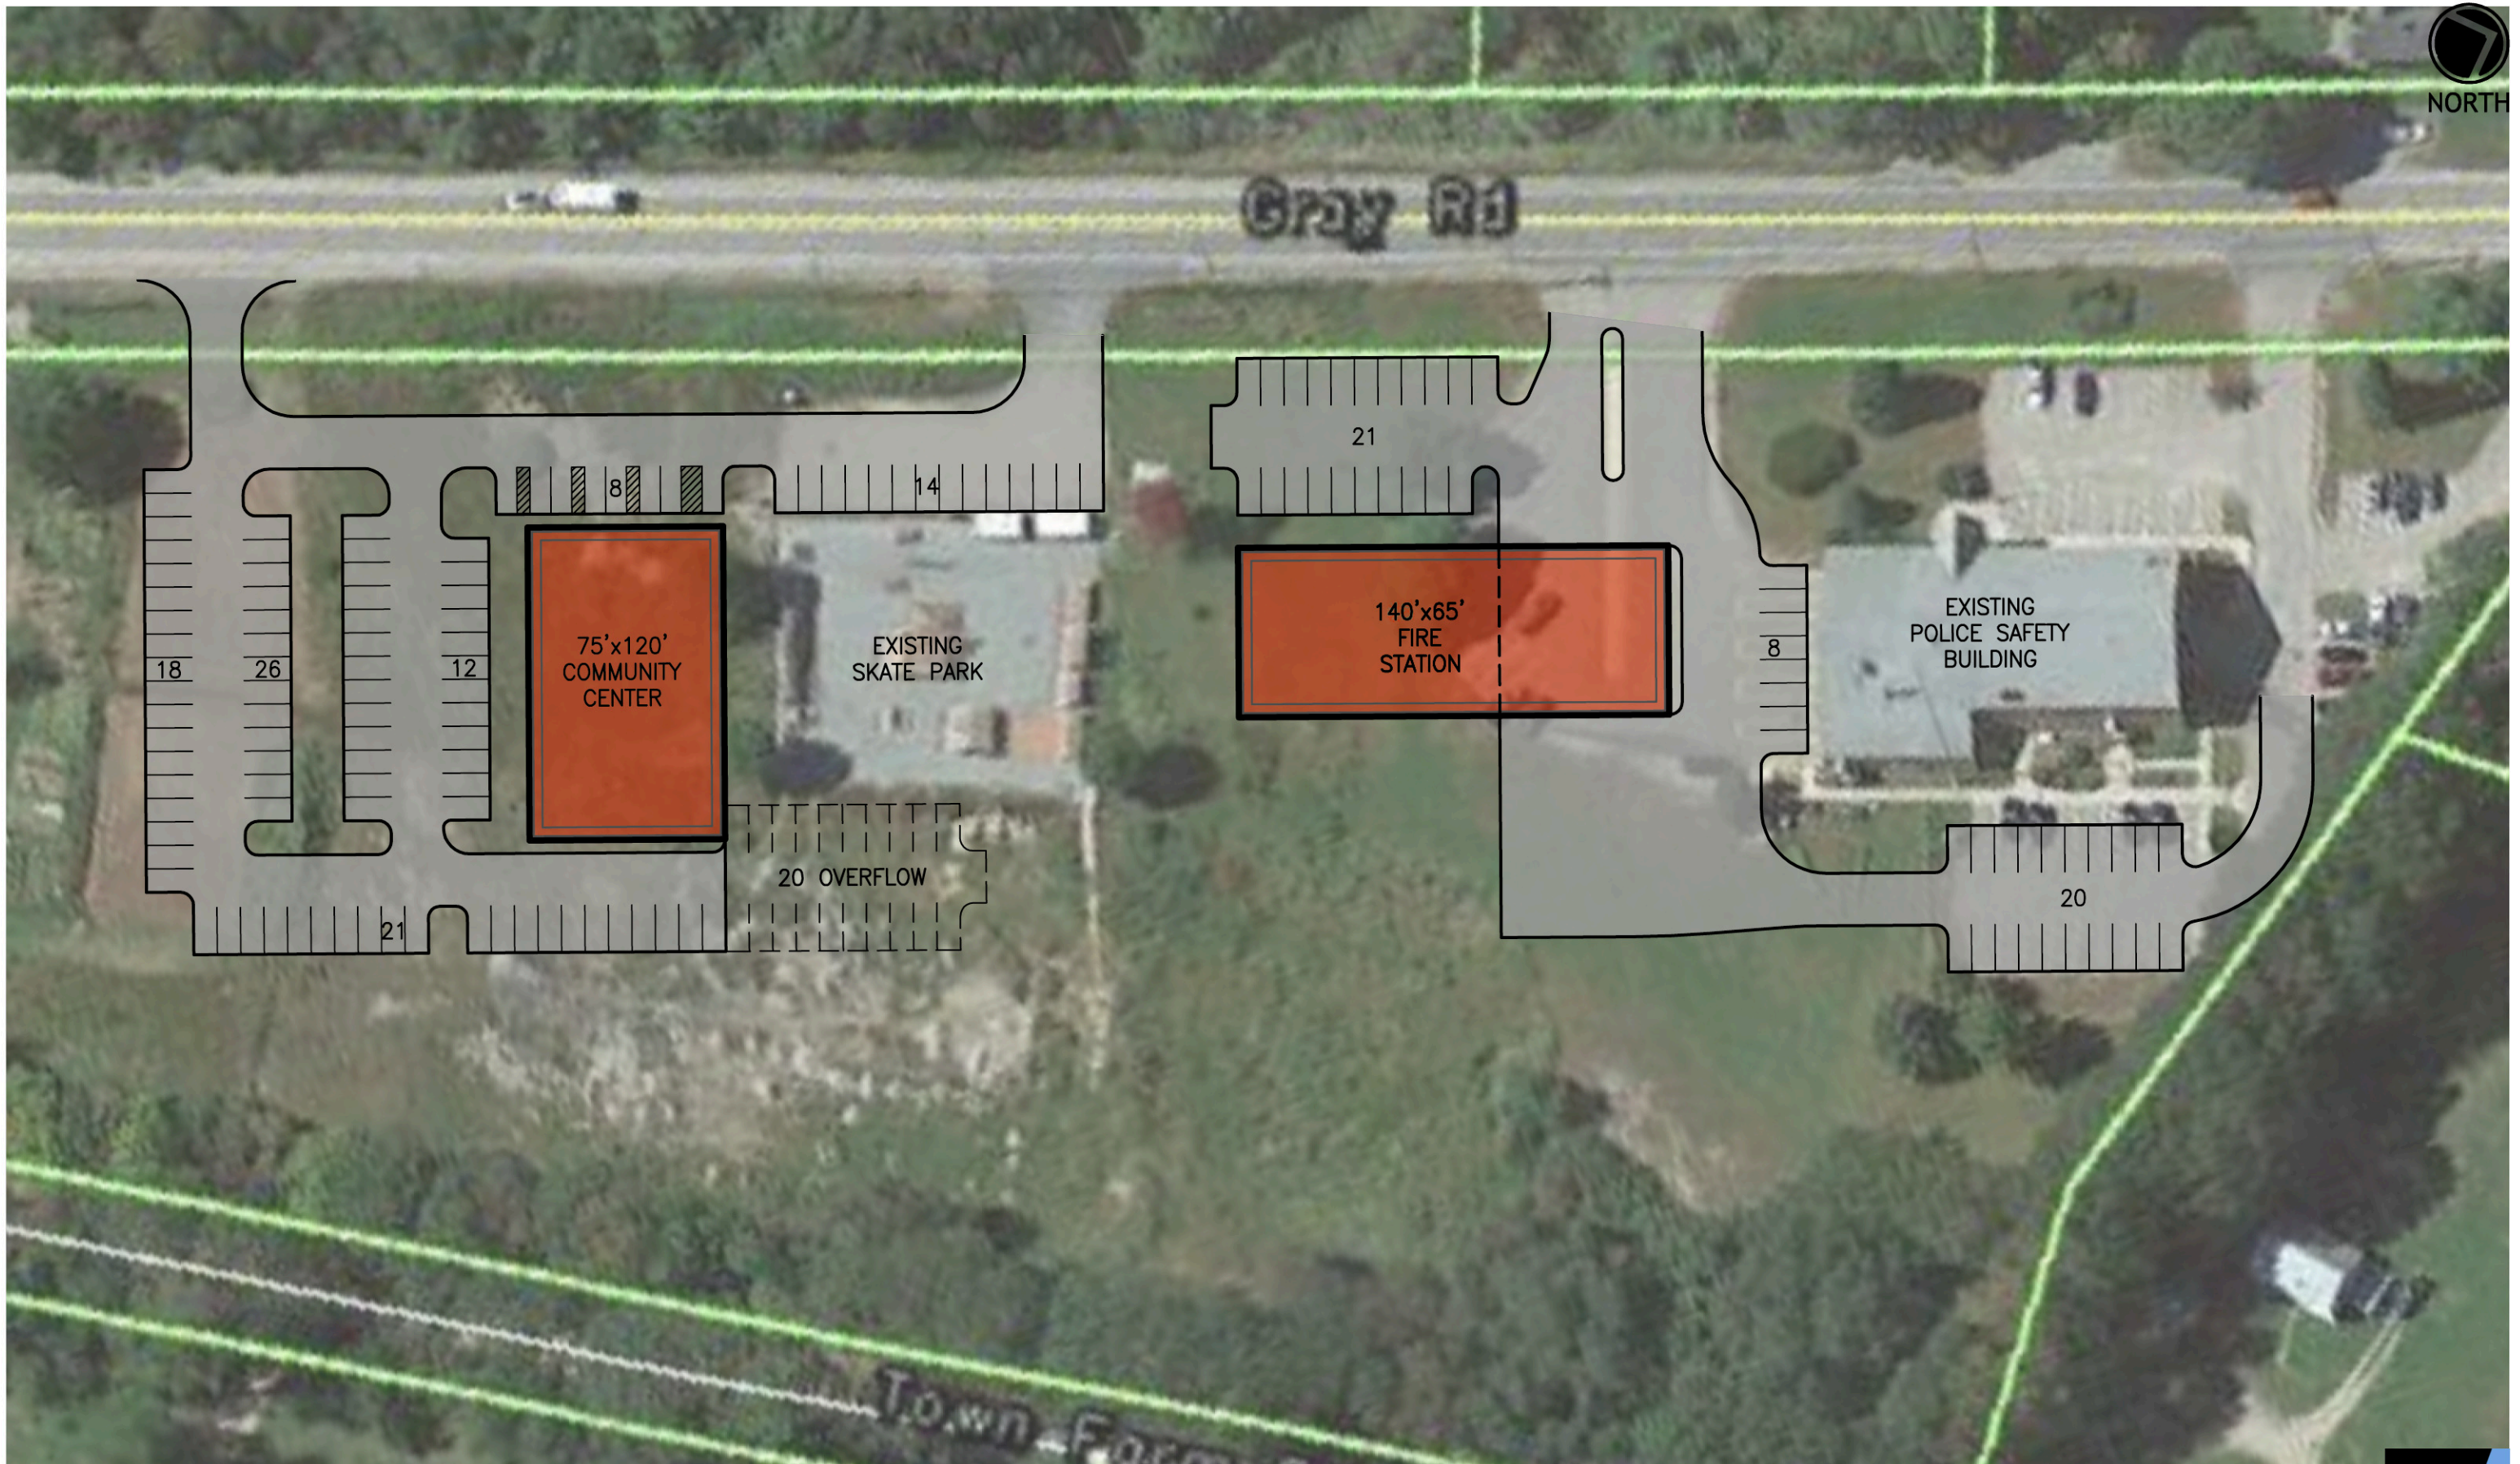
**COMMUNITY CENTER SITE PLAN**  
**COMMUNITY CENTER & TOWN HALL OPTION**
