# Town of Windham

## Municipal Facilities Space Needs Study And Master Plan

## Final Report

September 5, 2014  
SMRT Project No. 13137

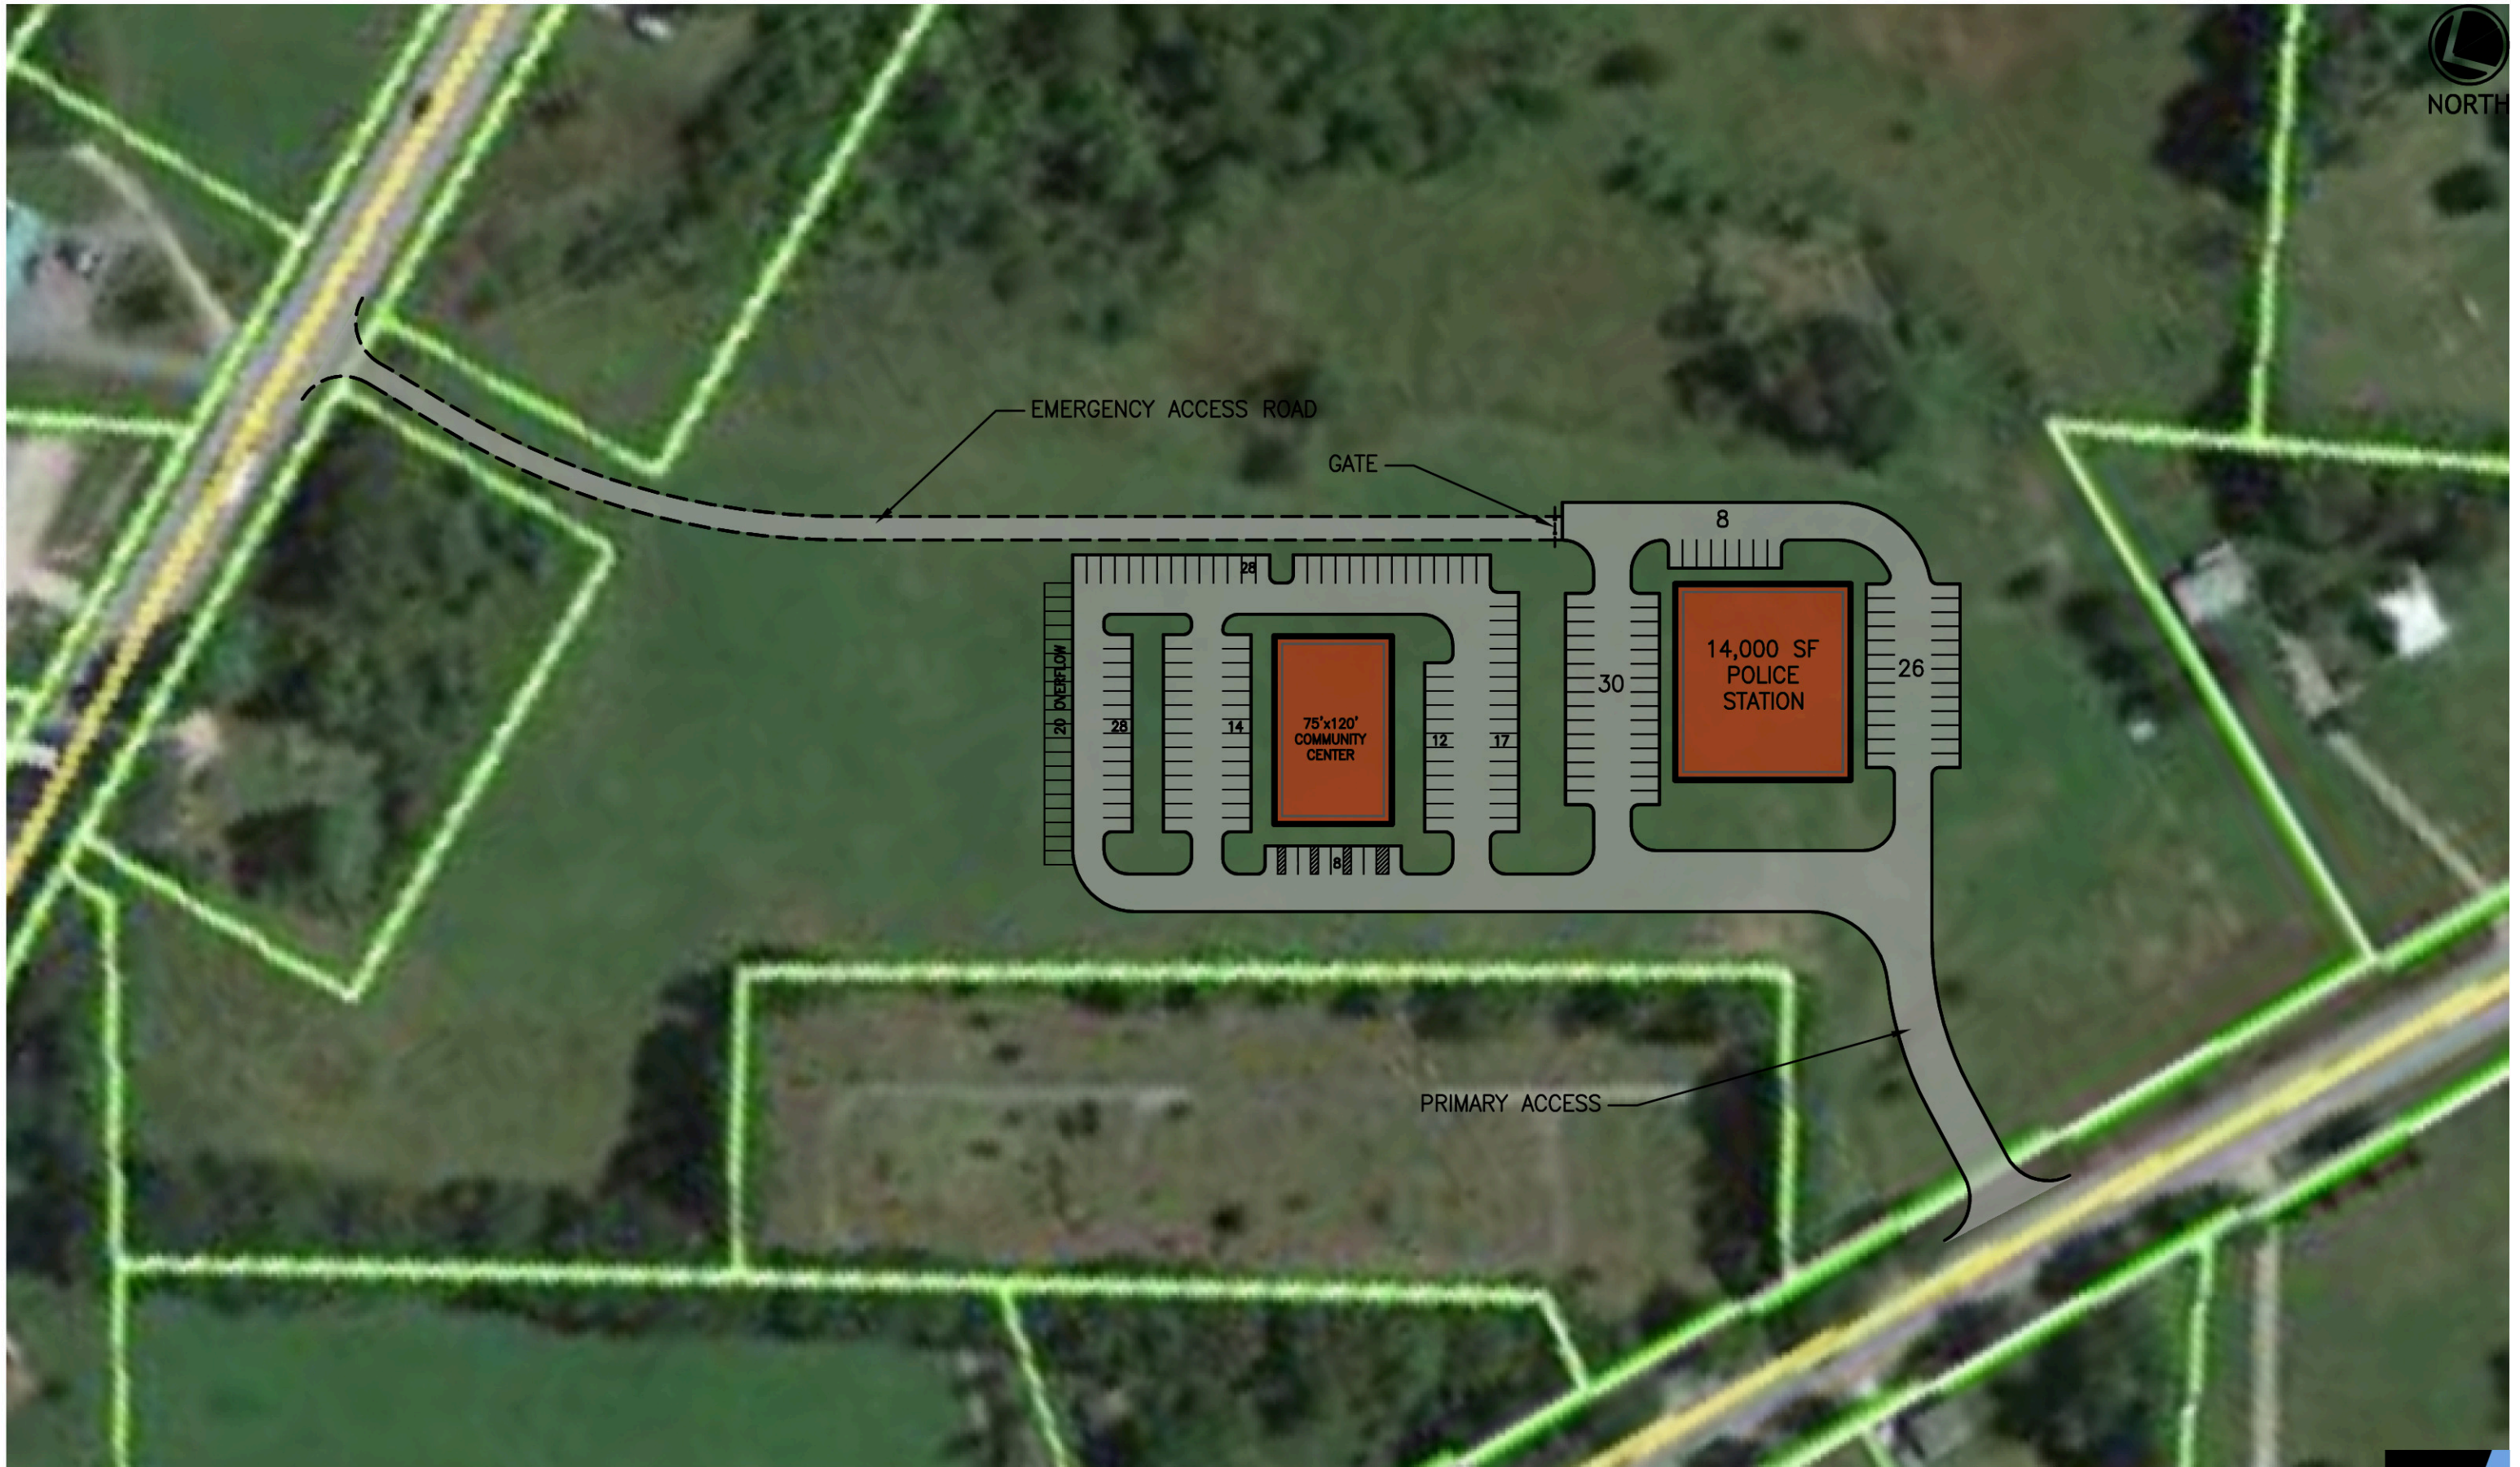
**POLICE STATION SITE PLAN**  
 COMMUNITY CENTER & TOWN HALL OPTION C - MORRELL SITE
