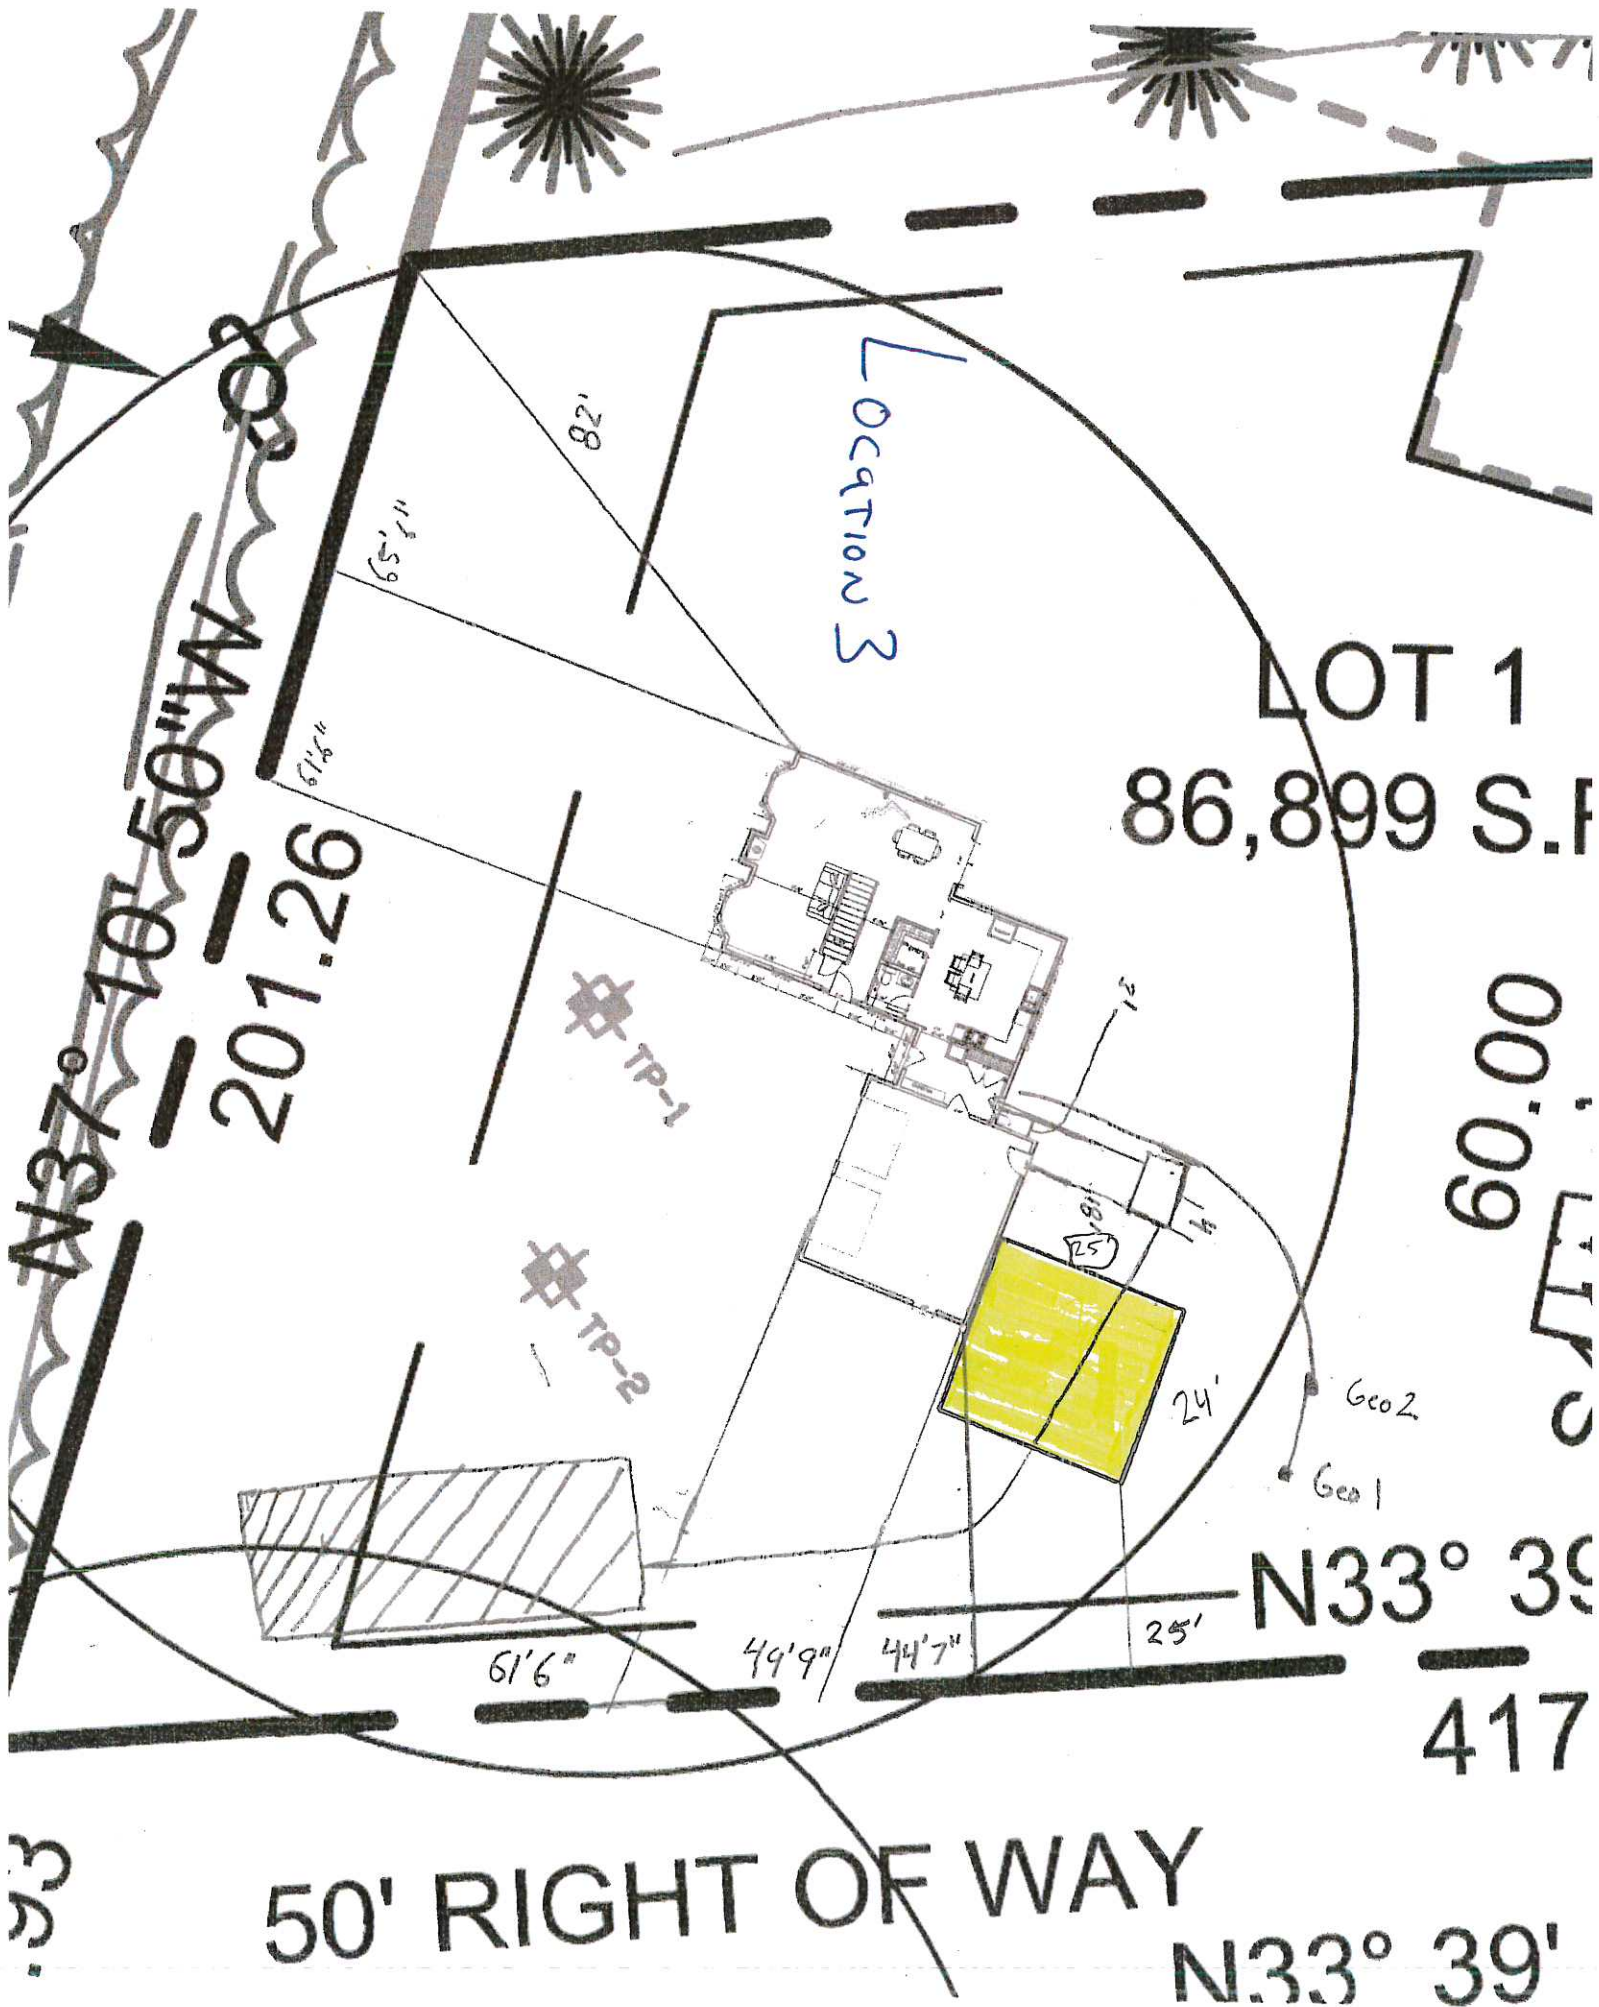
Location 3

Loss of 2 egress windows in Master Bedroom.

Cut new egress windows 2 times into side of house.

The foundation needs more linear feet of frost wall and also more walls constructed.

Re route pump line around foundation

Cut Drywall in finished Garage and re route water line to rear of garage.

Cut Drywall in garage and route all electrical lines through garage wall.

Repainting and retrimming interior windows.

Loss of use of rear garage door. Unable to resale for price recently paid.

Realtor "You will loose value if the addition is not ascetic pleasing or takes away from the functionality of the rest of the house. In this location the Ascetic is dramatically altered form resulting in the potential loss

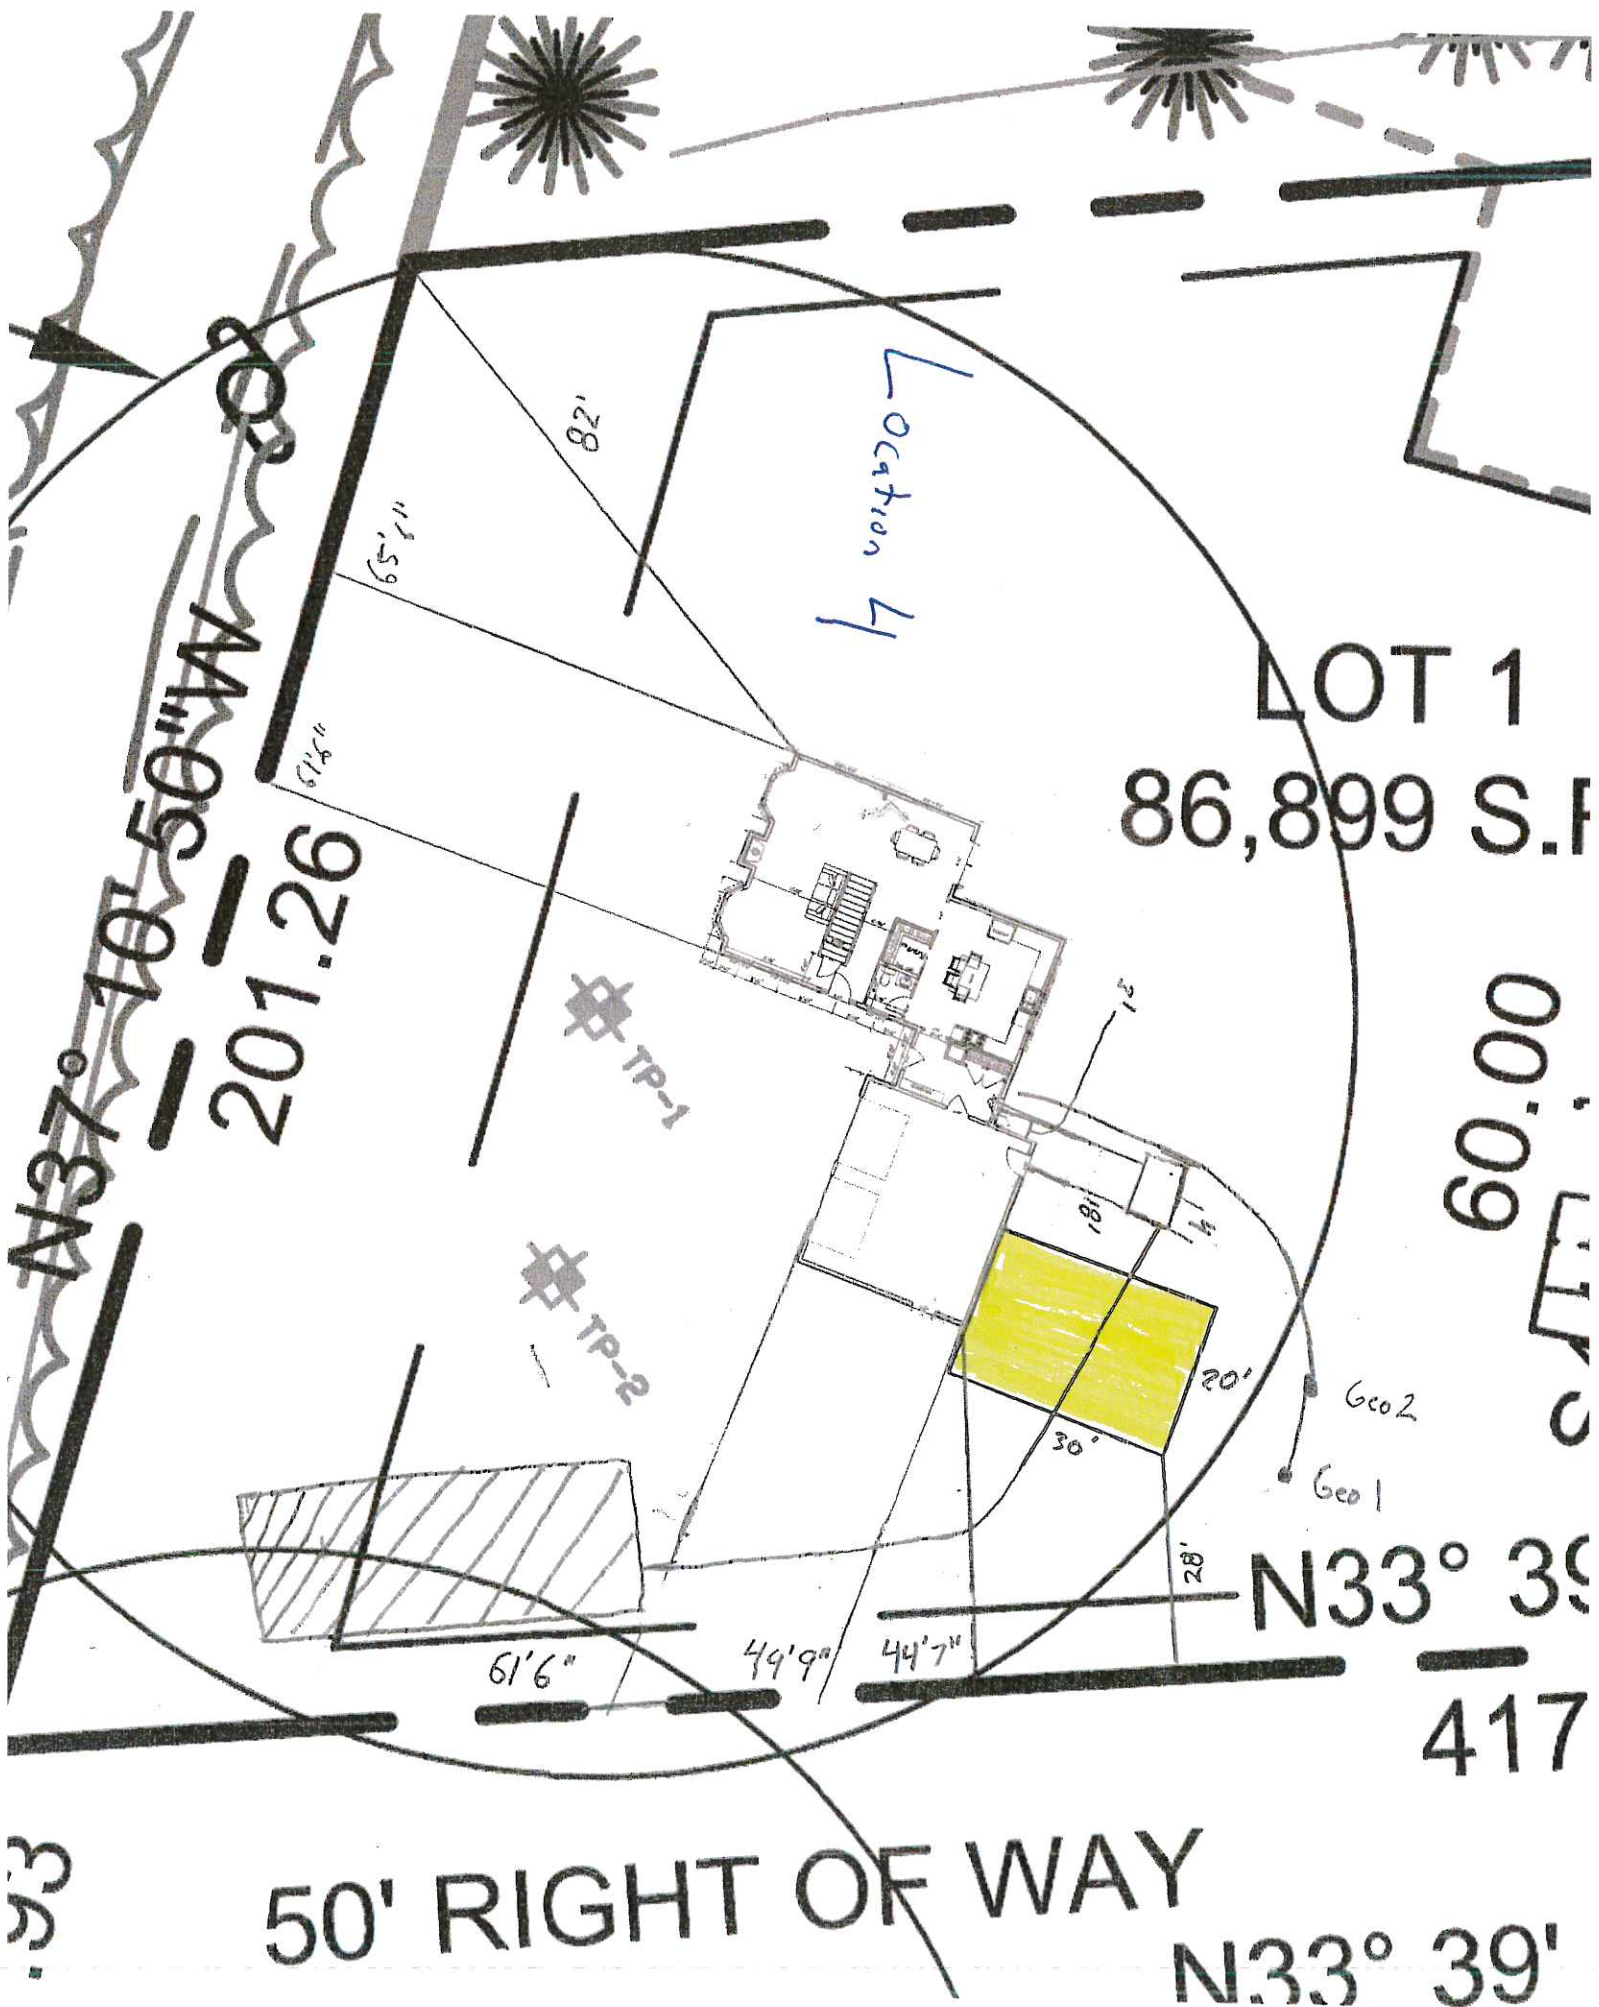
Location 4

Loss of 2 egress windows in Master Bedroom.

Cut new egress windows 2 times into side of house.

The foundation needs more linear feet of frost wall and also more walls constructed.

Re route pump line around foundation

Cut Drywall in finished Garage and re route water line to rear of garage.

Cut Drywall in garage and route all electrical lines through garage wall.

Repainting and retrimming interior windows.

Loss of use of rear garage door. Unable to resale for price recently paid.

Realtor "You will loose value if the addition is not ascetic pleasing or takes away from the functionality of the rest of the house. In this location the Ascetic is dramatically altered form resulting in the potential loss
