FIELD OBSERVATION REPORT

Project: Sebago Heights Subdivision – Phase 5

GPCEI Project No: 2786.69

Visit Date: November 9, 2017

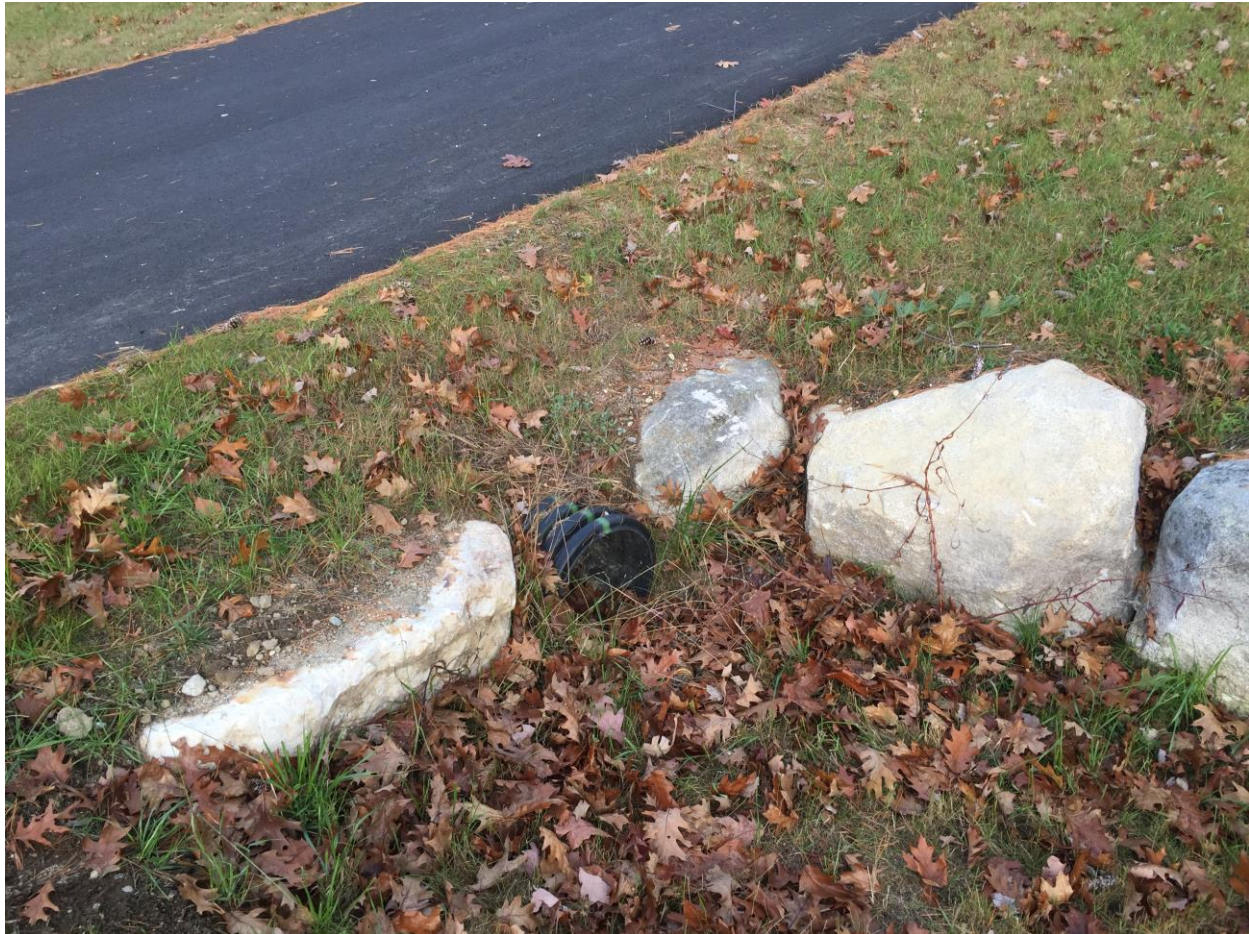
Photo 1 - Construct Riprap Aprons (#79 Harvest Hill Rd).

| 9 | 11/9/17 | | Construct riprap aprons at #79 Harvest Hill Rd |

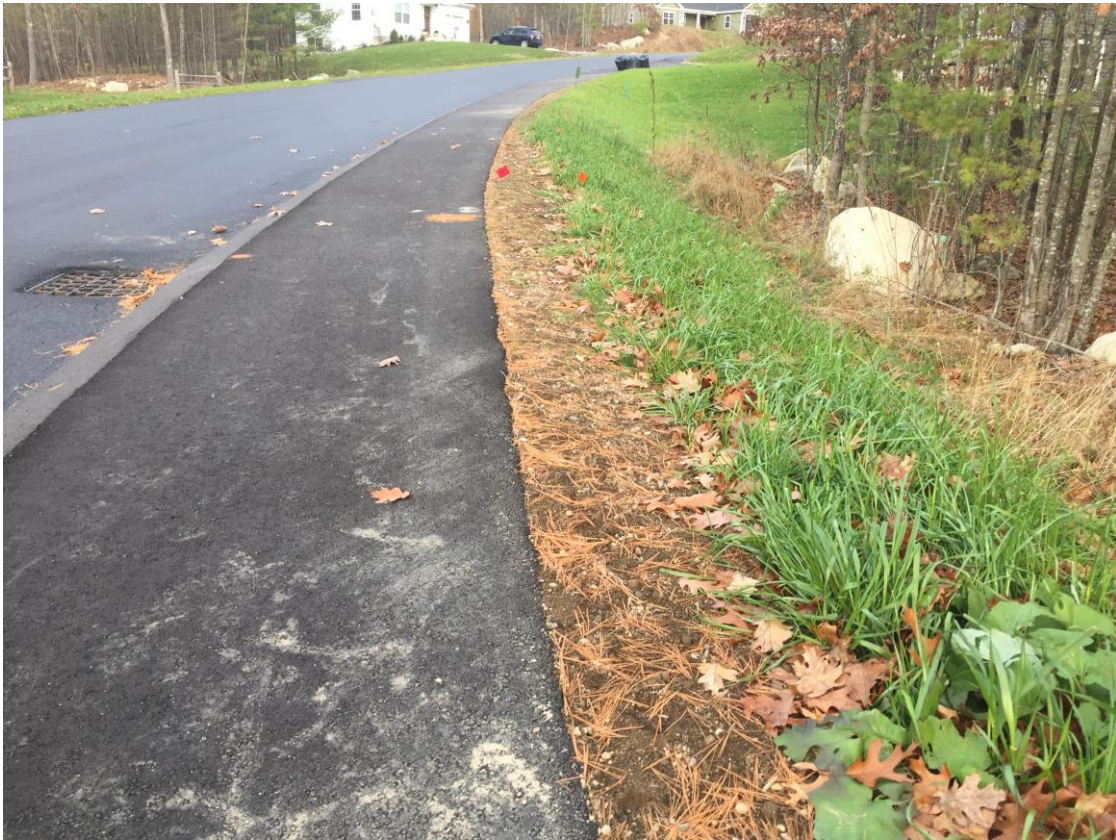
Photo 2 – Re-Seed Loam.

| 10 | 11/9/17 | | Re-seed loam along sidewalk |

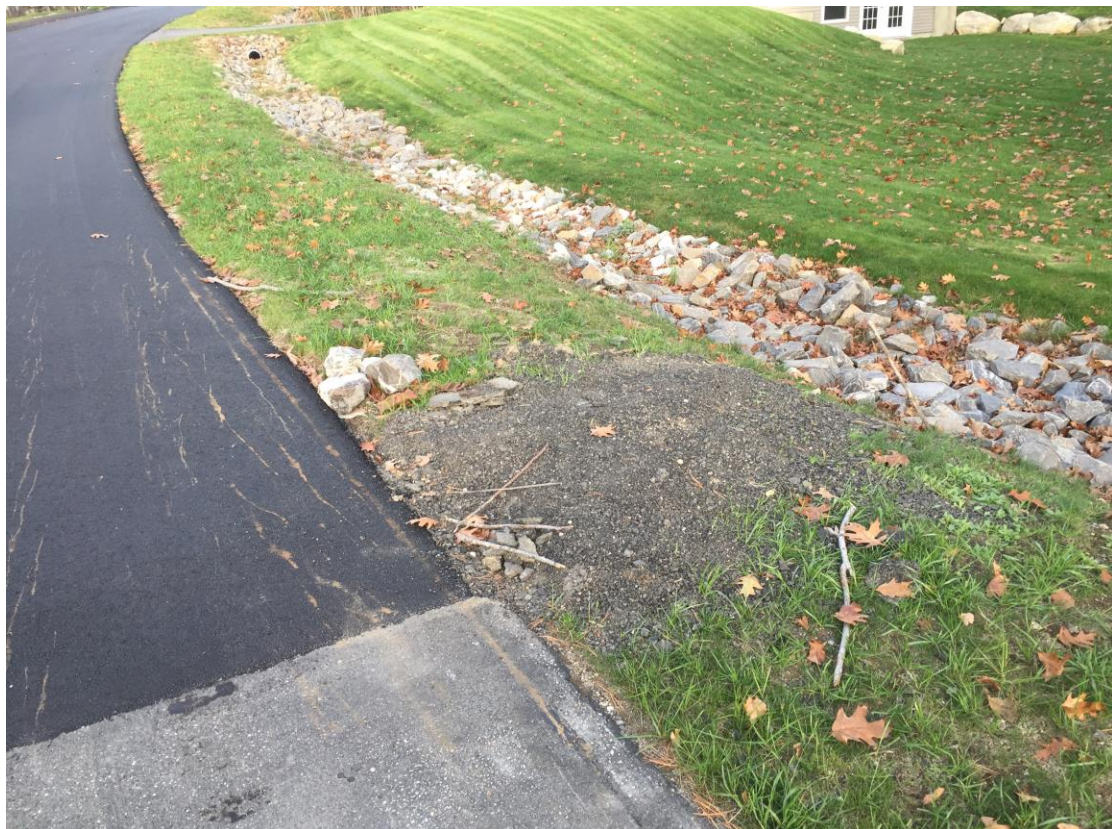
Photo 3 – Remove Pavement Millings (Sta. 38+00).

- OC reviewed the completion of Phase 5 after developer requested acceptance to the Town.
- The following catch basins have accumulated sediment in the sumps and shall be cleaned:
 - CB39 – 6-8"
 - CB40 – 2-4"
 - CB41 – 6-8"
 - CB42 – 24-36"
 - CB43 – 12-24"
- The driveway culvert associated with #79 Harvest Hill Road doesn't have riprap aprons (see Photo 1). Contractor shall construct riprap aprons as shown on the detail plans.
- Loam areas along the back side of the sidewalk hasn't caught grass. Contractor shall monitor and reseed as necessary (see Photo 2). Given the time of year, contractor may be required to re-seed next year.
- Pavement millings (from surface paving) shall be removed – Sta. 38+00 (see Photo 3).

| 11 | 11/9/17 | | Remove pavement millings at Phase 4 butt joint |
