SEBAGO LAKE

WATERSHED NEWS

WINTER 2019

New Sebago Lake Buoy Makes Real Time Data Available to Researchers and the Public

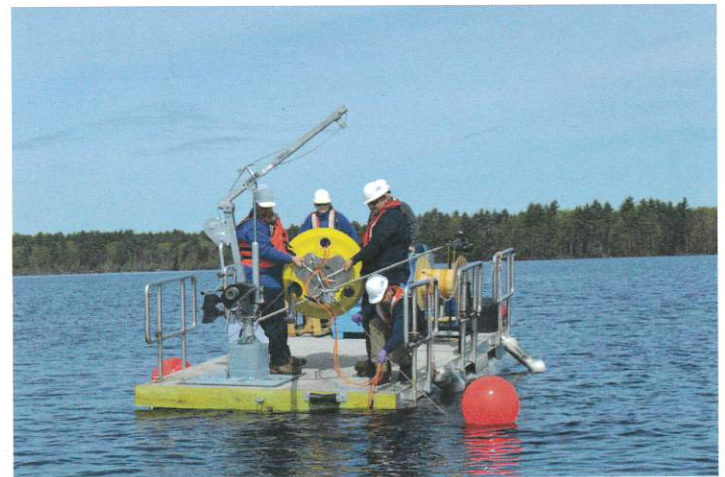
The first step in this grant project was to purchase and install the Sebago Lake buoy. Powered by solar panels and equipped with a variety of sensors, the 145-pound buoy is located at Lower Bay's deepest point. The buoy records and wirelessly transmits data on temperature, dissolved oxygen, chlorophyll (a measure of algae in the lake), water clarity, and

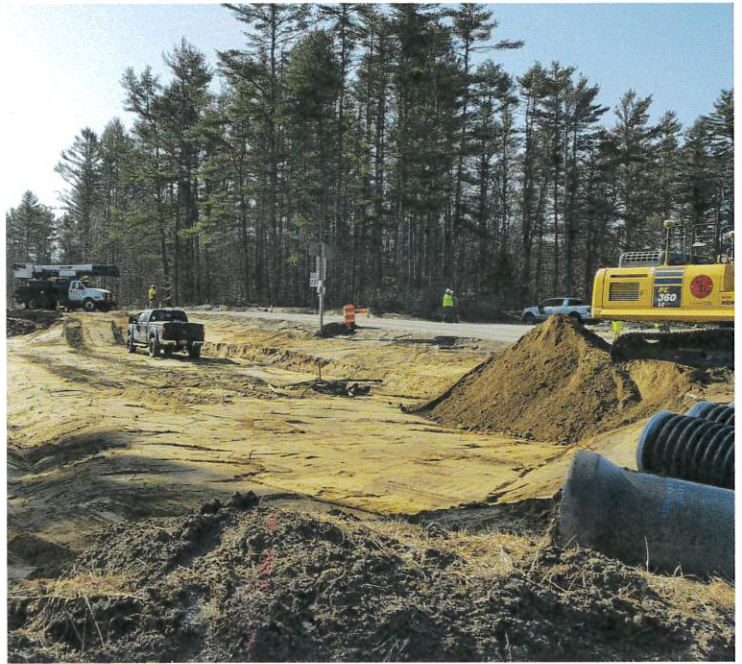
Moving the Rte. 35 and 237 intersection

- Directing stormwater to the side of Route 35 that is farthest from the lake
- Moving the intersection of Routes 35 and 237 to the east so that the corner no longer points directly toward a lake viewing area adjacent to the shores of Lower Bay
- Adding a turning lane for traffic taking a left onto Route 237
- Improving the site distance to the southwest of the intersection with Route 237

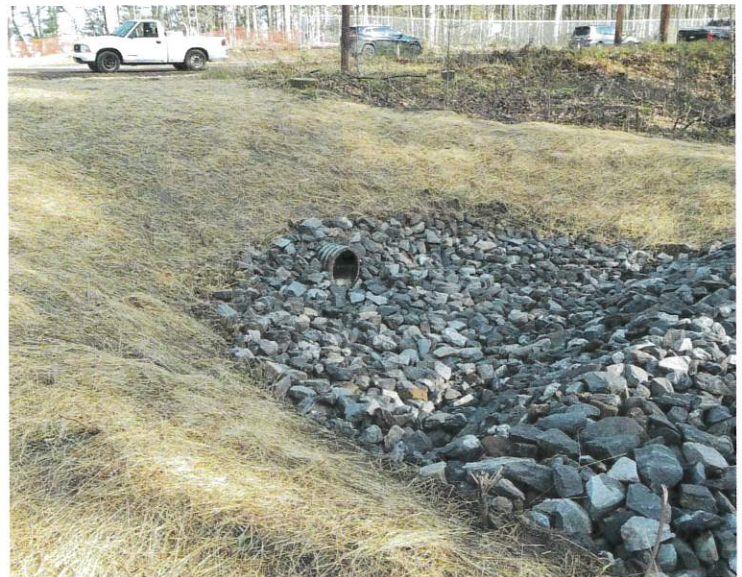
Level lip spreader installed to prevent ditch erosion

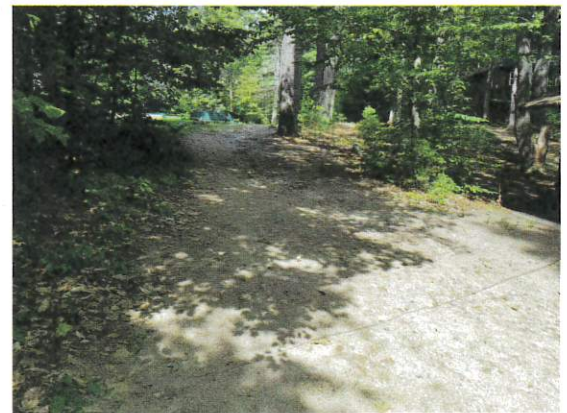
Before – eroding hillside

Camp O-AT-KA is located on the shorefront of Sebago Lake in the town of Sebago. The camp's property is on a hillside that slopes steeply down to the lake. Over the years, the camp has dealt with stormwater running down the hillside, throughout the camp, and causing soil erosion along the way. This summer the camp was eager to fix some of these problems. Fortunately, the District and the Cumberland County Soil and Water Conservation District (CCSWCD) had some money available through a federal Clean Water Act grant; a grant that was designed to protect the water quality of Sebago Lake. CCSWCD evaluated the stormwater runoff at the camp and provided numerous recommendations for reducing erosion and infiltrating stormwater runoff. Over the last few months the camp has completed the following projects: installation of Geoweb (plastic webbing) filled with crushed stone to stabilize an eroding roadway, enhancement of existing infiltration steps, definition of walkways with crushed stone and mulch, and installation of a crushed stone trench in front of the Great Hall to absorb roof runoff. The camp reports that these projects have helped to significantly reduce the amount of runoff flowing into Sebago Lake.

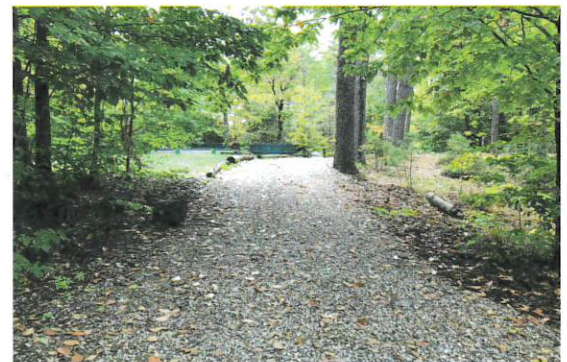
After – hillside stabilized with Geoweb filled with crushed stone
